## FAILURE OF GAS TURBINE CONE BURNER BY CARBURIZATION

### **Abstract**

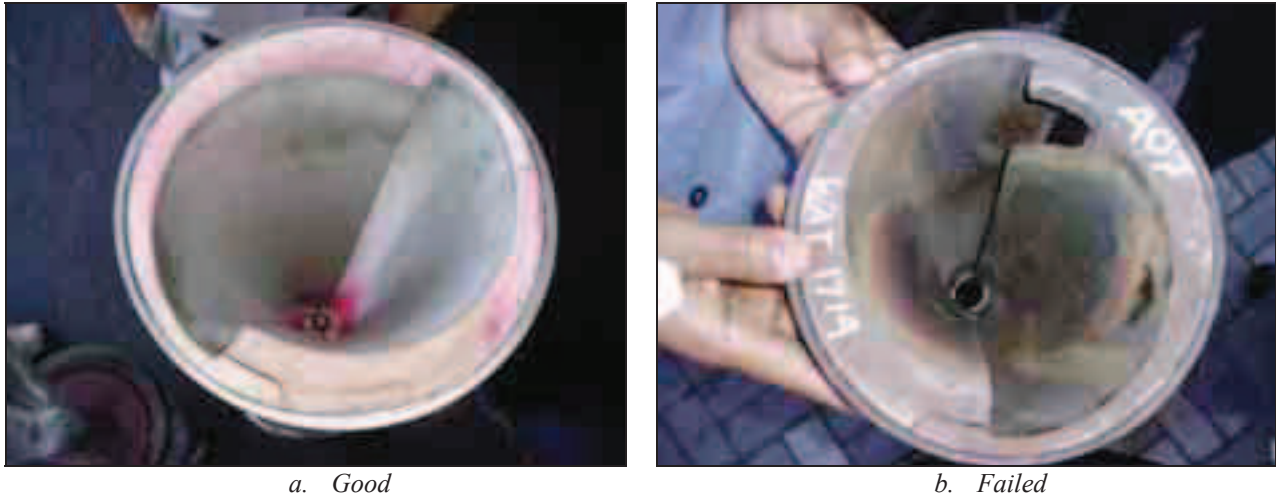
Fig. 2. Comparison between good and failed cone burners

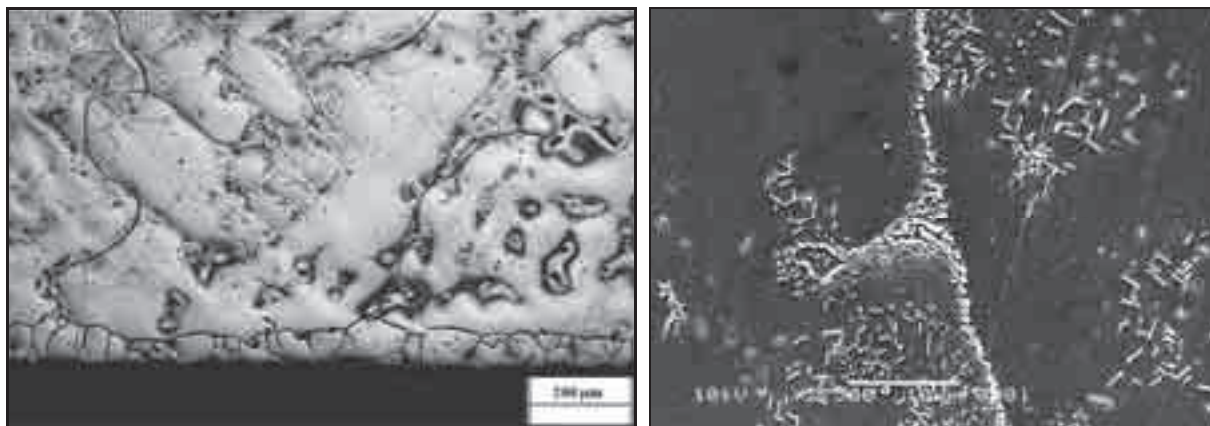
Microstructure of cone A at the lowest temperature section is shown Fig. 3. The microstructure consists of austenitic matrix and fine carbide distribution along grain boundaries and inside the grain (Fig. 3b). Cone burner was manufactured by casting as indicated by the irregular and elongated grains geometry.

Fig. 3. Microstructure of cone A, lowest temperature section

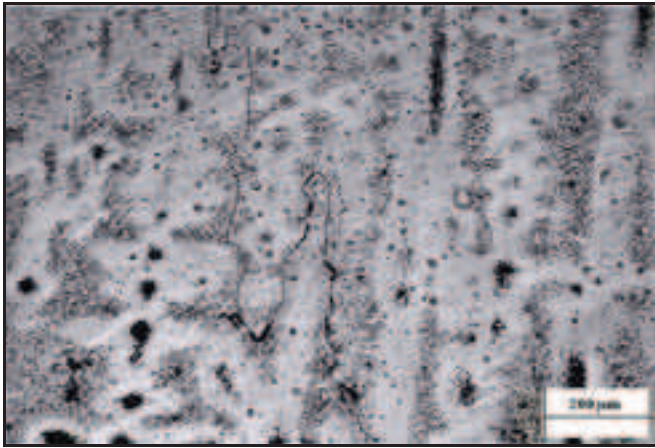
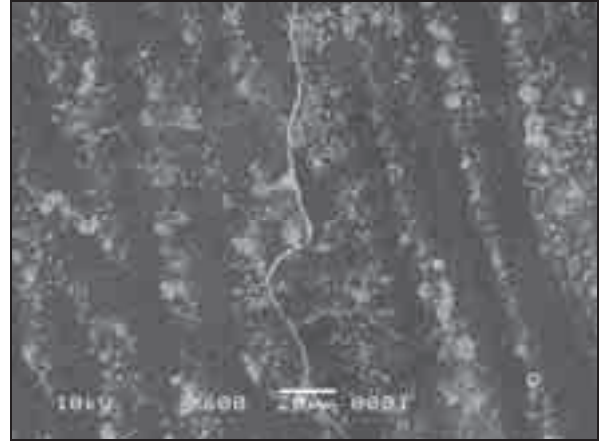
Figure 4 shows the microstructure of cone B from the lowest temperature section. Cone B is also manufactured by casting as shown by the geometry of the grain. Carbide precipitates were evident along grain boundaries and inside the grain. Carbide volume fraction in cone B is much higher than that of cone A because cone B has been exposed longer than cone A. Carbide precipitation will increased with higher exposure (aging) time.

*Fig. 4. Microstructure of cone B, lowest temperature section*

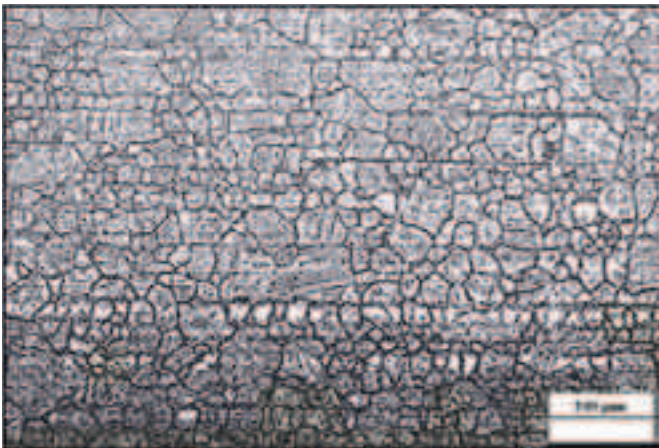
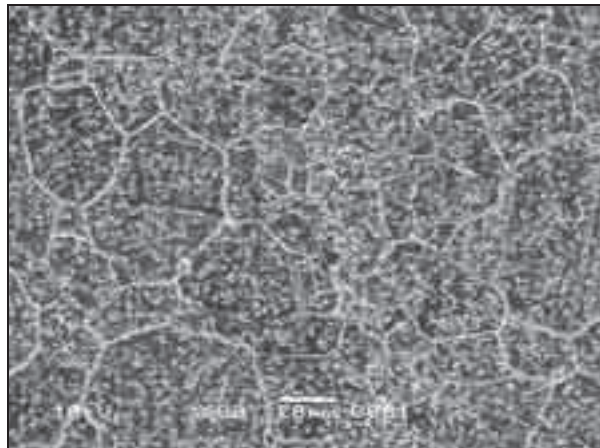
The fresh material for repair is not available because the repaired process was done by outside workshop, therefore the observation has to be done on repaired section at the least attack part. The microstructure consists of equiaxed austenitic matrix grains (Fig. 5). Material for repair is not cast material but hot rolled plate under solution-annealed condition. Fine carbide precipitates in material are due to the effect of exposure during service.

*Fig. 5. Microstructure of material for repaired*

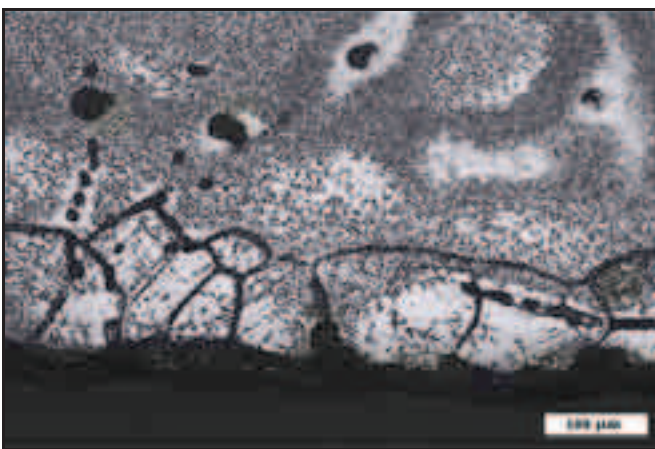
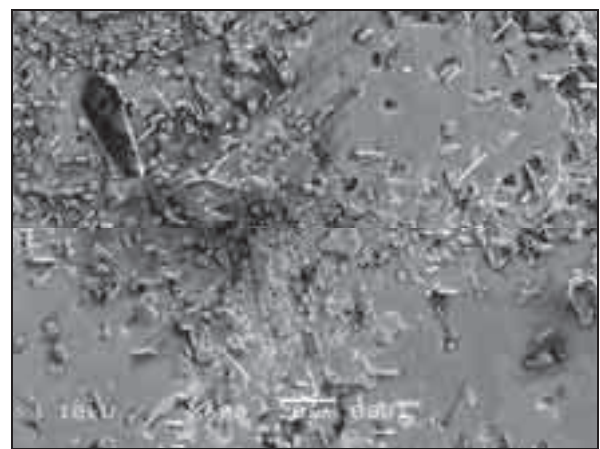
Microstructures of the damage cone bonner are shown in Fig. 6 to 8. Carbide precipitates volume fraction increase significantly even the maximum carbon content in Hastelloy X is 0.1%, therefore carbon in the combustion gas diffused into material (carburization) during the service. Carburization occurred because the service temperature is above 650°C and carbon potential in combustion gas is high.

*Fig. 6. Microstructure of damaged cone A*

Carbides in cone burner material consist of primary and secondary carbides. Primary carbides are formed during casting while secondary carbides precipitate and growth during service (aging). Two types of carbides were examined, fine, and coarse carbides (Fig. 6b). Summary of examination is shown in Tab. 3. Aluminum in the measurement result is the trace of alumina particle for polishing.

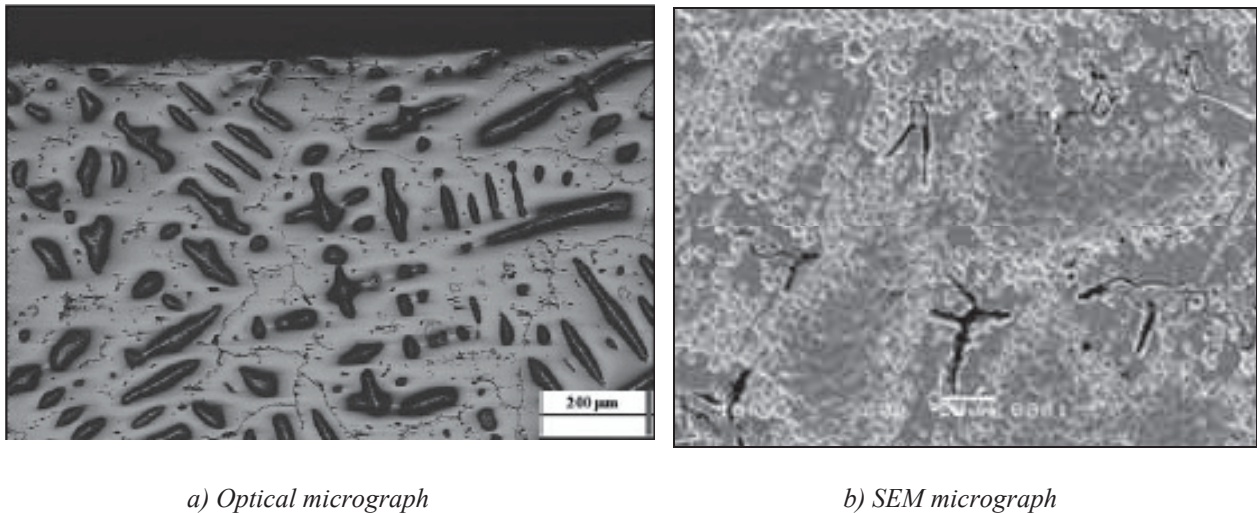
Fig. 7. Microstructure of damaged cone B

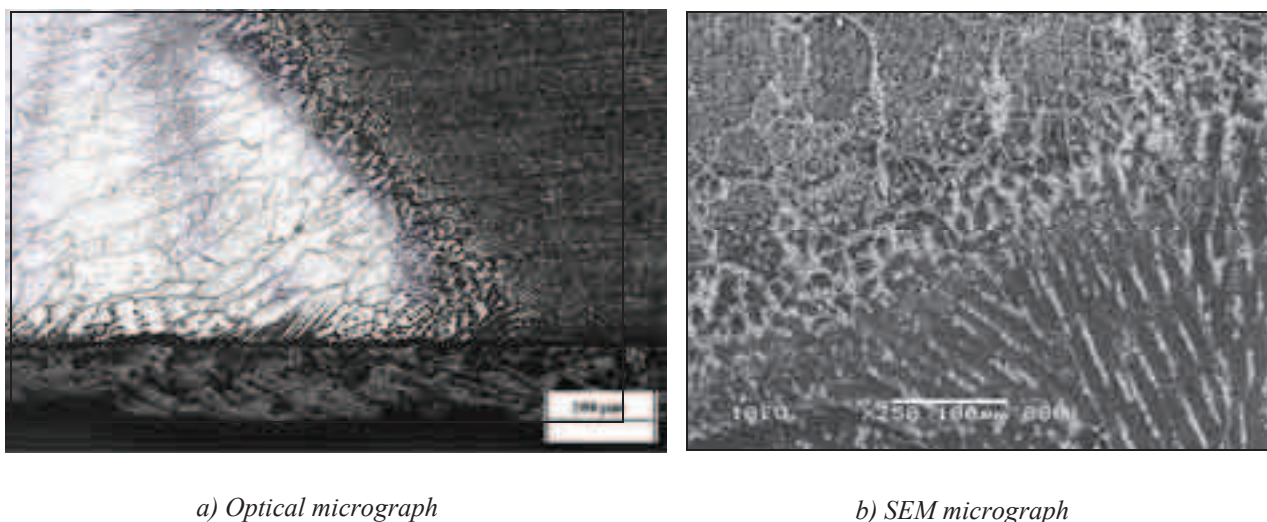
Fig. 8. Microstructure of damaged material for repaired

Figure 8 shows the microstructure at the interface between cone burner base metal (bright) and repaired material (dark). Carburization in repaired material is much severe compared to that of base metal (Fig. 8a) because carburization occurred through grain boundary diffusion [3]. Grain boundary diffusion rate of carbon in repaired material is much higher than the base metal because the repaired material has much finer grain size. Volume diffusion dominant in the near surface region.

coating on the edge breaks, the fresh surface is exposed to the carbon environment and initiates the carburization attack. Welding repair has successfully extend cone burner life but longer life extension can be expected if material for repair has a coarse elongated grains similar to that of cone burner material.
