## FAILURE OF GAS TURBINE CONE BURNER BY CARBURIZATION

### **Abstract**

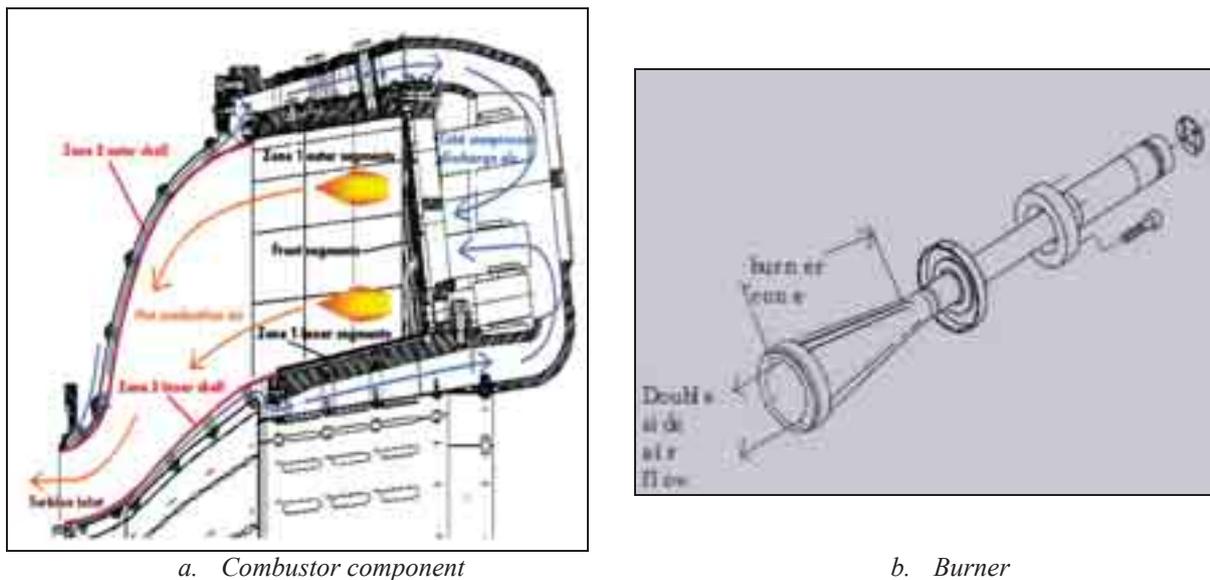
Fig. 1. Annular combustor in gas turbine engine [4]

The gas turbine engine (133.8 MW, 3000 rpm) was commissioned in 1997 and has 72 annulus burners. High-speed diesel oil fuel is injected into the combustion chamber and at the same time, water is also injected through oil lance tip nozzle. The purpose of water injection is to soften the flame and reduced the emission (NOx), and to increase the fuel flow rate that will shift the flame forward. The inhomogeneity of water and fuel distribution will result in inhomogeneous combustion that can damage the burners. Fig. 1 shows the schematic of combustion chamber and the geometry of the annulus burner.

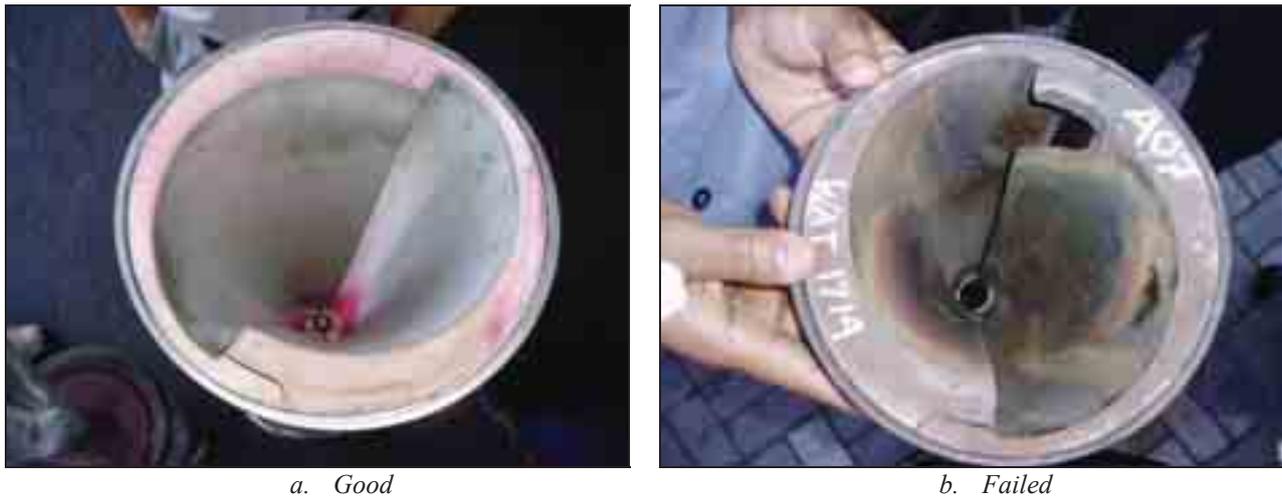
Fig. 2. Comparison between good and failed cone burners

Periodic maintenance schedule recommended by the Original Engine Manufacturer (OEM) is 24,000 equivalent operating hours (EOH), however the recommended service hours cannot be achieved because the hot gas path especially the cone burners were failed every 6,000 EOH even the fuel and water flow have been adjusted and optimized accordingly. Sixty percent of the burner cones failed and has to be replaced with the new one after 18,000 EOH instead of 48,000 EOH as stated in the engine manual. Fig. 2 shows the comparison between good and failed cone burner. The exposed surface of a new cone burner was coated by thermal spray to prevent direct contact with the combustion gas. Failure occurred on the edge side (Fig. 2b). The burner life was extended by welding repair followed by coating of the damaged section for every 6,000 EOH.

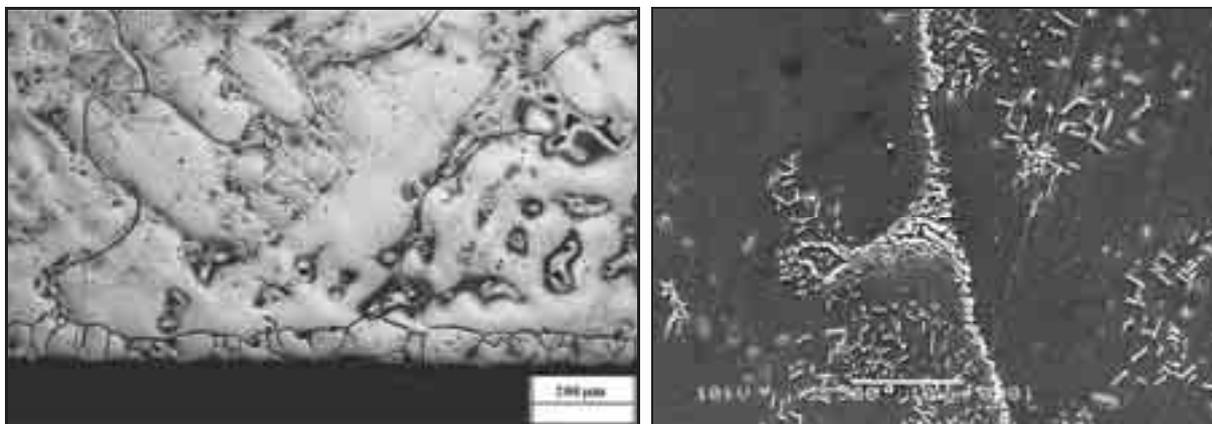
Fig. 3. Microstructure of cone A, lowest temperature section

Microstructure of cone A at the lowest temperature section is shown Fig. 3. The microstructure consists of austenitic matrix and fine carbide distribution along grain boundaries and inside the grain (Fig. 3b). Cone burner was manufactured by casting as indicated by the irregular and elongated grains geometry.

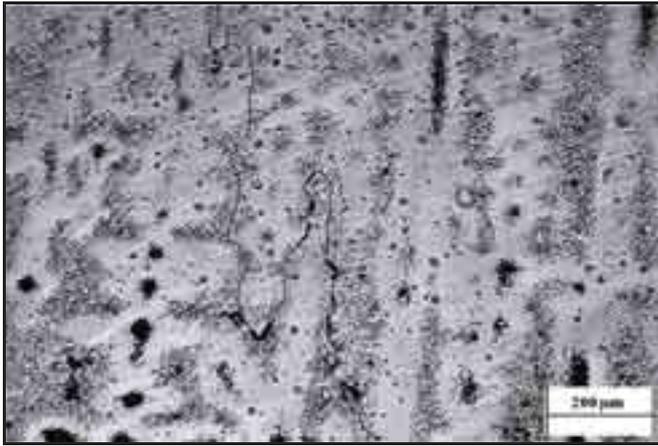
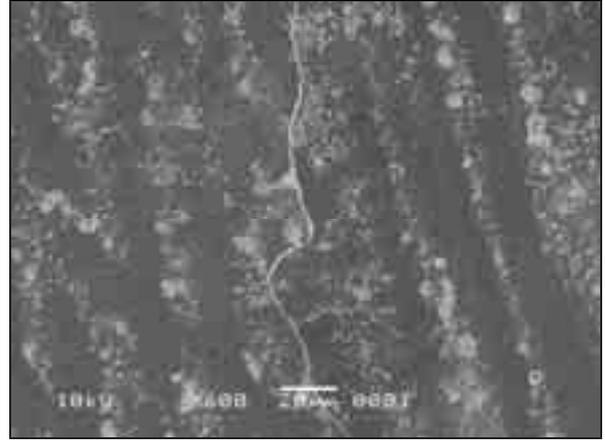
Fig. 4. Microstructure of cone B, lowest temperature section

Figure 4 shows the microstructure of cone B from the lowest temperature section. Cone B is also manufactured by casting as shown by the geometry of the grain. Carbide precipitates were evident along grain boundaries and inside the grain. Carbide volume fraction in cone B is much higher than that of cone A because cone B has been exposed longer than cone A. Carbide precipitation will increased with higher exposure (aging) time.

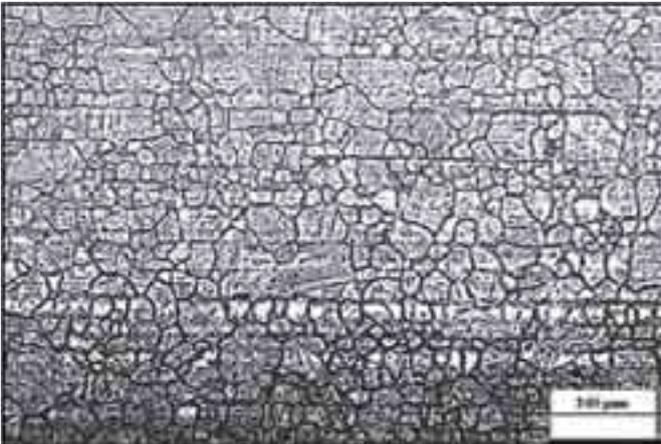
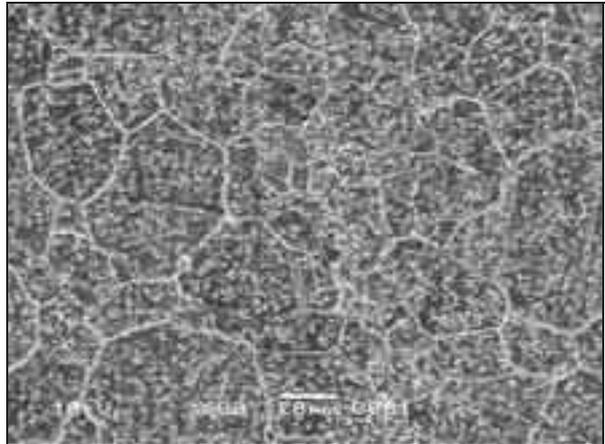
Fig. 5. Microstructure of material for repaired

The fresh material for repair is not available because the repaired process was done by outside workshop, therefore the observation has to be done on repaired section at the least attack part. The microstructure consists of equiaxed austenitic matrix grains (Fig. 5). Material for repair is not cast material but hot rolled plate under solution-annealed condition. Fine carbide precipitates in material are due to the effect of exposure during service.

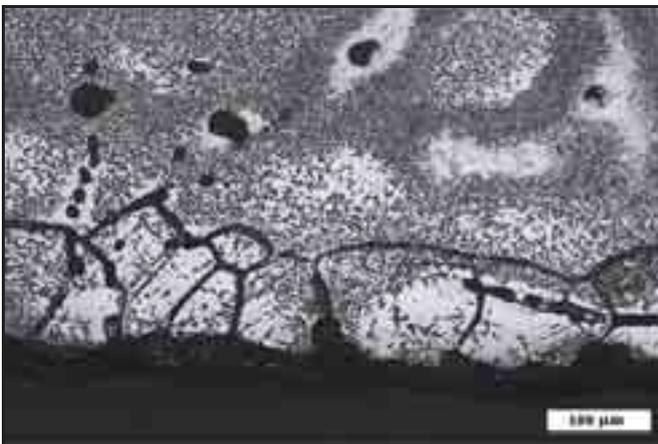
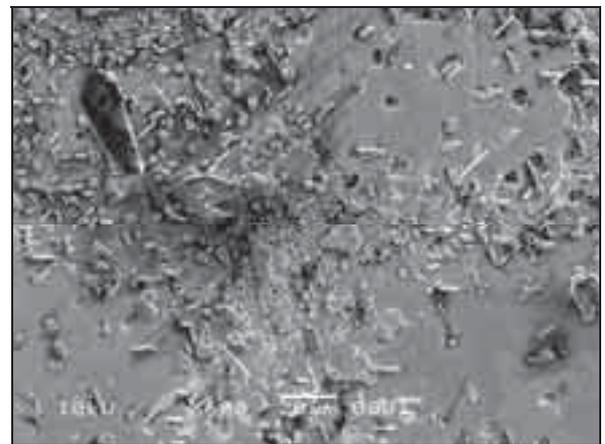
Fig. 6. Microstructure of damaged cone A

Microstructures of the damage cone burner are shown in Fig. 6 to 8. Carbide precipitates volume fraction increase significantly even the maximum carbon content in Hastelloy X is 0.1%, therefore carbon in the combustion gas diffused into material (carburization) during the service. Carburization occurred because the service temperature is above 650°C and carbon potential in combustion gas is high.

Carbides in cone burner material consist of primary and secondary carbides. Primary carbides are formed during casting while secondary carbides precipitate and growth during service (aging). Two types of carbides were examined, fine, and coarse carbides (Fig. 6b). Summary of examination is shown in Tab. 3. Aluminum in the measurement result is the trace of alumina particle for polishing.

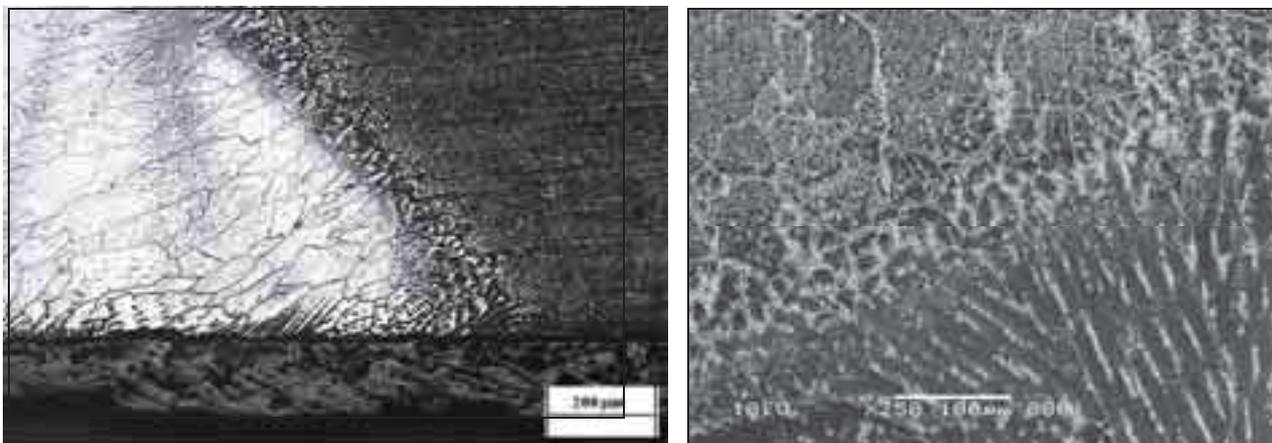
Fig. 8. Microstructure of damaged material for repaired

Figure 8 shows the microstructure at the interface between cone burner base metal (bright) and repaired material (dark). Carburization in repaired material is much severe compared to that of base metal (Fig. 8a) because carburization occurred through grain boundary diffusion [3]. Grain boundary diffusion rate of carbon in repaired material is much higher than the base metal because the repaired material has much finer grain size. Volume diffusion dominant in the near surface region.

coating on the edge breaks, the fresh surface is exposed to the carbon environment and initiates the carburization attack. Welding repair has successfully extend cone burner life but longer life extension can be expected if material for repair has a coarse elongated grains similar to that of cone burner material.
