IMPACT OF THE VIBRATION AMPLITUDE ON THE FATIGUE LIFE OF COMPRESSOR BLADES WITH MECHANICAL DEFECTS

Lucjan Witek, Arkadiusz Bednarz

Rzeszow University of Technology, Department of Aircraft and Aircraft Engines
Powstancow Warszawy 8, 35-959 Rzeszow, Poland
tel.: +48 178651324, +48 177432348
e-mail: lwitek@prz.edu.pl, abednarz@prz.edu.pl

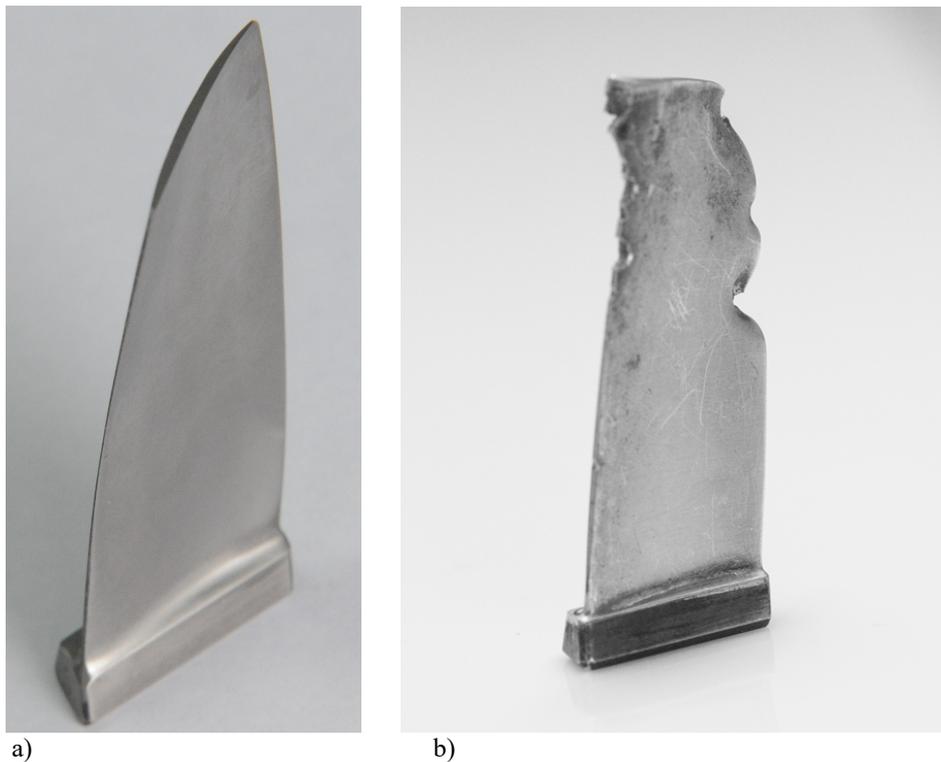
The axial compressor blade (Fig. 2a) has a small cross-section area. The small thickness of the profile causes that the blade is susceptible to resonant vibration, which can be excited by unbalanced rotor or non-uniform air pressure in the compressor passage. During the work of the engine, especially close to the ground, the compressor blades are also susceptible to foreign object damage (FOD). FOD is often caused by small objects (stones, sand grains) sucked to the inlet channel of engine. FOD often causes mechanical defects (notches) located often on the attack edge of the blade (Fig. 2b). These defects accelerate the fatigue process of the compressor blades.

Fig. 2. View of an undamaged blade (a) and blade after FOD (b)

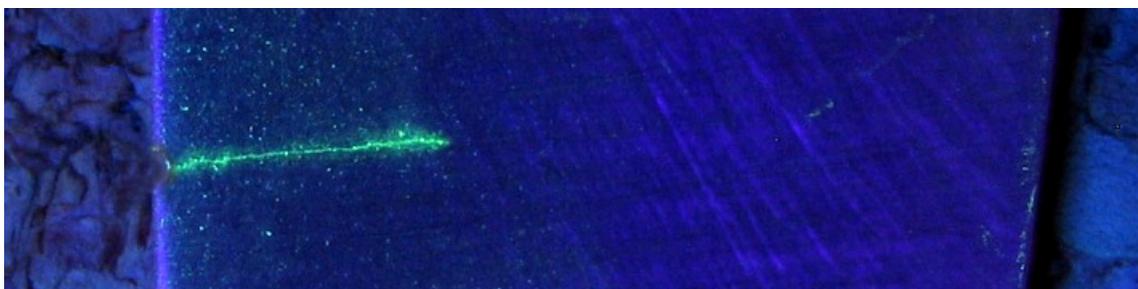
Fig. 5. View of fatigue crack in UV light (fluorescent NDE method)

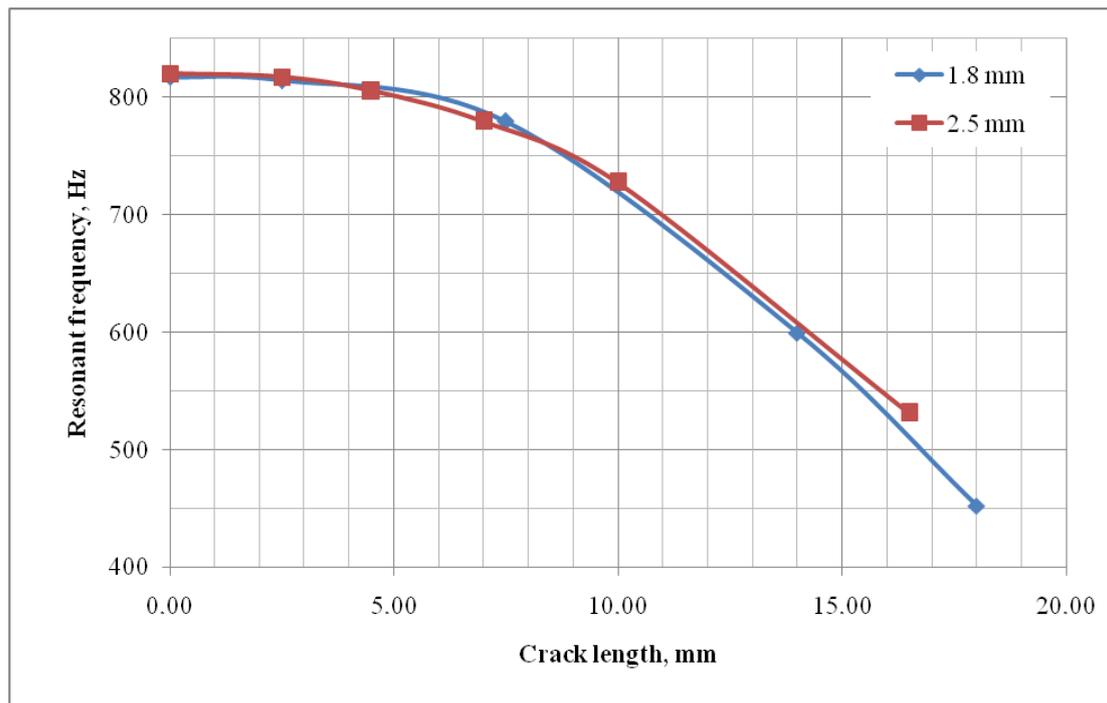
Fig. 6. Resonant frequency of the compressor blade as a function of crack length

Resonant frequency as a function of the crack length were shown on Fig. 6. As seen from this figure, the resonant frequency of the blade no. 1 (without the crack, $a=0$ mm) is equal to 820 Hz. After increase of the crack to the value 4.5 mm the resonant frequency decreases to the value of 805 Hz (relative decrease of resonant frequency at about 2%). When the crack length increases to 10 mm, the relative decrease of resonant frequency is about 11%.
