DIAGNOSTIC OF THE PISTON ROD GLAND'S FAILURE OF MARINE SLOW SPEED MAIN ENGINE

Lech Murawski, Do Van Doan

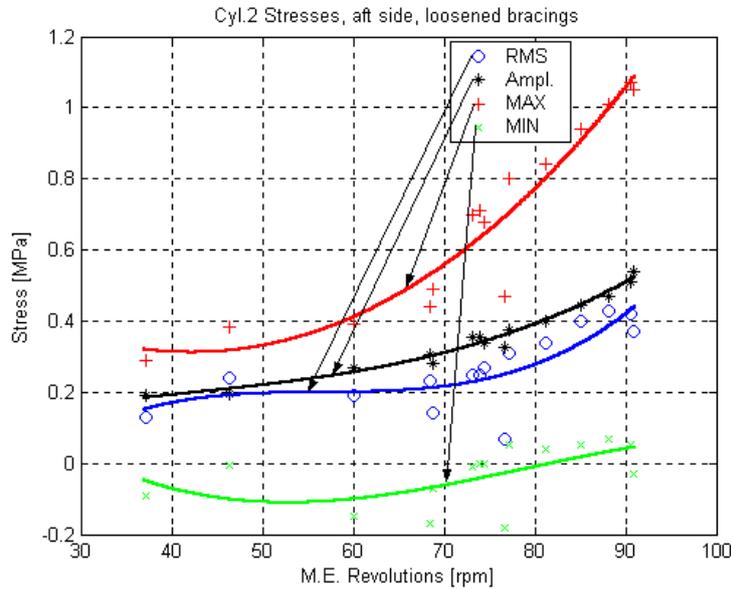
Fig. 2. Stresses in aft A-frame, in operation with loosened bracings

The diagram of exemplary stresses in the engine “aft” A-frame, in operation with loosened transversal bracings, is shown in Fig. 2. The measured values, marked with points, have been approximated by means of third degree polynomials. The presented values are defined by the equations (1) and (2). The measured values of type “*Ampl.*” are responsible for dynamic loads of the structure, whereas the values of type “*RMS*” are equivalent quasi-static load.

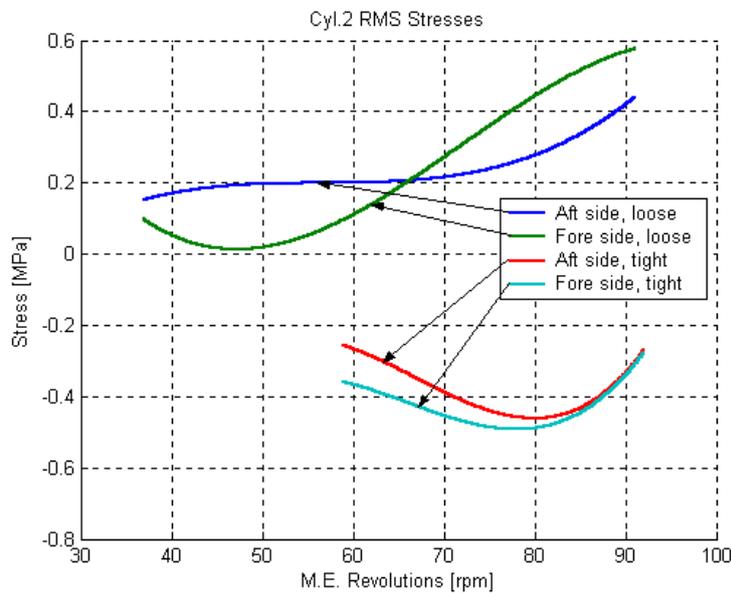
Fig. 3. RMS type stresses in the engine A-frames

The stresses level in the engine A-frames is low. The hazard of A-frame fissure may happen only in the event of serious material defect, defective welding process or serious assembling error. Such events are little probable for the engines made by recognized manufacturers and installed by recognized shipyards. Similar stresses level for the both measuring points for dynamic component and for RMS proves that the A-frames are not defective. The level of dynamic loads increases with

the increase of engine load, whereas the characteristics of RMS stresses are flat. No abnormal stress distribution has been observed in A-frames. Tensions in the transversal bracings are a source of small changes of quasi-static stresses in the engine body. These phenomena might be a cause of small changes in geometry of piston-crank system motion. However, it cannot be substantial cause of the analyzed failure, because the level of dynamic stresses in relation to the engine load does not change for tighten upper transversal bracings.

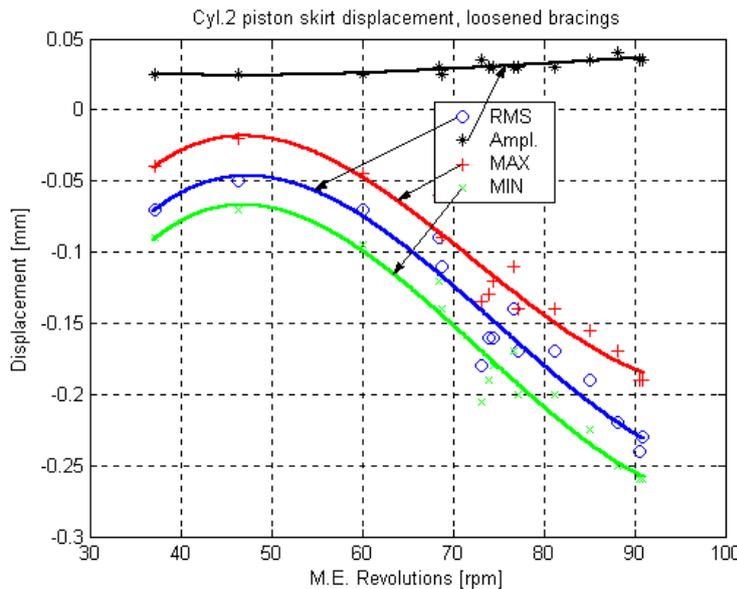
Fig. 5. The displacements of cylinder liner No. 2 (M.E. running; loosened bracings)

An exemplary (for cylinder No. 2 with loosened upper bracings) changes of displacements of cylinder liner lower edge is shown in Fig. 5. For each measurement, the displacements are small – not exceeding 0.3 mm. Constant value of dynamic component of the displacement, poorly dependent on engine rpm shows that the loads of piston-crank system are not transferred to the cylinder liners. All transverse loads are transferred by the crosshead system. The quasi-static displacements increase with increasing rpm of the engine. Displacements of the cylinder liners cannot be the cause of the analyzed failure.

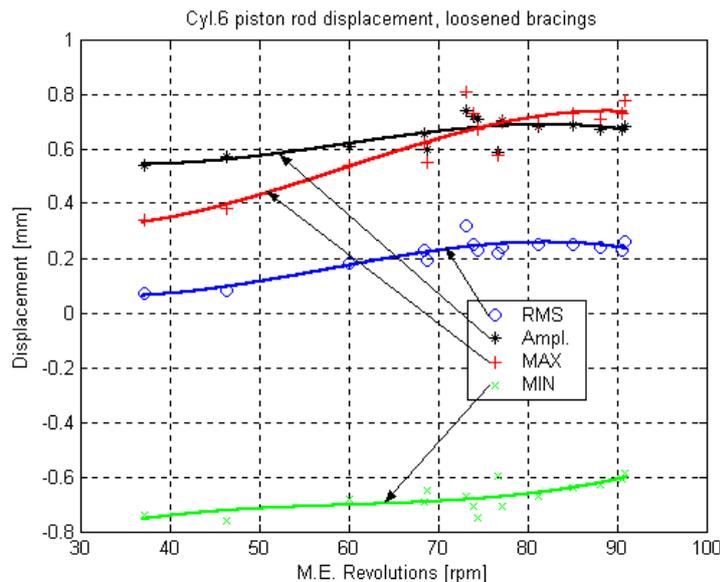
Fig. 6. The displacement of piston rod of cylinder No. 6 with loosened bracings

The comparative measurements of piston rod displacement show that the results for failure-free cylinder No. 6 are two times worse than those measurements for cylinder No. 2 after replacement of the elements. The displacement of piston rod No. 6 was near to 1 mm (with tight upper bracings). The displacements changes of piston rod No. 6, with loosened upper bracings, are shown in Fig. 6. The dynamic displacements of the both analyzed piston rods with loosened upper bracings are shown in Fig. 7.

There are considerable transverse displacements of piston rods in the region of under piston space. Moreover, these displacements differ considerably from each other (cylinder No. 2 and 6). After replacement of gland and crosshead of cylinder No. 2 (by standard spare parts), the system condition became even better in comparison to that of free of damage system No. 6. In the present condition, there is no risk of failure and the engine can be operated without limits.

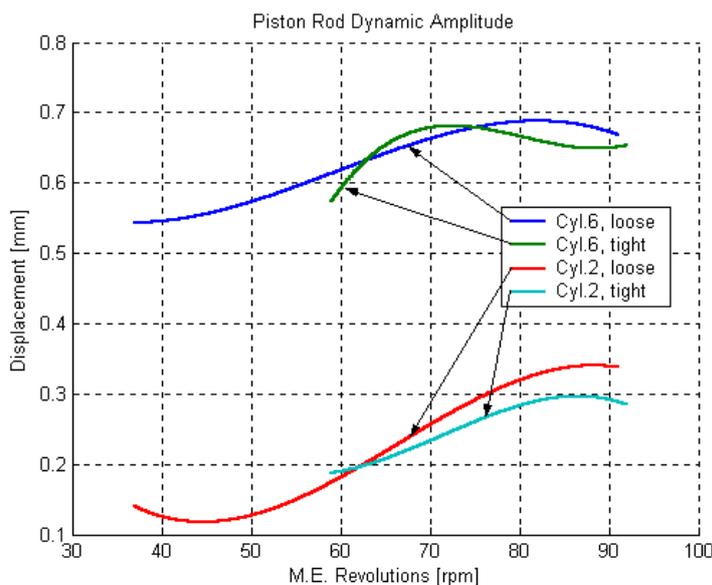
Fig. 7. The piston rod dynamic displacements

Exact analysis of dynamic displacements of the piston rods showed that the first harmonic component (once per revolution) is the dominant one. The displacements increase relatively slightly with increased engine load (Fig. 7). The values of analyzed displacements do not depend on the engine operational parameters. The decisive factor is summary of geometry of piston-crank system, including tolerances of manufacturing and assembling of individual parts. In correctly functioning system of cylinder No. 6, the displacements are going even to ± 0.7 mm. The standard

backlash between the piston rod and gland body is 2 mm. Unfavorable summary of tolerances of correctly made elements of piston-crank system is hardly probable, but possible. According to theory of great numbers, the probability of analyzed failure is real for suitably great number of manufactured engines.
