THE IMPACT OF UNEVENNESS AND INSTABILITY OF FLUE GAS TEMPERATURE ON THE TECHNICAL CONDITION OF GAS TURBINE BLADES

Józef Błachnio, Artur Kułaszka, Jerzy Perczyński

Air Force Institute of Technology Ksiecia Boleslawa Street 6, 01-494 Warsaw, Poland tel.: +48 261 851393 e-mail: jozef.blachnio@itwl.pl, artur.kulaszka@itwl.pl jerzy.perczynski@itwl.pl

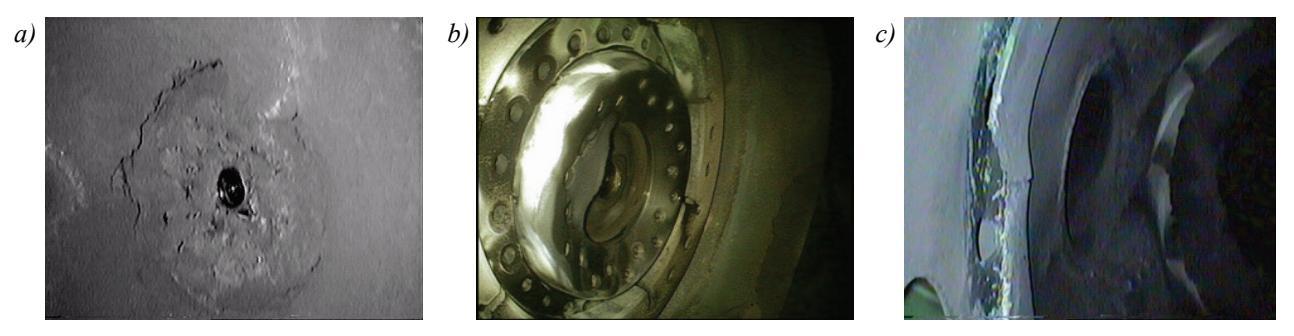
The fuel combustion process is a complex issue associated with the physical and chemical reaction of the fuel-air mixture. An important role is played by, mainly, the properties responsible for correct spraying and for complete combustion. The most important parameters in this context seem to be the ones associated with the formation of deposits on hot elements of the chamber. These are primarily thermal stability and the content of "present resin" [2, 9]. Both parameters are associated with a set of chemical changes undergoing in the fuel. Resins and thermal degradation products, as high molecular compounds are not sprayed, and as a result, are not completely burned in the engine. As a result of high temperature acting on non-vaporized, relatively high hydrocarbon particles, they undergo thermal degradation, and its products deposit on the injectors and hot engine parts in the form of carbon deposits. It usually leads to the impairment of the fuel-air mixture preparation and intensifies the carbon deposit formation process. In order to prevent loss of combustion stability, special treatments increasing the thermal stability of fuel are used. For example, Fig. 1 shows the impact of an anti-corrosive/lubricant additive (s) and preventing water crystallization (w), and their introduction manner on thermal stability. An additional factor impacting fuel quality change is long-term storage. The presence of microorganisms, which accelerate ageing (thermal and chemical stability is accelerated) is also important, with the decomposition products of biological impurities with mainly acidic reaction (biological corrosion), and dead microorganisms cause filter clogging and problems with supply continuity. The functioning of the injectors impacts the correct spraying of fuel (Fig. 2) [13]. These anomalies have a significant impact on correct combustion, and the correct location of the combustion zone in the flame tube, in particular. Single-sided deposition of coal deposits causes fuel spraying toward the flame tube wall. As a result, a flue gas stream with significantly lower temperature than the average value flows from the flame tube. Otherwise, when the carbon deposit on the injector is deposited along the injector perimeter, the injector supplies fuel in the form of a stream and the combustion area dangerously extends towards the turbine. As a result, a flue gas stream with significantly higher temperature than the average value flows from the flame tube. In consequence, incorrect operation of the injectors impacts the peripheral unevenness of the flue gas temperature field upstream of the turbine.

Fig. 2. Condition of fuel injectors and glow tube: a) carbon deposit along the perimeter, b) single-sided carbon deposit, c) burnout of glow tube

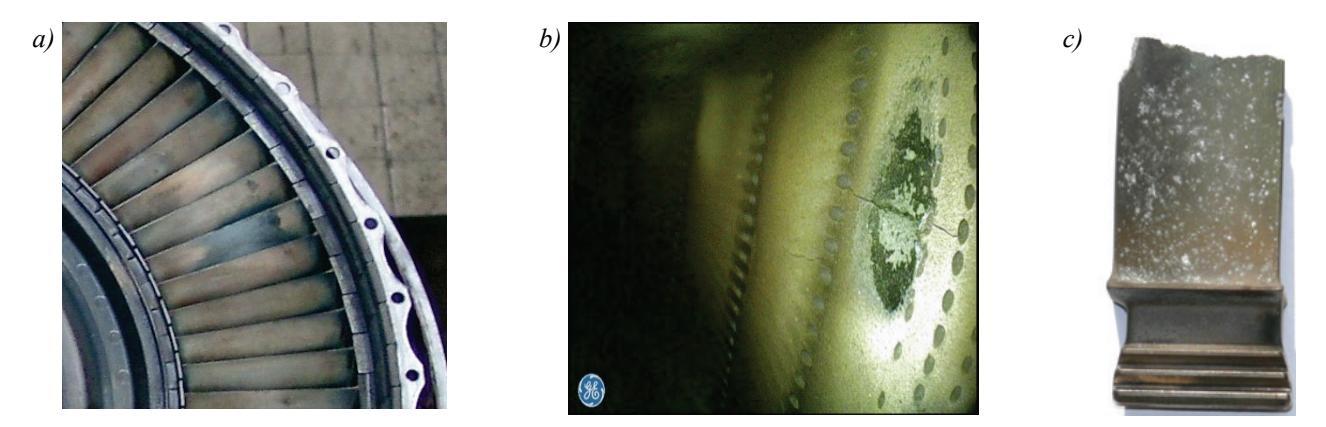
Various types of combustion chamber and gas turbine elements appear within the turbine engine operating process [1, 16]. This is primarily caused by adverse conditions of fuel combustion in the combustion chamber. This leads damage to the flame tubes, a mainly, the turbine blades, in the form of overheating, deformation, creep, burn-through, as well as thermal fatigue of their material (Fig. 5).

Fig. 5. Forms of gas turbine damage: a) different colours on vanes surfaces exhibiting various overheating degree [13], b) nozzle apparatus vane with an overheating zone,
 c) rotor blade torn off due to burn-through

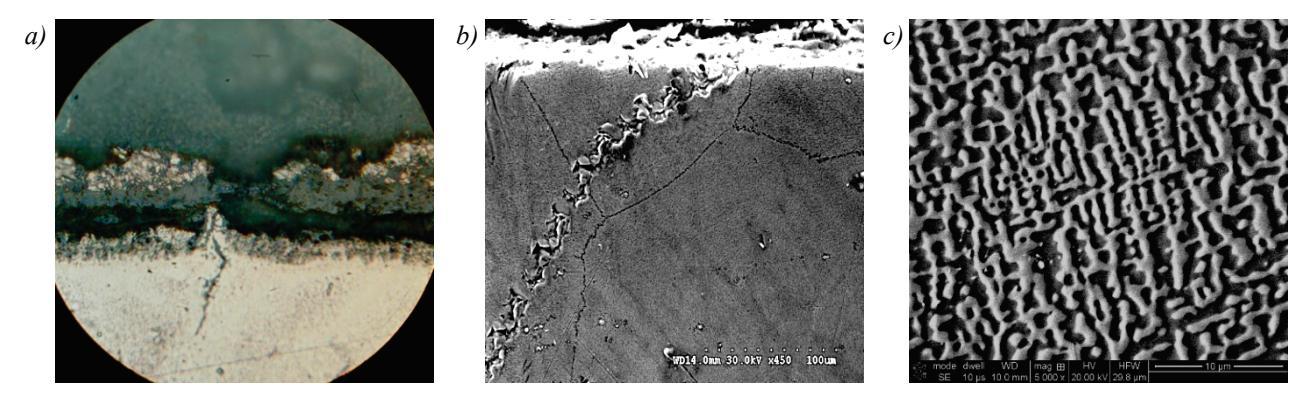
Results of metallographic tests covering blades, which were new and blades after various periods of operation, indicated the growth of the heat-resistant coating, numerous thermal and erosive damage. The latter impacts the reduction in its thickness, which impairs blade heat-resistance. Among others, delamination between the heat-resistant coating and the native material of the blade was observed (Fig. 6a). Moreover, transverse and longitudinal cracks were noticed in

the layer, as well as propagations of some cracks inside the blade material to a depth of over 500 μ m (Fig. 6b). It was also stated, that the oxidation process, and subsequently cracking, is preferential over dendrites or interdendritic spaces. The recorded degradation of coatings also translates to microstructural changes, which undergo within the coating itself, as well as the native material of operated blades (Fig. 6c). The average coating thickness was worn to 30 μ m. It was observed that in the case of blades after an extended period of operation, this lead to significant changes of the particle morphology of the strengthening phase γ' and its participation under the coating surface (Fig. 7).

Fig. 6. An example of turbine blade overheating, a) heat-resistant coating delamination and rupture of its material
b) SEM microstructure of a rupture with a trans-crystalline character - ×450
c) microstructure of the strengthening phase y' in lamellar form - ×5000

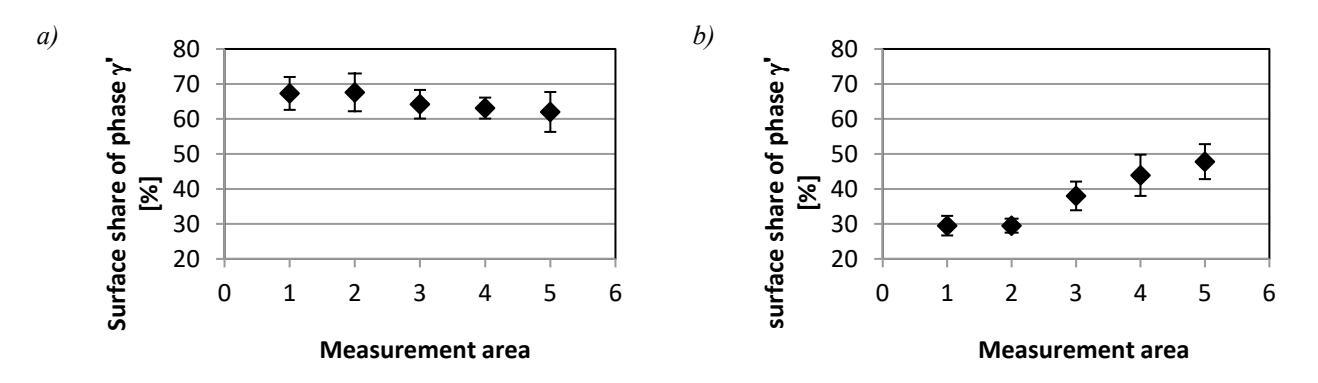
Fig. 7. The surface participation of strengthening phase γ' inside the edge of attack in individual blades: a) new blade, b) a blade after a significant period of operation (l - blade surface)

Observations of structural changes were carried out on transverse (in relation to the blade axis) metallographic micro sections in five areas equidistant from the surface (1). It was stated that the operating conditions result in the growth of the strengthening phase γ' (Fig. 6b). In the case of a new blade, the average size of phase γ' particles is approximately 0.3 µm. As a result of high flue gas temperature impact, this value increases to a level of 2 µm. Moreover, a significant decrease in its participation near the blade surface is observed (Fig. 7b). Such substantial participation of the strengthening phase γ' in the blade alloy structure and its deformation from the cuboid shape to lamellar, has a significant impact on its heat-resistance and high-temperature creep resistance properties [8-12]. Hence, during the operating process, in the presence of excessively high flue gas temperature, the aforementioned damage appears, in the form of overheating, deformations, creeping, burn-through, as well as thermal fatigue of the material.
