ANALYSIS OF THE WEAR OF PISTON RING PROTOTYPE OF AN EMBANKMENT OF DIAMOND IN TERMS ENDURANCE TEST

Andrzej Kaźmierczak, Łukasz Kaźmierczak

Abstract

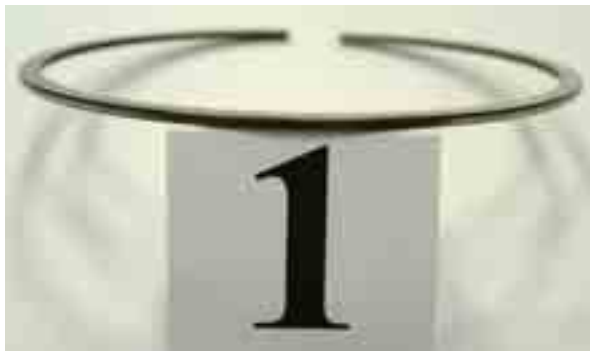
Fig. 2. View of side surface of the first ring of the cylinder No. 1

All of the rings shows the correct cooperation with the surface of the cylinders. The surface of the rings is evenly worn around the perimeter of the height of the rings (Fig. 2–5). In particular, the

rings 1 and 3 were slightly consumption over the entire surface, at about 3/4 height from the bottom edge. 2 and 4 rings are worn on the entire surface, while maintaining a symmetrical barrel shapes.

Average value of wear of the radial width of the **ring 1/1** is equal to -0.0104 mm. In all 10 measuring points on the circumference of increment widths ranging from -0.02 to 0.0 mm were measured. Also increase of the axial high -0.003 Mm were measured. Was measured the weight gain equal to 0.0025 g, confirming increasing the size of the rings. Any discussion about the causes of this phenomenon requires detailed materials research

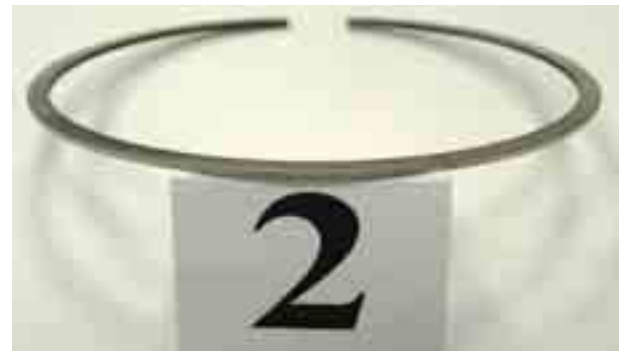
Fig. 3. View of side surface of the first ring of the cylinder No. 2

Average value of wear of the radial width of the **ring 2/1** is equal to 0.0017 mm. In all 10 measuring points on the circumference of wear ranging from -0.003 to 0.003 mm was measured. Average value of wear of the axial height is equal of 0.0044 mm. Loss of weight of the ring 2/1 is equal to 0.0047 g and it confirms the results of the wear of the width and height of the ring.

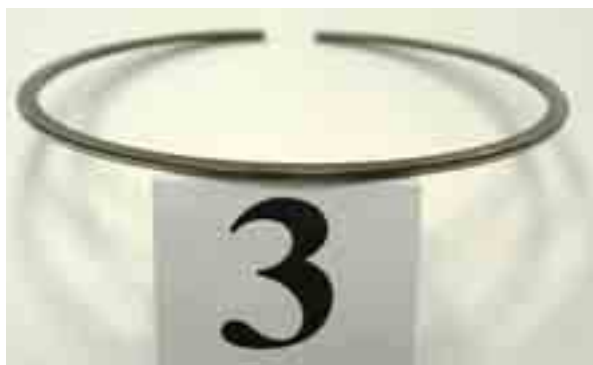
Fig. 4. View of side surface of the first ring of the cylinder No. 3

Average value of wear of the radial width of the **ring 3/1** is equal to -0.0016 mm. In almost all 10 measuring points on the circumference of increment widths ranging from -0.006 to 0.003 mm were measured. Also increase of the axial high -0.003 Mm were measured. Was measured the weight gain equal to 0.0161 g, confirming increasing the size of the rings. Any discussion about the causes of this phenomenon requires detailed materials research

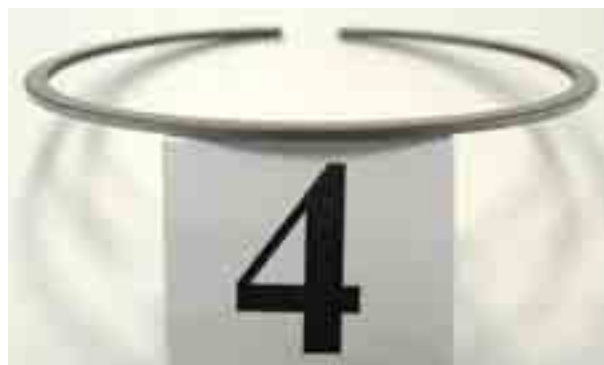
Fig. 5. View of side surface of the first ring of the cylinder No. 4

Average value of wear of the radial width of the **ring 4/1** is equal to 0.0008 mm. In all 10 measuring points on the circumference of wear ranging from -0.003 to 0.003 mm was measured. Average value of wear of the axial height is equal of 0.0104 mm. Loss of weight of the ring 2/1 is equal to 0.0158 g and it confirms the results of the wear of the width and height of the ring.

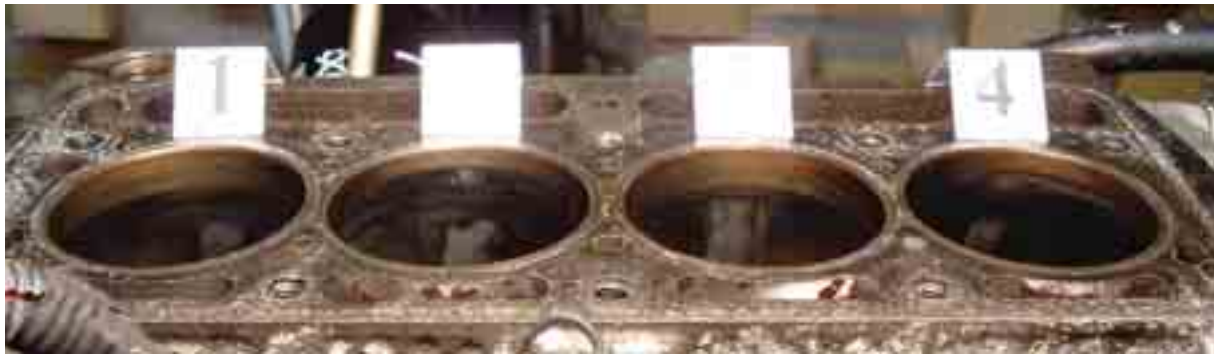
Fig. 6. View of the engine block after test, removing the pistons and removing deposits

Cylinder liners have a little wear except the sleeve 2 and 4. Honing features are not visible. On all surface of the cylinder above the TDC, I of the sealing ring and on the surface of the combustion chamber of the cylinder head were found deposits. Deposits have a thickness of about 0.3 mm.

In all cylinders between the TDC of the third ring, and the BDC of the first ring was found in a direction perpendicular to the motor cross the occurrence of longitudinal features on both sides of the sleeve (Fig. 6). It should be noted that the sleeves have 1500 hours engine traffic the total mileage (seven tests including one longer by 50%). In summary, the wear of the sleeve is the result of the 1500 hours work [4, 5].

- There has been little measurable wear the rings first. This applies mainly to the embankment diamond rings mounted in slots 2 and 4,
- Cooperation is the correct side surface around the perimeter of the first ring and cantered in the middle of their height (symmetrical barrel),
- The wear of cylinder in slots 2 and 4 qualify the engine block to the overhaul.

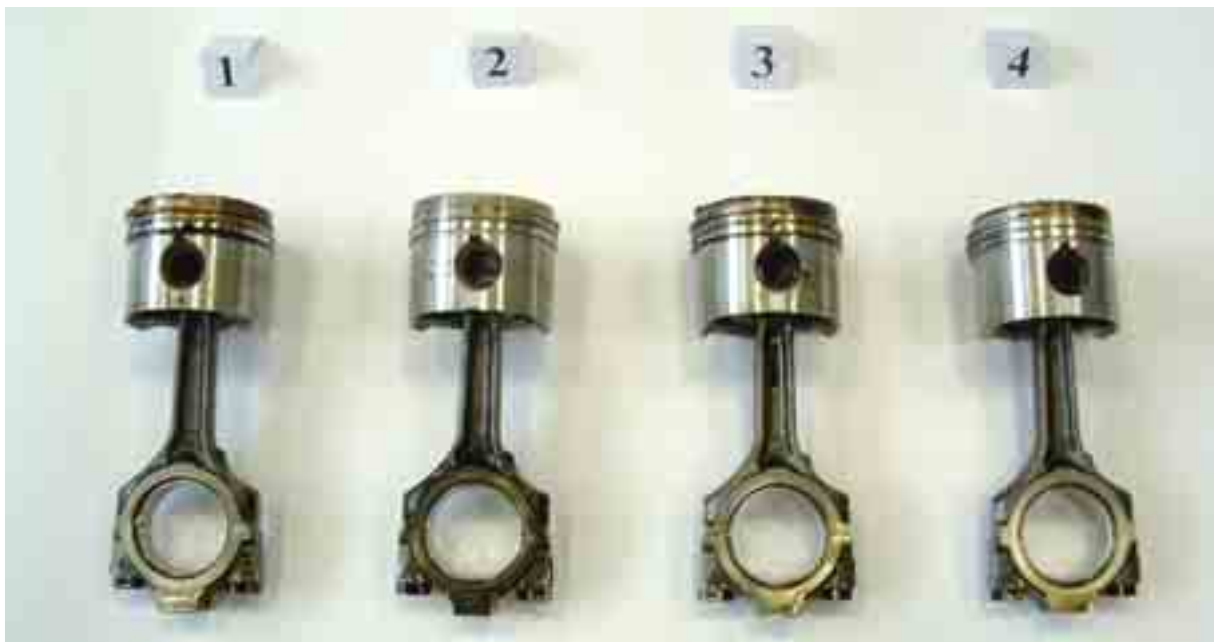
Fig. 7. The view of the piston groups after the tests

In this test was used a new custom pistons. The height the groove of the first sealing ring equal to 1.2 mm, and the standard height of the groove of oil ring equal to 2 mm.

Pistons organoleptic tests showed no significant wear. Cooperation with the piston rings, cylinder liners as well was fine. It was only found tiny imperceptible features on the piston surface in the section parallel to the axis of piston pin (Fig. 7).

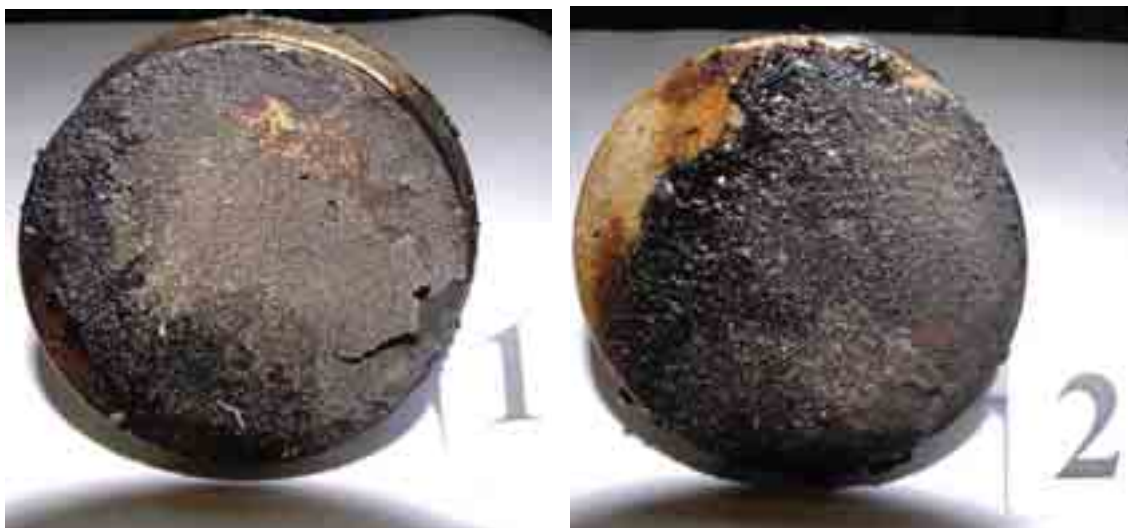
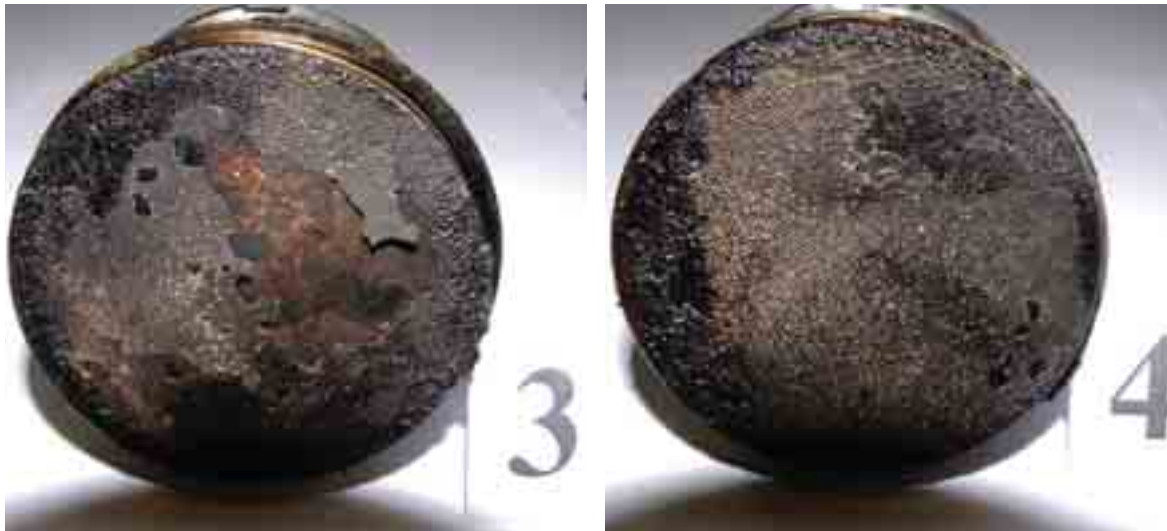
Fig. 8. View of the pistons after tests

It was a large amount of carbon deposits on pistons bottom, which is the result of the increased by about 50% lubricating oil consumption compared to the normal wear (Fig. 8). This may be due to the reduced height of oil rings.
