## ANALYSIS OF THE WEAR OF PISTON RINGS PROTOTYPE IN TERMS OF TEAM ENDURANCE TEST

### **Abstract**

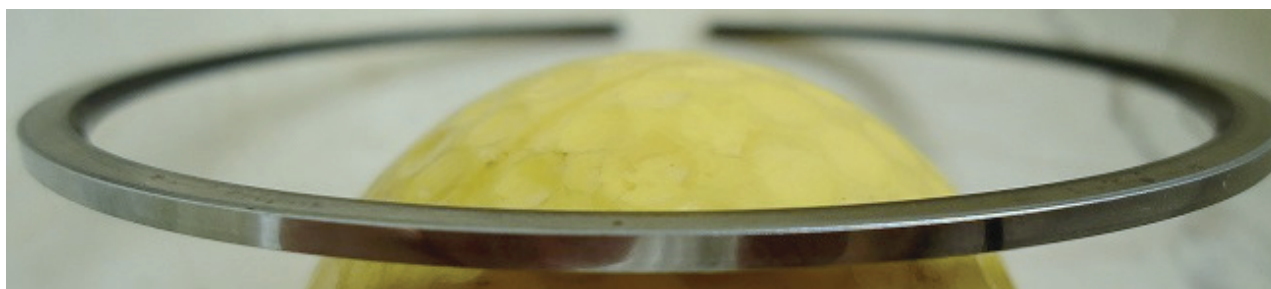
All of the rings shows the correct cooperation with the surface of the cylinders. The surface of the rings is evenly worn around the perimeter of the height of the rings (Fig. 2-5).

Fig. 2. View of side surface of the first ring of the cylinder No. 1

Average value of wear of the radial width of the ring 1/1 is equal to 0.003 mm. In all 10 measuring points on the circumference of wear ranging from 0.00 to 0.008 mm were measured. Also the rounding of the axial high is equal to 0.007 mm were measured. Was measured the weight gain equal to 0.0322 g, confirms the results of the wear of the width and height of the ring.

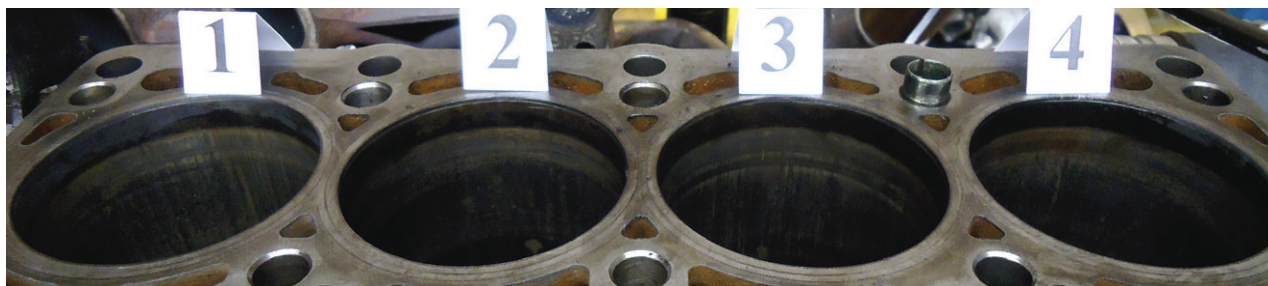
In all cylinders between the TDC of the third ring, and the BDC of the first ring was found the occurrence of longitudinal features on both sides of the sleeve (Fig. 6) [4, 5].

Fig.6. View of the engine block after test, removing the pistons and removing deposits

Cylinder liners have a little wear except the sleeve 2 and 4. Honing features are not visible. On all surface of the cylinder above the TDC I of the sealing ring and on the surface of the combustion chamber of the cylinder head were found deposits. Deposits have a thickness of about 0.1 mm.

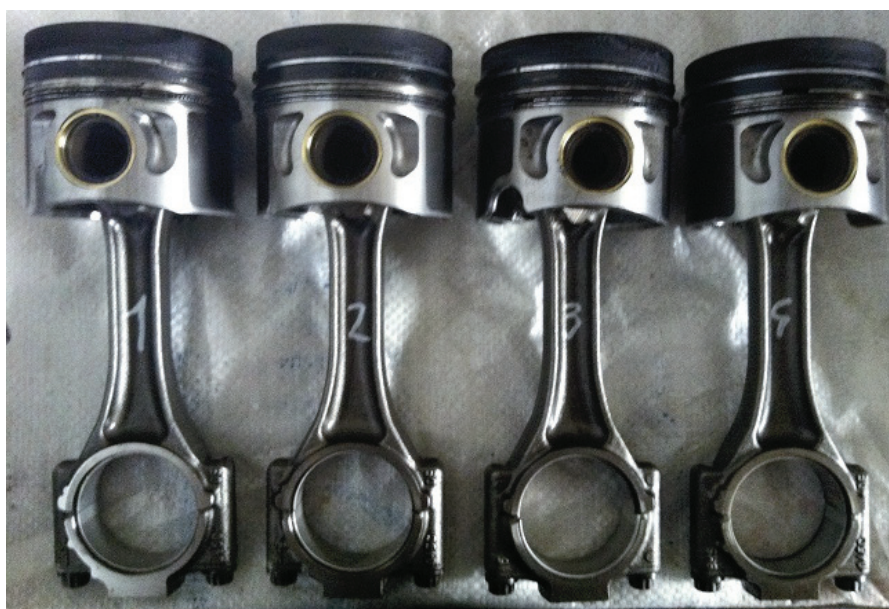
Pistons organoleptic tests showed no significant wear. Cooperation with the piston rings, cylinder liners as well was fine. It was found only a tiny imperceptible features on the piston surface in the section parallel to the axis of piston pin (Fig. 7).

Fig.7. The view of the piston groups after the tests
