## UTILIZATION OF ANTI-HEELING SYSTEMS ON VESSELS AND CHOSEN MALFUNCTIONS DURING THEIR EXPLOITATION

**Jerzy Herdzik**

*Gdynia Maritime University  
Marine Power Plant Department  
Morska Street 81-87, 81-225 Gdynia, Poland  
tel.: +48 586901430, fax: +48 586901399  
e-mail: j.herdzik@wm.am.gdynia.pl*

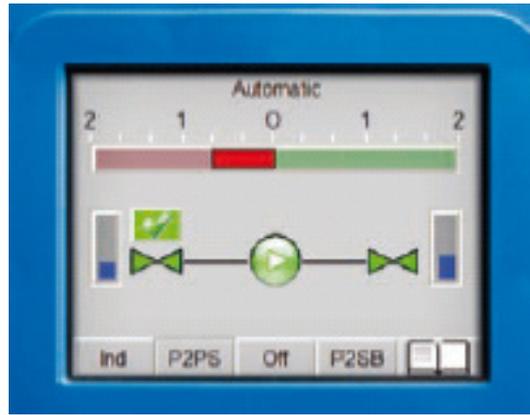
Fig. 1. Visualization of heel (in degree – heel about 1/3 degree on portside)

It is achieved by pumping ballast water (or other fluids) between the heeling tanks using reversible pumps or valves system changing the flow direction. The centrifugal pumps are more often used due to their capacity. Butterfly valves are standard parts and are activated pneumatically or hydraulically (remote controlled). Pipelines connected the heeling tanks ought to have as high as possible diameter due to pump capacity, more often from 50 mm up to 1500 mm (2"-60"). Clear visualization is presented in Fig. 1.

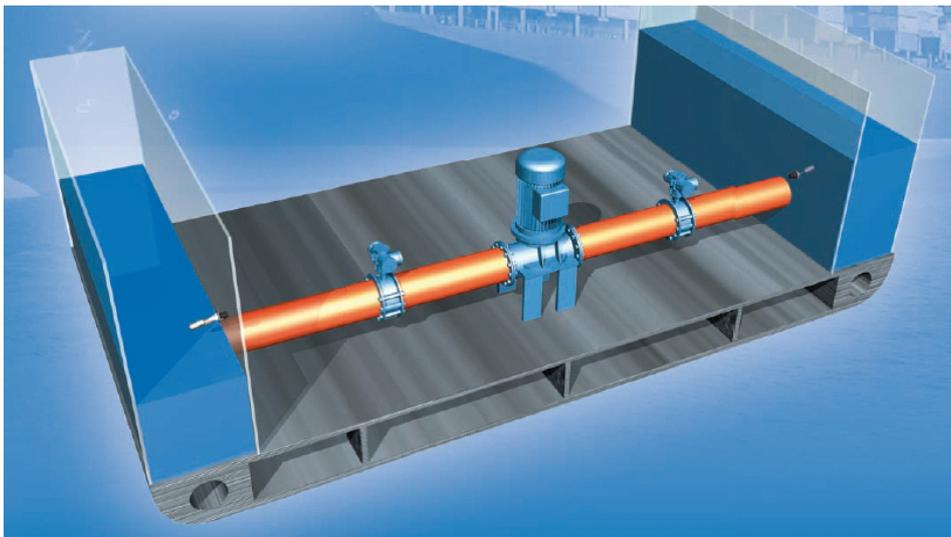
Fig. 2. Idea of anti-heeling system of Hoppe Marine [3]

An idea of A-H system with water pump is presented in the Fig. 2.

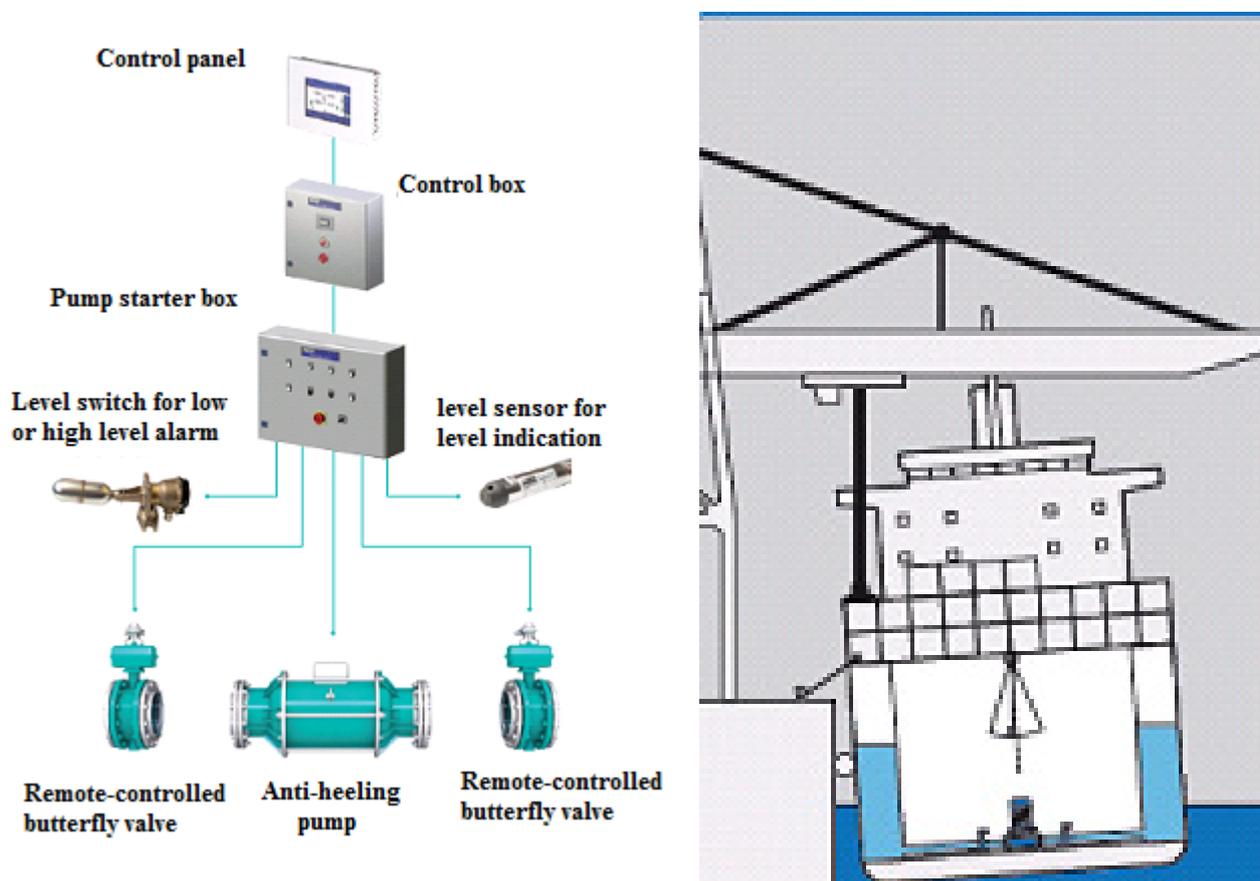
The main components of A-H system are (Fig. 3) [1, 8, 11, 12]:

- pump starter panel and control panel,
- heeling pump driven by electric motor,

- variable frequency drive (VFD) with flow controller,
- control valves,
- level switches for pump dry-running protection,
- level sensors for tank content indication,
- inclinometer for static heel measurement,
- inertial measuring unit for dynamic heel measurement (optional).

Fig. 3. Main components (left side) of anti-heeling system (right side) [1]

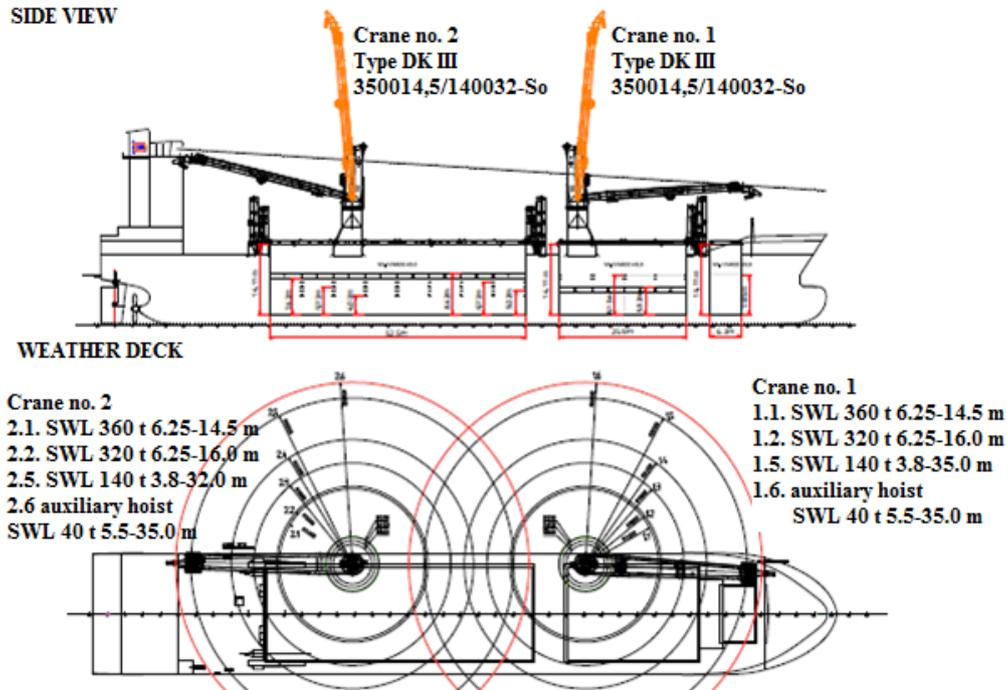
Fig. 4. Two cranes of SWL 350 tons each on m/s AAL Bangkok (built 2012) [13]

An example of a vessel needed such A-H system is presented in Fig. 4. It may be seen what kind of problem ought to be solved. The mass of two cranes in side position and the load up to 350 tons each gives such a heeling moment too danger for safe operations. For the safety of vessel's operation, the heel ought to be compensate through the anti-heeling system.

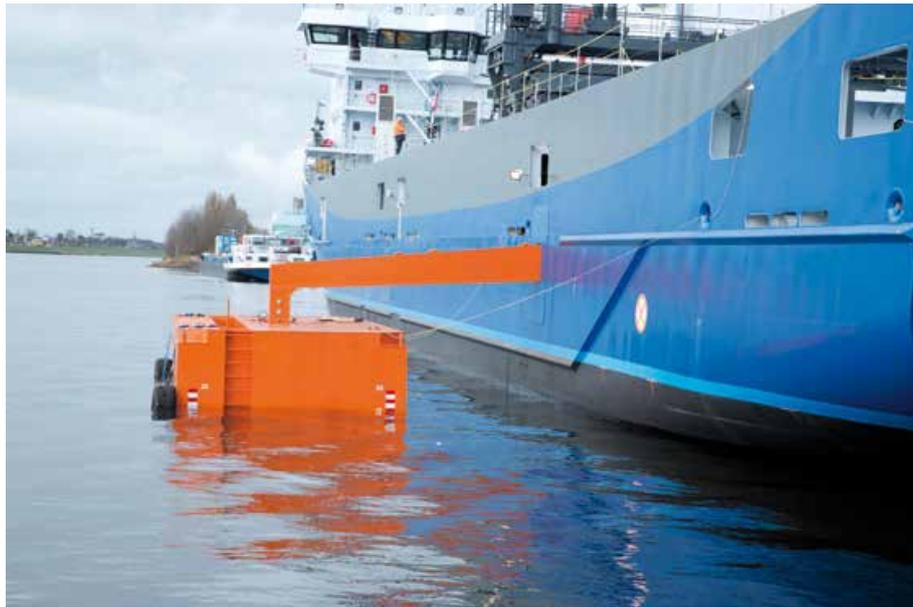
Fig. 5. The Atlantic Dawn with external anti-heeling device [18]

During heavy lift operations in ports, the A-H systems are not to be sufficient to counteract the forces and moments from cargo masses. The added and supportive solution is a using of a stability pontoon. For example for m/s *Atlantic Dawn* (presented on Fig. 5) the large cargo cranes each have a maximum SWL (safe working load) of 150 tons at 16 meters and a SWL of 38 tons at a maximum outreach of 28 meters. Both cranes can also operate in tandem to facilitate the moving of large project loads. In such situations, the use of a “stability pontoon” is required, due to the relatively small beam (required for higher speed hull shape). This pontoon, with the dimensions: 11.0 times 5.50 times 3.40 meters, is normally stored flush in the cargo deck, next to the funnel. When deployed, it is put overboard with the aft cargo crane and hooked into the side of the vessel. The pontoon is then partially filled with seawater by gravity, thus providing a stable buoyancy component to counteract the lifting forces. There are the large volume dedicated heeling tanks also. They are provided in the sides, especially on port side (the vessel crane is starboard side). For optimal use of these heeling tanks, an Azcue transfer pump, with a capacity of 600 cubic meters per hour, is fitted in a special pump room halfway along the piping duct. The total bilge/ballast pump capacity is complimented with two bilge/ballast and two “general service” pumps, located in the forward pump room.

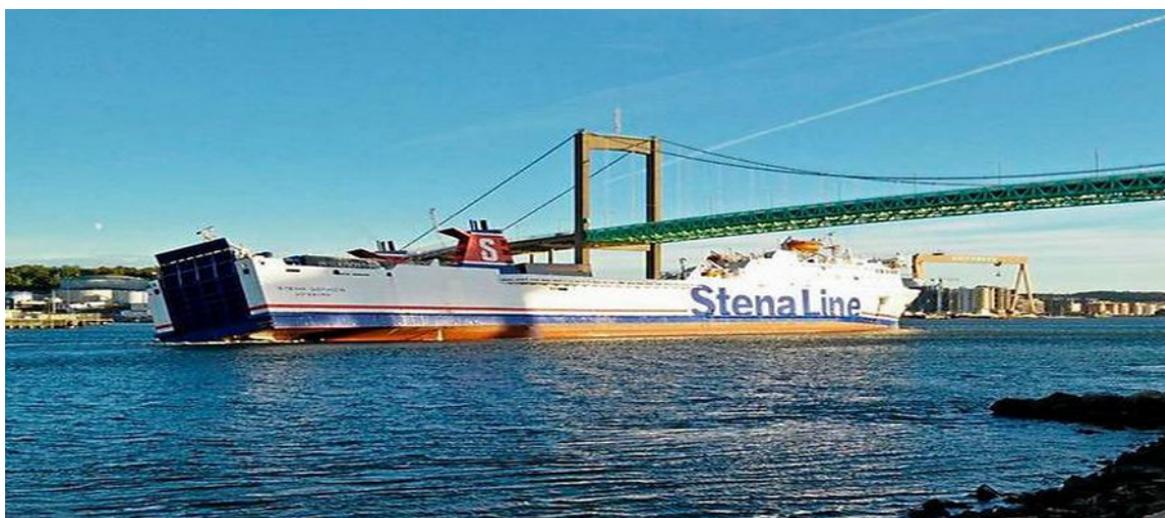
Fig. 6. *Stena Gothica* problems with anti-heeling system [17]

On October 06<sup>th</sup>, 2015 (Tuesday) the passenger/ro-ro cargo ship m/s *Stena Gothica* (built 1982) called on the port of Frederikhavn (Denmark) with a severe list to port side (Fig. 6). The vessel is on regular route: two trips per day between Gothenburg and Fredrikhavn. As she passed under the Älvsborgs Bridge at around 08:00, a heavy list was occurred. There were on-board 39 passengers, 35 persons of crew, 35 trucks etc. [16]. The vessel proceeded towards Majnabbe Quay and berthed at around 08.45 hrs. The investigation shows that the reason of listing was a technical fault.

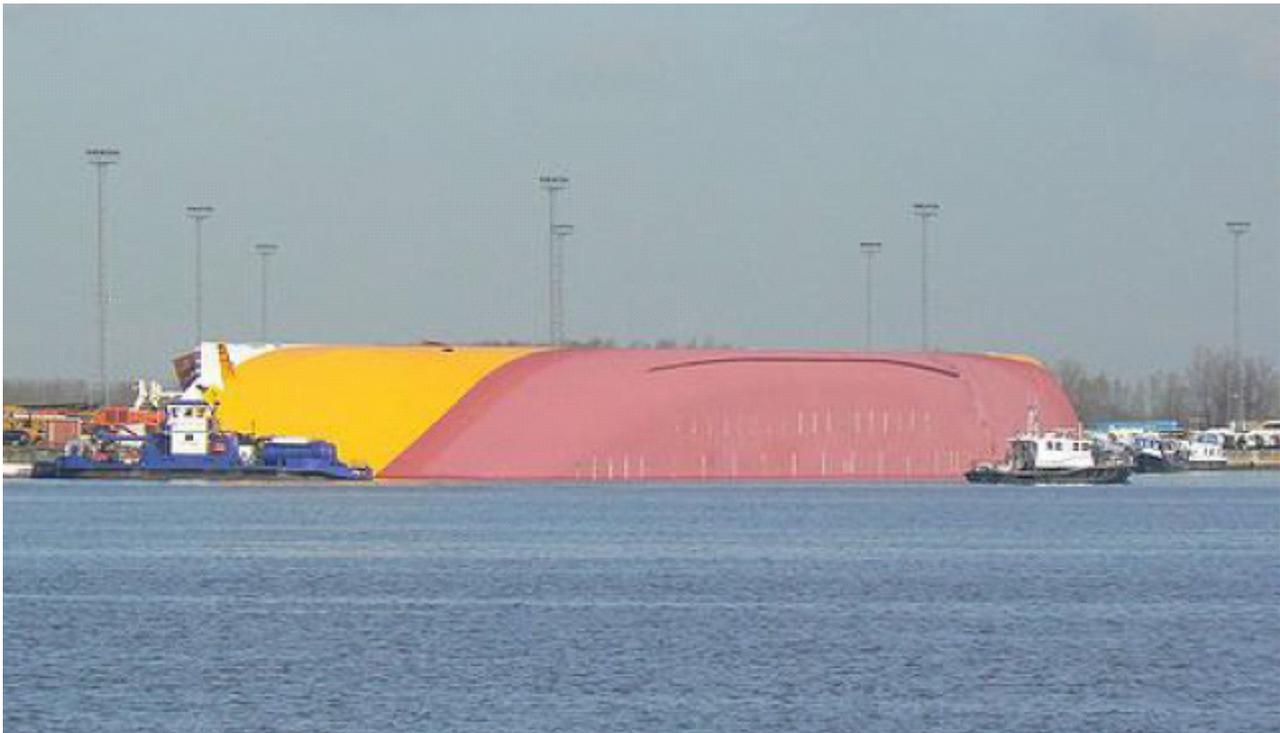
Fig. 7. *Repubblica di Genova* capsizing [International Marine Consultancy]

Next example – March 08<sup>th</sup>, 2007 the m/s *Repubblica di Genova* (built 1988) owned by Grimaldi Lines. Early morning that day during loading operations a containership capsized in the port of Antwerp. Antwerp port authorities reported all crew evacuated in time and there were no casualties. The vessel was lying in the Verrebroekdok and was loaded with containers and cars, about 100 containers and cars had fallen overboard (cargo capacity is 3,400 cars and 1,316 TEU). The 216-meter long vessel slowly rolled onto its starboard side in a dead end dock. After when the ship began taking on water the captain ordered the crew to evacuate [14, 15].

Around the capsized vessel, a security zone of 800 meter has stayed in force. No environmental damage was reported. Again, the technical error in A-H system was the main reason of vessel's capsizing.

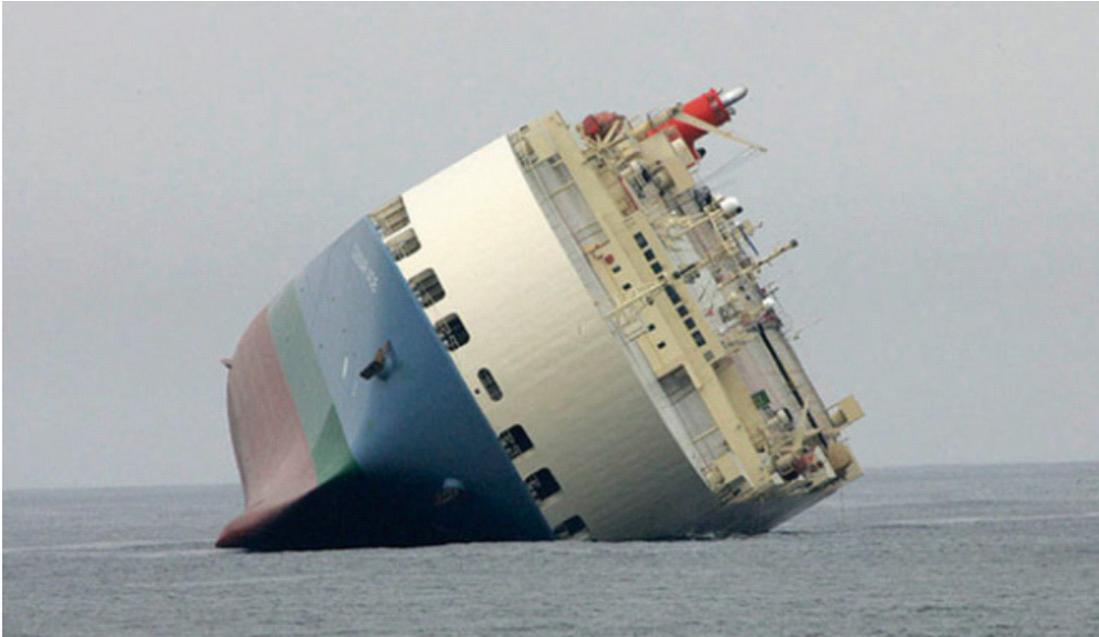
*Fig. 8. The Cougar Ace flip [18]*

On July 23<sup>rd</sup> 2006, the *Cougar Ace* (built 1993) sailed out from Hiroshima to Vancouver with a cargo of 4703 brand-new Mazda cars and 109 small commercial trucks (value \$ 103 million). At sea near the Aleutians crew had started the exchange of ballast water (due to requirements of American Coastguard regulations) to avoid fouling local marine environments with non-native species. The seas were relatively calm and the weather almost balmy by Arctic standards. The water from the starboard ballast tanks was drained without being refilled simultaneously with fresh seawater. Therefore, the top-heavy ship keeled over almost instantly and onto its port side. The vessel's flip (Fig. 8) were damaged cargo. It is interesting that the worst injury was a steward's broken leg. All crew waited 23 hours until the helicopters lifted them to a safe place [17].

The indirect reason was inappropriate water ballast operation and with reduced transversal stability resulting in a vessel to flip aside. A mechanical failure between ballast and anti-heeling system was the direct reason of accident.
