INVESTIGATIONS INTO THE DEGRADATION MECHANISM OF THERMAL BARRIER APPLIED IN IC ENGINE

Tadeusz Hejwowski^{1,2}

Abstract

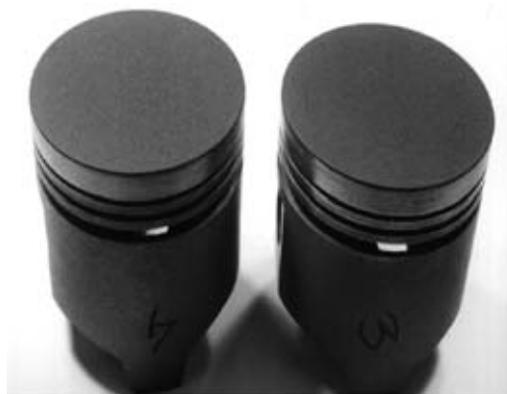
Fig. 1. Piston heads of SI engine with TBC

Two piston heads, cylinder head and inlet and outlet valves were plasma sprayed with 0.09 mm thick NiCrAl bond coat and 0.36 mm thick $\text{Al}_2\text{O}_3\text{-40\%TiO}_2$ top coat. The coatings were subjected to the exploitation test in road traffic in the passenger car driven by spark ignited engine. The total mileage was 5000 km. The coatings were subsequently examined by means of optical microscopy and SEM. Fig. 1 and 2 show the coatings performed on SI engine components.

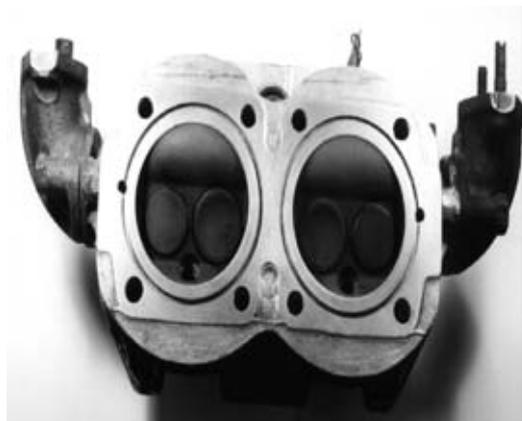
Fig. 2. Cylinder head of SI engine with TBC

Figures 5 and 6 show the TBC on piston heads after thermal fatigue test (Fig. 5) and the exploitation test on SI engine. Both pistons are covered with thick layer of soot, no spallation of coatings was stated. However durability of thermal barrier coatings performed on cylinder head and outlet valves was much worse. Coating on the outlet valve detached completely, TBC on cylinder head became liable to spalling.

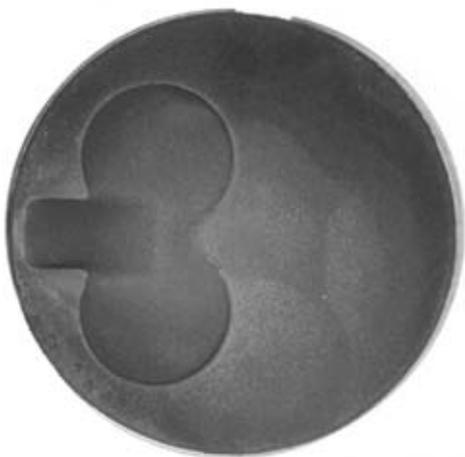
Fig. 5. Piston head of diesel engine with TBC after test

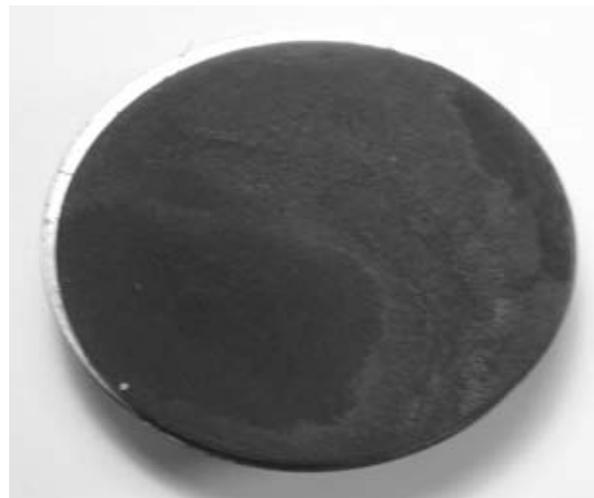
Fig. 6. Si engine piston head with TBC after thermal fatigue test
