## CRASH TESTS OF A CAR WITH MODIFIED ROAD BARRIERS

### **Abstract**

*In this article experimental results of a car impact into a modified road barrier are presented. For crash tests a modified protection barrier SP-04, composed of guide poles, type B, and bridge posts IPE140, was chosen. The road barrier modification lies in using additional panels absorbing the impact energy. The protective panels, subjected to examination, consisted of a metal or a composite (laminated, glass-polyester) shield in which the foamed aluminium or polyurethane foam was a filling. The Suzuki Swift cars were prepared for the crash tests. Tests were carried out at the Automotive Industry Institute (PIMOT) in Warsaw, with the use of a test sample of the road barrier. For the safety sake the car's speed during the experimental examinations was limited to 50 km/h. Moreover, the vehicle hits perpendicularly in a properly modified road barrier's sector. During the test a registration of acceleration was carried out by the acceleration sensors placed in the car (among others in the centre of gravity and over the rear axle of a car). A crash test course of the system C-G was registered with the use of two ca

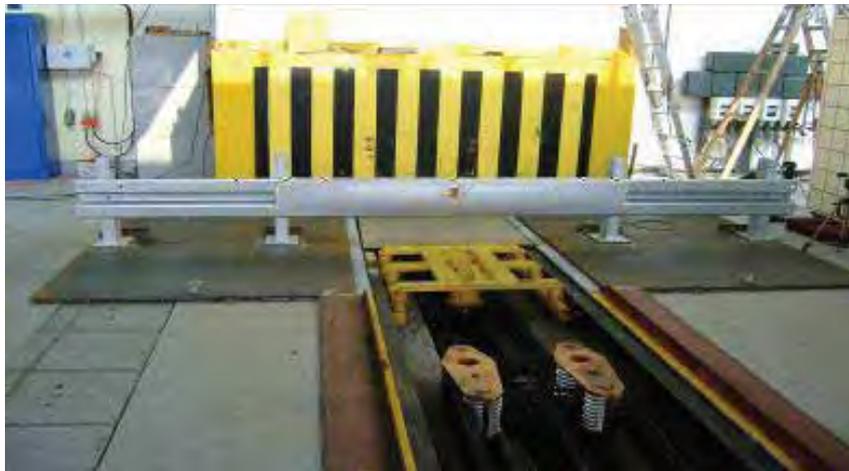
*Fig. 1. Stand for vehicle crash tests with a modified road barrier in PIMOT's Vehicle Safety Laboratory*

Experimental full-scale tests of the system C-MRB (car-modified road barrier) was carried out in the Vehicle Safety Laboratory of the Automotive Industry Institute (PIMOT) in Warsaw (Fig. 1). The examination stand enables carrying out crash tests of vehicles with a barrier (guardrail). For the sake of safety it is only possible to carry out tests with a perpendicular impact to the road barrier's surface. The tested vehicle is hitched to a special platform that is accelerated on the track with a help of a catapult. The catapult enables carrying out impact of whole vehicle weighting up to 2500 kg with a speed to 65 km/h. Before the impact, the car is released from the platform and with the force of impetus hits the barrier. The test is registered with the use of cameras designed for fast shooting. During the test measurements of accelerations are performed with the use of acceleration sensors respectively placed in the car. In the examined vehicle a driver manikin is also placed.

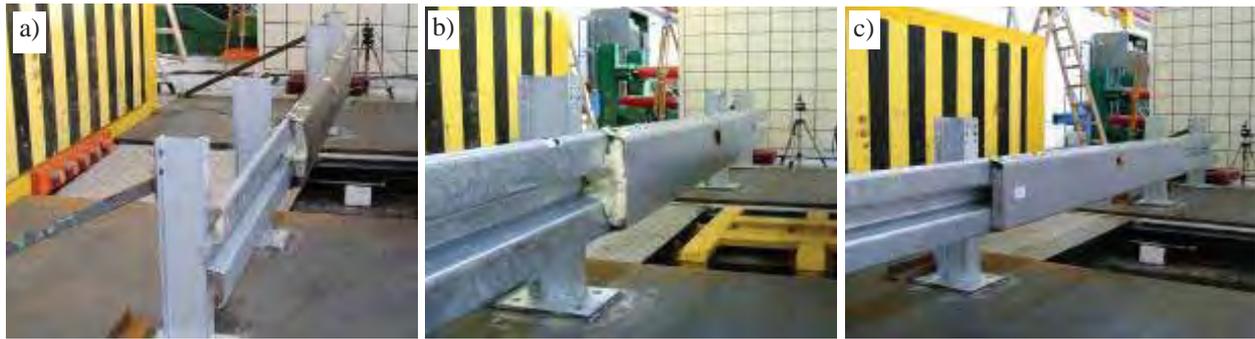
Fig. 3. Road barrier with a panel type 1A (a), 1B (b), 1BL (c)

The barrier's modification lies in the assembling an additional protective panel on the barrier's guide bar, which was done in order to increase the barrier's energy absorption. For the experimental research three types of protective panels were prepared in shapes presented in Fig. 2, the length of the panels amounted to 2 m. The examined construction is depicted in Fig. 3a-c.

The protective panel (marked as 1A) presented in Fig. 3a comprised a casing made of a steel sheet DC01, thickness 0.5 mm, filled with polyurethane foam (Ekoprodur). The panel was assembled to the guide bar by riveting. The rivet spacing was equal to 10 cm. The car Suzuki Swift with a mass 725 kg was used to the test with the described barrier.

In the protective panel (marked as 1B) depicted in Fig. 3b, instead of a steel casing, a casing from a composite material was used (a fabric with a straight interlace 0/90, 450g/m<sup>2</sup> - glass E, resin VE-11 M) with a thickness of 1.2 mm. The same polyurethane foam, as in the first case, was the filling of the panel. To the crash test the Suzuki Swift car with a mass of 715 kg was prepared.

The protective panel, marked as 1BL, comprised a composite casing and a filling in a cuboid form made of foamed aluminium. The panel is presented in Fig. 3c. A crash-test was performed with the use of a car with a mass of 720 kg.
