DYNAMIC LOADS EXERTED ON LEGS OF SEATED PASSENGERS DURING FRONTAL COLLISION OF A BUS WITH AN OBSTACLE

Abstract

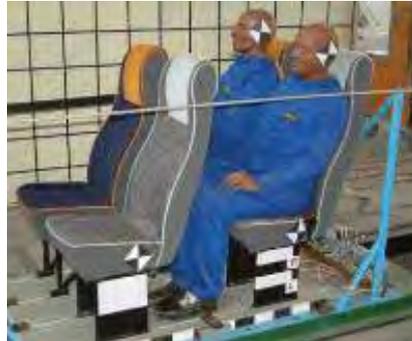
Fig. 1. Two sets of double seats

The measurements of dynamic loads exerted on seated passenger legs were performed by the Automotive Industry Institute at a dedicated impact-test station. A section of a bus floor was attached to the testing sledge and two pairs of seats were fixed to the floor section (Fig. 1).

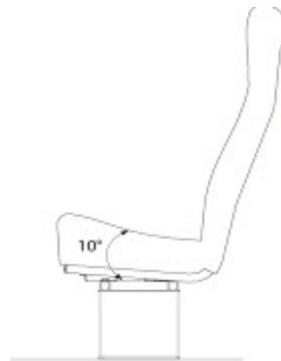
Fig. 7. Seat inclination angle

The results apply to seats inclined at an angle of 10° (Fig. 7).

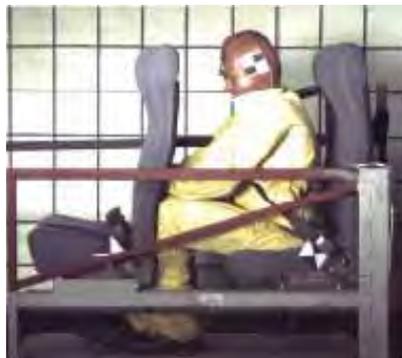
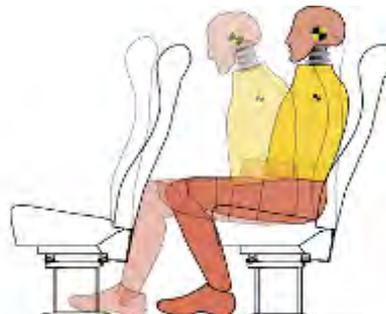
Fig. 8. Dummy secured with a 3-point belt, seat angle 10°

Figures 8-10 show the following dummy leg displacement phases in the test. The drawings can be referred to one of the body positions shown on the photograph. Such juxtaposition of displacements of the dummy secured with a 3-point belt (Fig. 8), secured with a 2-point belt (Fig. 9) and unsecured (Fig. 10) is also worth referring to the knee movement trajectory (Fig. 6). The slanted thick line in Fig. 6 represents the back of the seat facing the dummies. The fact that the knee trajectory crosses this line means that the backrest of the seat was distorted or broken by the impact of the dummy's legs. The point in time when the knee touches the backrest is the start of abrupt build up of the forces shown in Fig. 11, 13 and 14.

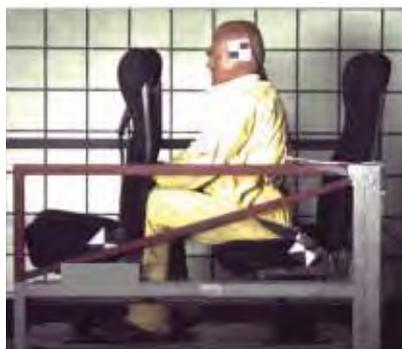
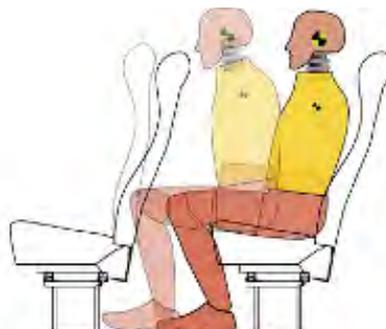
Fig. 9. Dummy secured with a 2-point belt, seat angle 10°

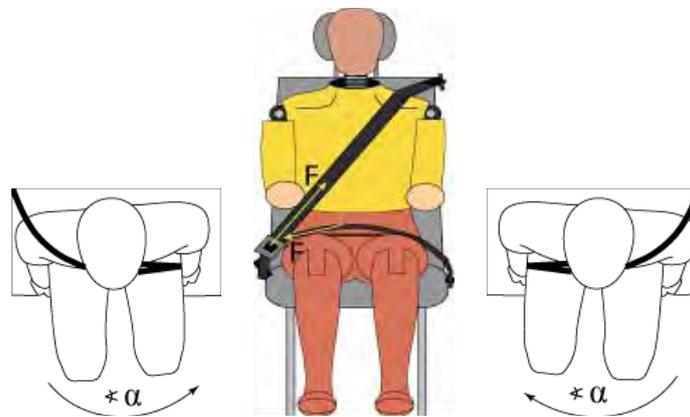
Fig. 12. Lower torso (hips) rotation depending on belt orientation and seat position

The difference between forces recorded for the left and right thighs, shown in Fig. 11, is caused by the dummy's position against the belt and the front seat during the impact. In this case, the left leg (knee) hits the back of the front seat stronger than the right one. The cause of the difference is the dummy's hips rotation resulting from asymmetric operation of the seat belt and inertia forces acting on the hip section of the dummy's trunk. It is the seat belt that is responsible for this effect [3, 4]. In the initial impact phase, when the dummy is thrust forward by forces of inertia, the chest and shoulder and hip sections of the 3-point belt hold the trunk (see the center section of Fig. 12). Then, forces of inertia acting on the upper part of the dummy (torso and head representing the bulk of the weight of this part of the body) load the chest and shoulder section of the belt much stronger but asymmetrically against inertia forces. The result is the stretching of the lower, hip section of the belt through the buckle on one side of the belt. Accordingly, the lower part of the dummy's trunk (hips) is rotated by forces of inertia in the direction opposite to the direction of rotation of the upper part (chest). Obviously, even a small hip rotation produces a strong difference in knee thrust against the base of the front seat (Fig. 12).

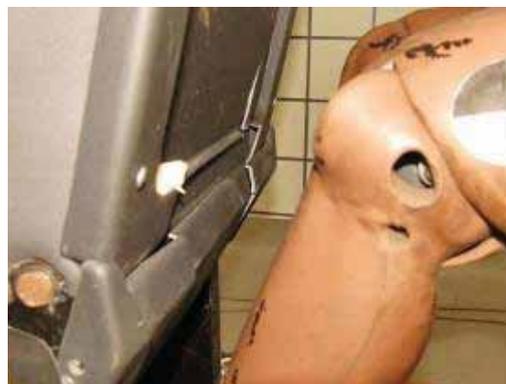
Fig. 15. Visible damage to the backrest caused by the Hybrid dummy's knees impact

The problem of rotation of the hips of the dummy secured with a 3-point belt, illustrated by the damage to the bus seat, calls for continued research, which is particularly important for speeds above 30 km/h. The figures provided in Tab 1 provide an indication of significance of the issue. The differences between forces acting on the left and right legs depend on the angle of inclination of the seat, among other factors.
