VIBRO-ACOUSTIC METHODS IN MARINE DIESEL ENGINES DIAGNOSTICS

Tomasz Lus

2. Objects of investigations – the WOLA 57H6Aa type diesel engine with the WSK–Holset 4MD turbocharger and SULZER 6AL20/24 type diesel engine with Napier C–045/C turbocharger

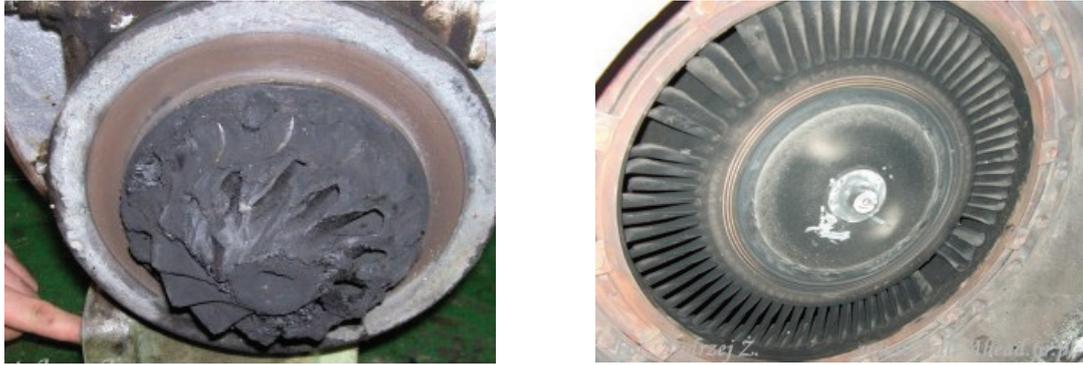
Fig. 1. Examples of radial-flow rotor turbine overgrown by carbon soot (left) and axial-flow rotor turbine without turbine blades (right) [www.ful-ahead.net]

Diesel engines technical condition assessment is a very complex process. Most of the malfunctions and troubleshooting in diesel engine installations are generated by the fuel injection system and valve gear mechanism [7]. Most of marine diesel engines are turbocharged. Turbochargers also caused significant number of engine malfunctions especially when engine is fuelled by heavy fuel oil. Conventional maintenance methods for engine turbochargers depend on bearings clearances checks between rotor shaft and bearing housing. Some parts of the turbocharger have to be checked on the special stands. But how check turbocharger bearings and rotor clearances without stopping the engine and dismantling it ? How to observe technical condition of the turbocharger on working engine? It is known that engine load and speed changes disturb observed turbocharger parameters. Heavy fuel oil not burnt to the end and severe engine working conditions (long time idling) led to several typical turbocharger malfunctions and damages of it in some cases. Chosen examples of turbocharger malfunctions are shown on the Fig. 1.

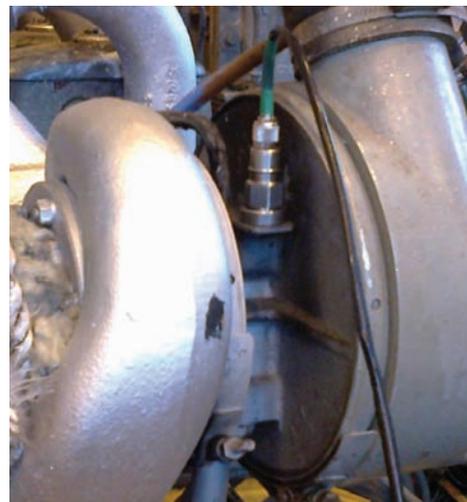
Fig.2a. WSK–Holset 4MD type turbocharger with vibration sensor mounted on the bearing housing

There were two objects of investigations. The first object of investigation was high-speed marine diesel engine WOLA type 57HGAA (Engine no 1) with its turbocharging system. The second was SULZER engine type 6AL20/24 (Engine no 2) with turbocharger both installed in Polish Naval Academy laboratory in Gdynia-Oksywie. The main data of the engine are presented in the Tab. 1. Measuring systems configuration and places where acoustic and vibration sensors were installed are shown on Fig. 2 and 2a.
