## EVALUATION OF DIAGNOSTIC INFORMATION ABOUT MARINE ENGINE WORK BASED ON MEASUREMENT OF THE ANGULAR SPEED DISCRETE VALUE

*The paper presents results of the experiment, aimed on finding the answer whether IAS (Instantaneous Angular Speed) and angular acceleration of the crankshaft is carrying information about quality of combustion in cylinder of the diesel engine. The experiment was carried out at laboratory stand in Gdynia Maritime University, equipped with diesel engine Sulzer 3AL 25/30 driving electro-generator. Sulzer 3AL 25/30 is three cylinder, medium speed, four stroke marine diesel engine, with maximum output 408 kW at 750 rpm. In order to evaluate of IAS utility for diagnosis of the engine, two kinds of malfunctions of engine's fuel system were simulated. First malfunction was fuel leakage from high-pressure line; the second was partly plugged injector's nozzle. Construction of high-pressure fuel pump enables to simulate fuel leakage. The level of leakage was controlled by simultaneous measurement of pressure in the high-pressure tube. For simulation of injector malfunction, the choked one was installed in second cylinder. The engine was running at different loads, start

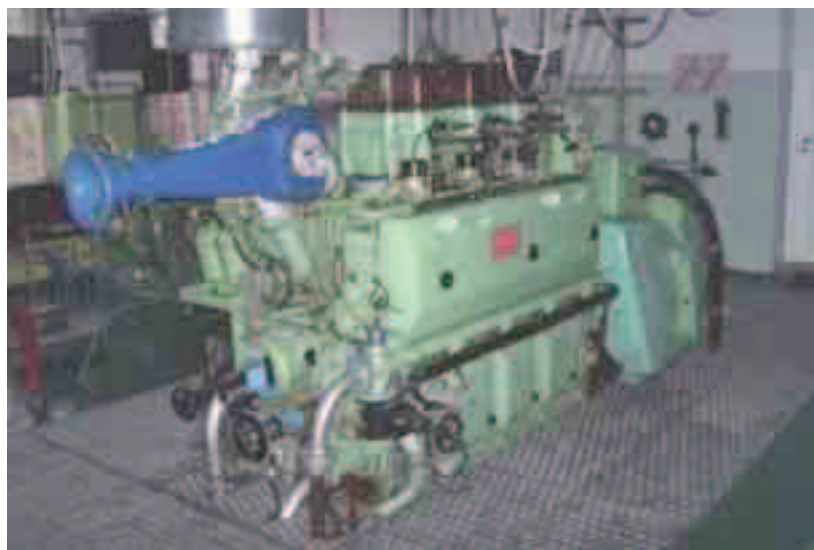
Fig. 1. General view of the Sulzer 3 AL 25/30

The main engine particulars are reported in Tab. 1. It is turbocharged medium speed diesel engine designed by Sulzer. This 3- cylinder in row engine develops 408 kW, at rotational speed of 750 rpm. The engine drives alternate current electro generator GD8-500-50, 500kVA, connected to the main electric board. The load of the engine can be fluently adjusted by changing of the load of generator (adjustable resistor). The high-pressure fuel system has three injection pumps, one for each cylinder. General view of the engine is presented in Fig. 1.

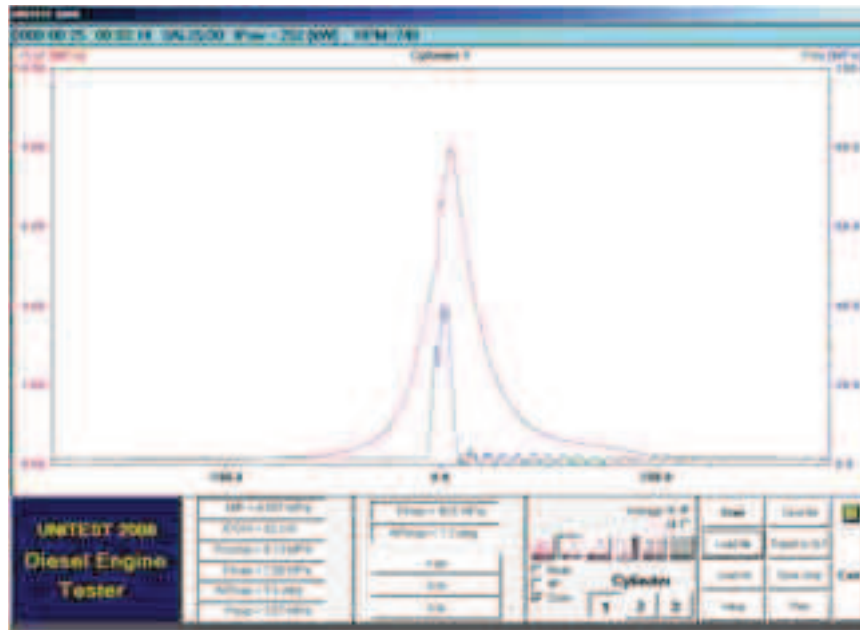
Fig. 2. Window of Diesel Engine Tester with in-cylinder and injector pipe pressure picture

The crankshaft angular speed variations were measured at the crankshaft free end. Measurements were carried out at different loads, i.e. 150, 200, 250 kW and idle run. IAS measurement was conducted under different loads, in healthy condition, with implemented malfunction of small and significant leakage of injection pump and partly plugged injector. The level of fuel leakage was set up observing the picture of decreasing of high-pressure value at UNITEST 2008 screen (Fig. 2).

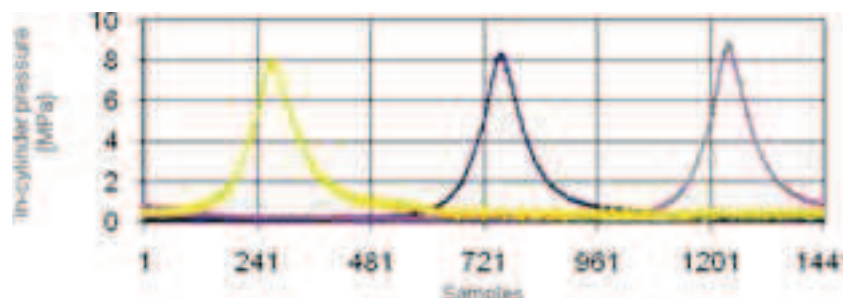
Fig. 3. In-cylinder pressure in domain of crankshaft angle (sampling interval  $0.5^\circ$ )

Simultaneously was recorded in-cylinder pressure of each cylinder using Diesel Engine Tester UNITEST 2008. This system is the permanent equipment of the laboratory test bed and enables measurement of in-cylinder pressure and high-pressure fuel pipe pressure in every cylinder in the same time. Fig. 3 presents a sample of in-cylinder pressure value of 3-cylinders in firing sequence.

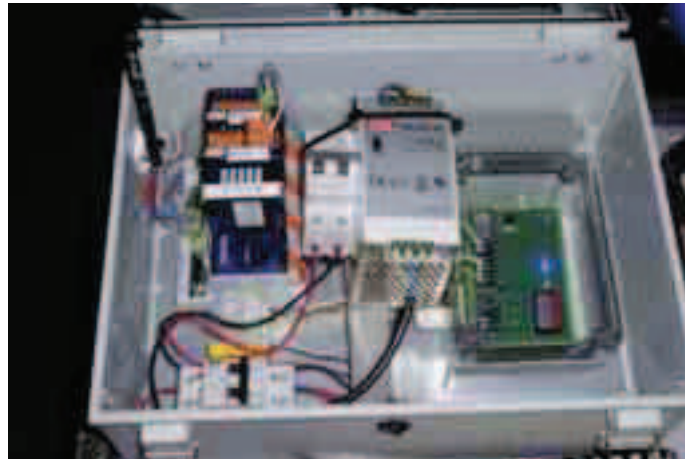
*Fig. 3. Calculating module ETNP-10 with PLC SAI A*

For measurement of the angular speed variation was used the laser photo optical system ETNP-10, produced by ENAMOR Ltd. Gdynia. The system originally dedicated for torque measurement at ship's propulsion shaft, consist of the laser sensor, which emits laser beam with frequency of 16MHz, and the calculating module based on signal converter and the programmable logic controller PLC PCD3 SAIA.

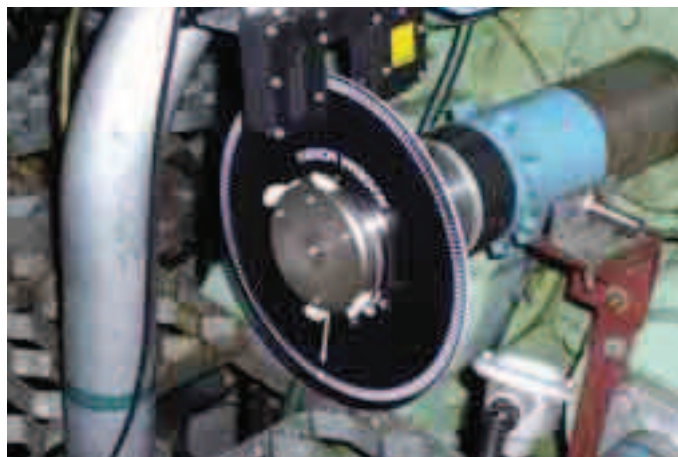
*Fig. 4. Measurement disc and laser sensor mounted at crankshaft free end*

The crankshaft angular speed variation signal transmitter is the perforated disc with 180 proportional slots and 180 teeth, at the disc's circumference. Number of impulses going through the slot or "blind" due to tooth depends on instantaneous angular speed. The picture of the disc and the sensor is presented in Fig. 4.

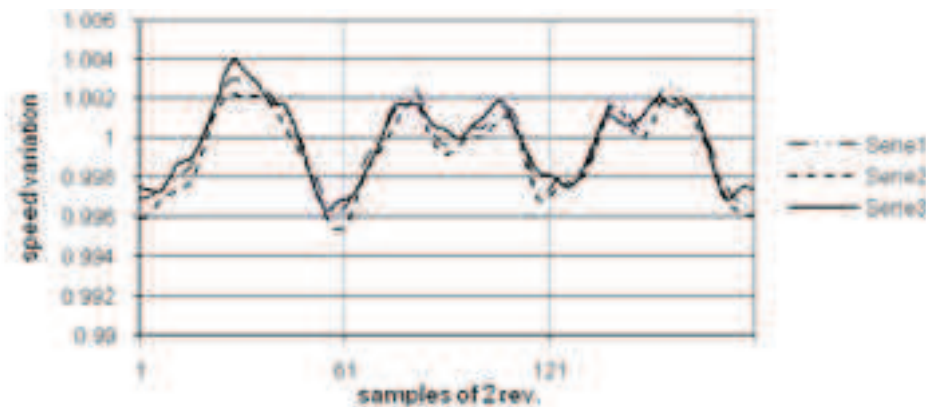
Fig. 5 Waveforms of angular speed variation of 3 runs, healthy engine, load 250 kW

ambient conditions have an impact at combustion process, then is necessary to determine the level of deviations between angular speed waveforms shape recorded during separate starts of the engine with time intervals. Figures below present comparison of 3-separate, independent records of IAS waveforms of healthy engine working at load 250 kW. The angular speed is presented as “instant-to-mean” ratio. Very important factor for further detecting and identification of malfunctions is the shape and the magnitude of difference value of compared runs’ waveforms. Fig. 6 presents comparison of two template runs of healthy engines at load of 250 kW. The maximum observed deviation is  $\pm 0.1\%$  of angular speed mean value.

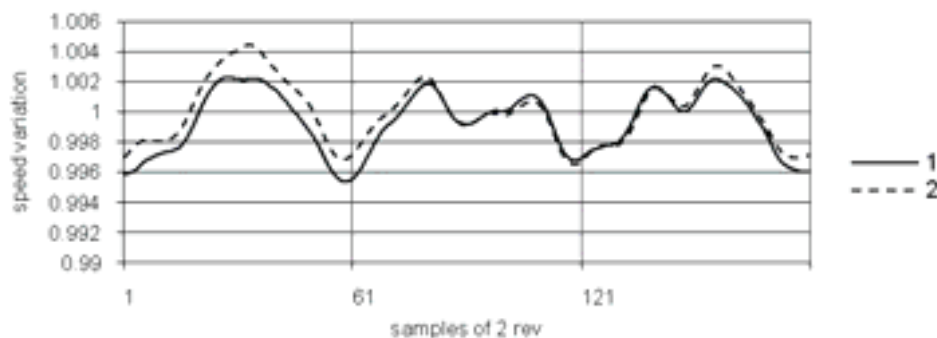
Fig. 7. Angular speed variations of healthy engine (1) and fuel leakage (2), load 250 kW

First malfunction was the leakage from injection pump number 2. The level of leakage was adjusted basing on observation of high-pressure fuel decreasing, at UNITEST display, and was established at 30% max. pressure down.

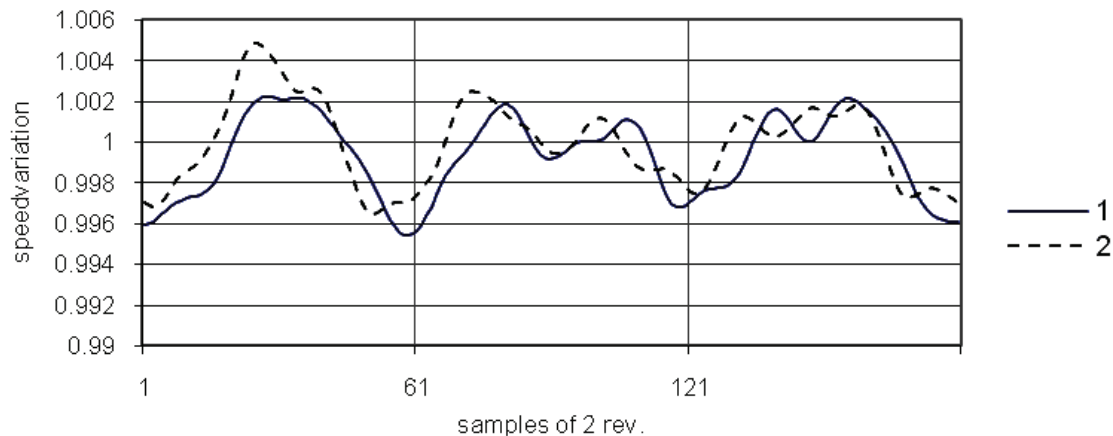
Fig. 9. Comparison of healthy engine (1) and partly plugged injector's nozzle (2), load 250 kW

In order to get records of impact of an injector malfunction, specially prepared injector with plugged 30% of nozzle openings was installed in 2<sup>nd</sup> cylinder's head. The engine was working at different loads. Simultaneously with angular speed recording, in-cylinder pressure and injection pressure were measured. The waveform of disturbed combustion in comparison with healthy one is presented in Fig. 9.

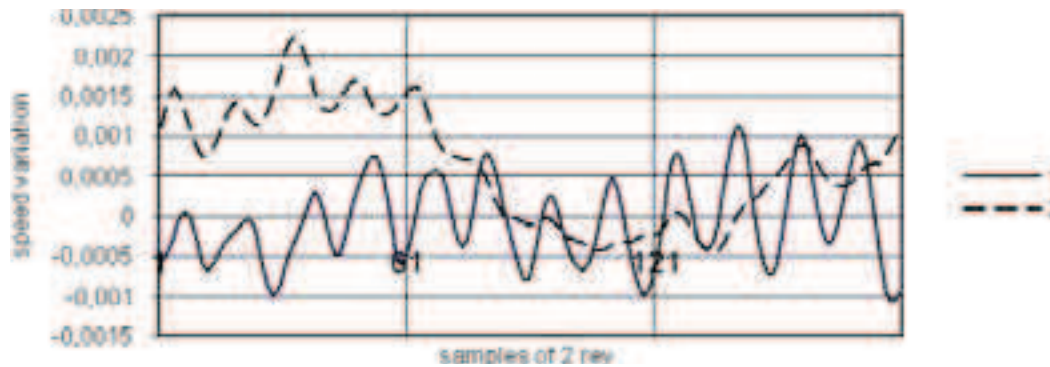
Fig. 10. Angular speed variation difference comparison: two runs healthy engine (1); healthy and fault of fuel leaking (2), domain of samples of 2 rev., 250 kW

After analysis of healthy and disturbed waveforms of IAS, became obvious that simple comparison is not sufficient for definition of the malfunction. Better picture of disturbances is given by comparison of waveforms presenting angular speed difference between healthy and faulty condition, at the same load value [6]. Analysis of tendencies and magnitudes can give the information about malfunction presence and its character. Samples of measured angular speed differences between: two healthy, healthy - leakage fault and healthy - plugged injector are presented at Fig. 10. and Fig. 11.

Occurring of the malfunction is shown due to magnitude amplification. Detection of faulty cylinder in the case of fuel leaking can be done in the way of span analysing between maximum and minimum value of variation's difference, in every interval (240°) between TDC's of the work stroke of each cylinder (Fig. 10). In the case of partly plugged injector, simple analysis of amplitude span is insufficient (Fig. 11).

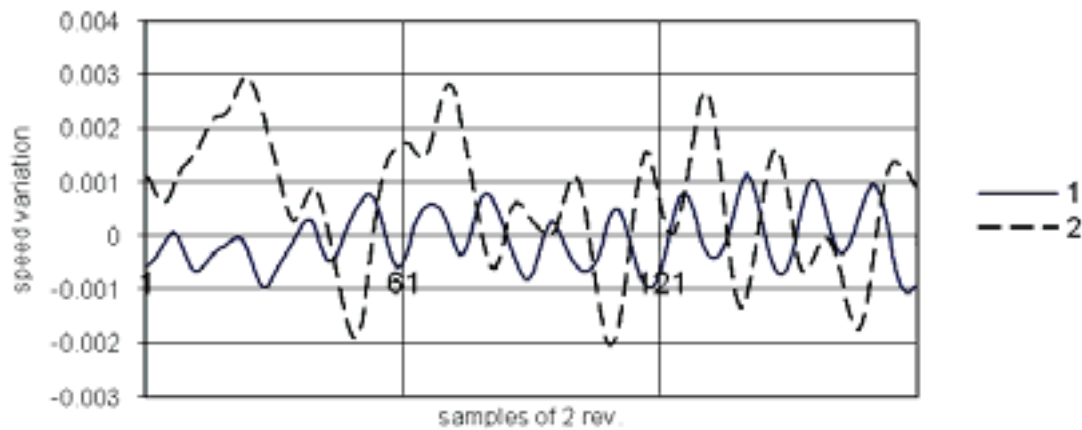
Fig. 11. Angular speed variation difference comparison: two runs healthy engine (1) healthy and fault of plugged injector (2), domain of samples of 2 rev. 250 kW
