## ANALYSIS OF THE WEAR OF PISTON RING PROTOTYPE OF AN EMBANKMENT OF DIAMOND IN TERMS ENDURANCE TEST

*The article discusses the results of the wear of piston rings for internal combustion engines with spark ignition. The research was a prototype multilayer ring sealing of the porous coating and the so-called chromium embankment diamonds. Technology of the rings is the deposition of multilayer coatings in the process of chromium plating. In times of chromium deposited from the bath, particles are technical diamond's shape, and granulation. This technology is a response to domestic factory piston rings to the needs of the automotive market and is an innovative development. Conducted engine tests consisted of a 50-hour cycle and to hour break-in team life cycle, which was repeated 150 times. Thus, the total duration of sample equal to 200 hours. Cycle life is a team containing a phase-hour cycle engine traffic load at maximum speed and maximum torque and maximum power of the tween partial load and idling. This cycle is repeated in the 200-hour test 150 times. During the measurement of key indicators were measured at the engine, the fuel consumption, coolant temperature and pressure o

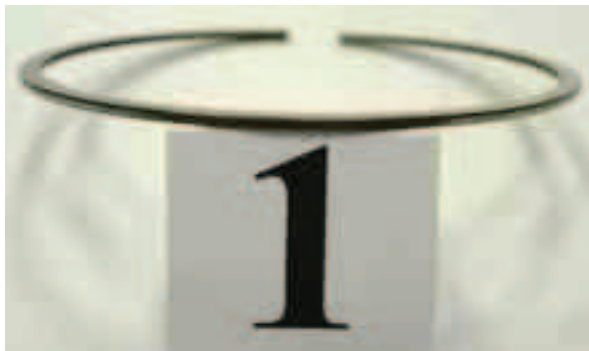
Fig. 2. View of side surface of the first ring of the cylinder No. 1

All of the rings shows the correct cooperation with the surface of the cylinders. The surface of the rings is evenly worn around the perimeter of the height of the rings (Fig. 2–5). In particular, the

rings 1 and 3 were slightly consumption over the entire surface, at about 3/4 height from the bottom edge. 2 and 4 rings are worn on the entire surface, while maintaining a symmetrical barrel shapes.

Average value of wear of the radial width of the **ring 1/1** is equal to  $-0.0104$  mm. In all 10 measuring points on the circumference of increment widths ranging from  $-0.02$  to  $0.0$  mm were measured. Also increase of the axial high  $-0.003$  Mm were measured. Was measured the weight gain equal to  $0.0025$  g, confirming increasing the size of the rings. Any discussion about the causes of this phenomenon requires detailed materials research

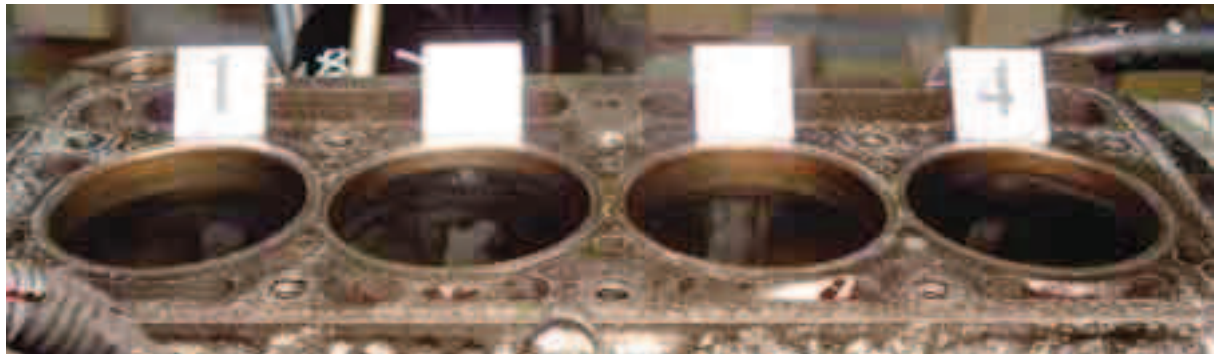
*Fig. 6. View of the engine block after test, removing the pistons and removing deposits*

Cylinder liners have a little wear except the sleeve 2 and 4. Honing features are not visible. On all surface of the cylinder above the TDC, I of the sealing ring and on the surface of the combustion chamber of the cylinder head were found deposits. Deposits have a thickness of about  $0.3$  mm.

In all cylinders between the TDC of the third ring, and the BDC of the first ring was found in a direction perpendicular to the motor cross the occurrence of longitudinal features on both sides of the sleeve (Fig. 6). It should be noted that the sleeves have 1500 hours engine traffic the total mileage (seven tests including one longer by 50%). In summary, the wear of the sleeve is the result of the 1500 hours work [4, 5].

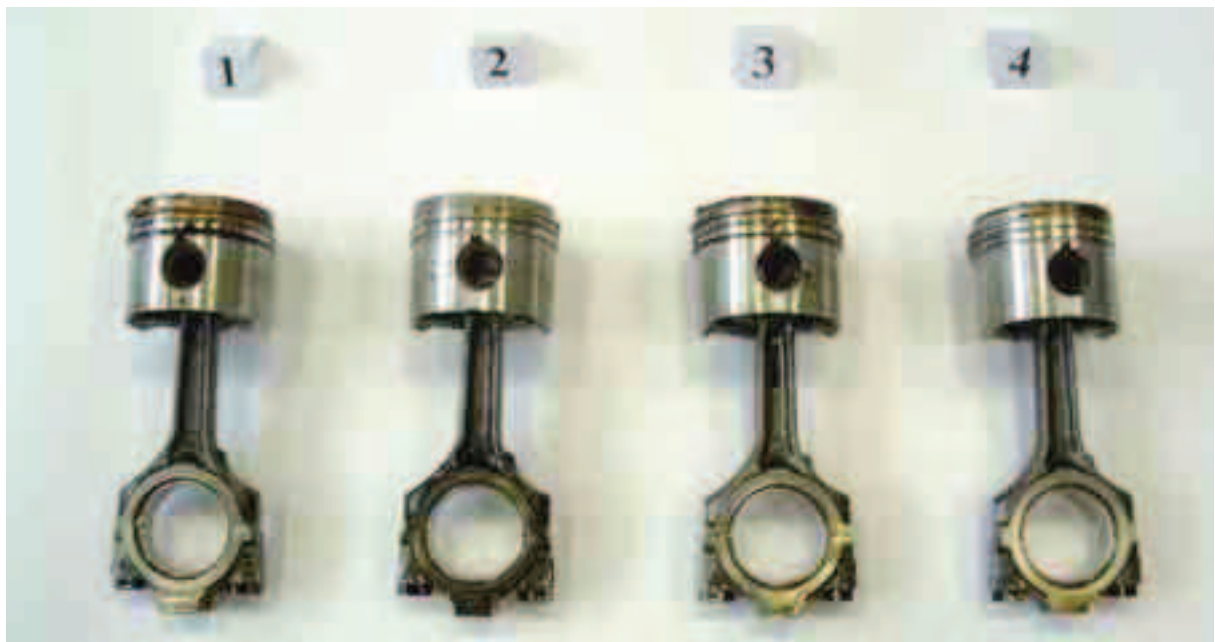
*Fig. 7. The view of the piston groups after the tests*

In this test was used a new custom pistons. The height the groove of the first sealing ring equal to  $1.2$  mm, and the standard height of the groove of oil ring equal to  $2$  mm.

Pistons organoleptic tests showed no significant wear. Cooperation with the piston rings, cylinder liners as well was fine. It was only found tiny imperceptible features on the piston surface in the section parallel to the axis of piston pin (Fig. 7).

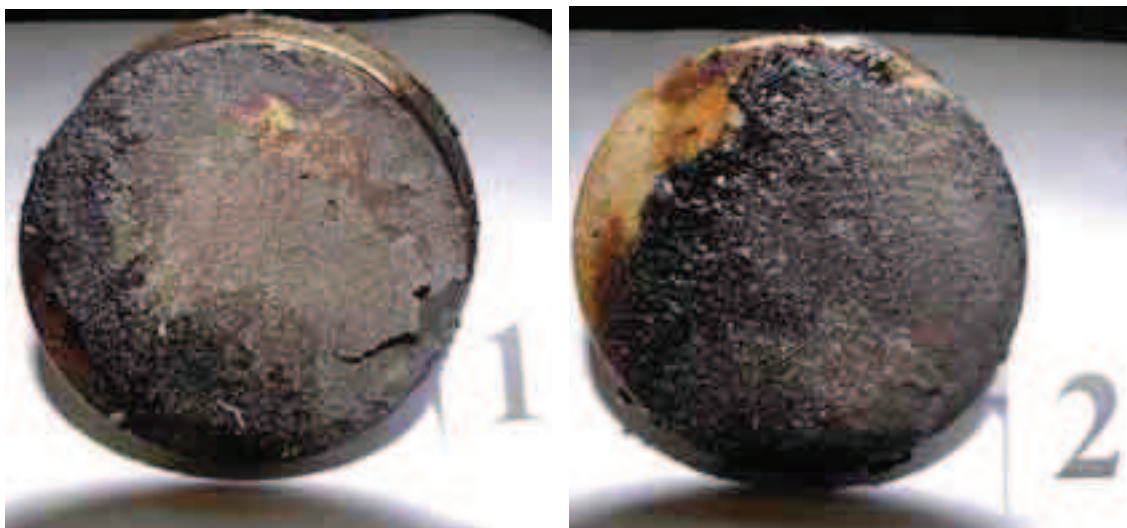
Fig. 8. View of the pistons after tests

It was a large amount of carbon deposits on pistons bottom, which is the result of the increased by about 50% lubricating oil consumption compared to the normal wear (Fig. 8). This may be due to the reduced height of oil rings.
