## SURFACE MODIFICATION OF POLYPROPYLENE NONWOVEN WITH COMPOSITE METALLIC LAYERS

### **Abstract**

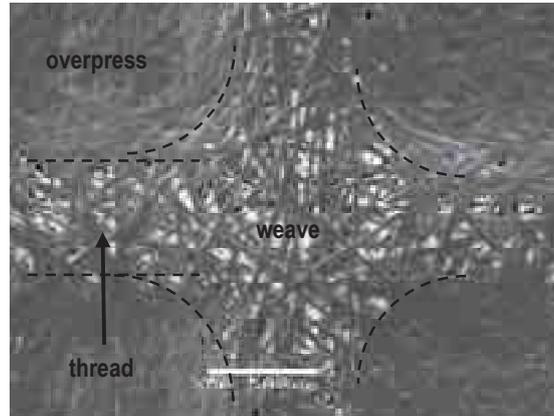
- “Weave” as the equivalent of crossing the “threads” made up of polypropylene fibres,
- “Overpress” is understood as an area located between the four “weaves” and corresponding to the site of thermal joint of unwoven fabric,
- “Thread” – the equivalent of the PP fibre set between overpresses, forming weaves (Fig. 1).

Fig. 1. SEM image, analyzed areas of polypropylene nonwoven fabric: thread, weave and overpress

The layers were analyzed on nonwoven fabric in areas conventionally known as “overpressing”, corresponding to sites of thermal joints and understood as areas lying between the four “weaves” of “threads”. They were analyzed in areas of “weaves” as the equivalents of crossing spots of the polypropylene “threads” and on single “threads” made up of “fibres” (Fig. 1).

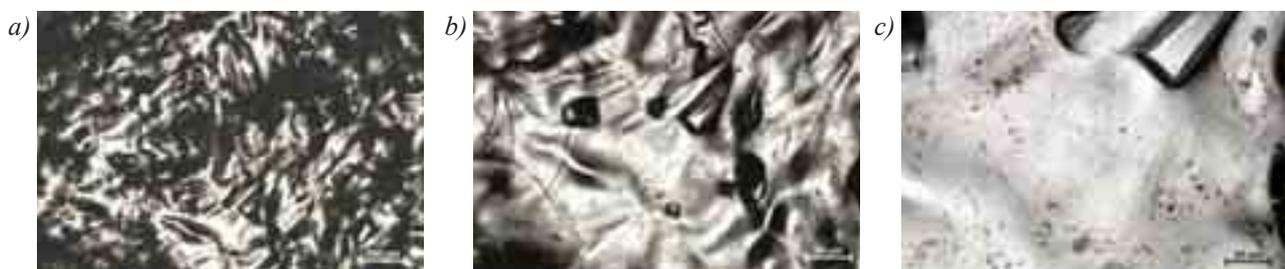
Images obtained by metallographic microscopy (Fig. 2) provide a monolithic surface of the nonwoven fabric, melted under the influence of temperature, and a few holes that are residues of free spaces characteristic of the design of non-deformed “weave”. A metal layer covering the molten substrate is continuous, marked by a few cracks, visible clearly in all sampling areas.

Fig. 2. MM images of 1 (CuZnNi) sample surface: a) the scale of 100μm, b) the scale of 50μm, c) the scale of 20μm

“Over-pressed” spots show a similar structure in all areas of the surface sampling. There are no visible signs of “flow” of substrate material. The deposited layer is uniform and smooth, and the visible points of discoloration may be a sign of initial chemical changes, possibly corrosive destroying of the layer.

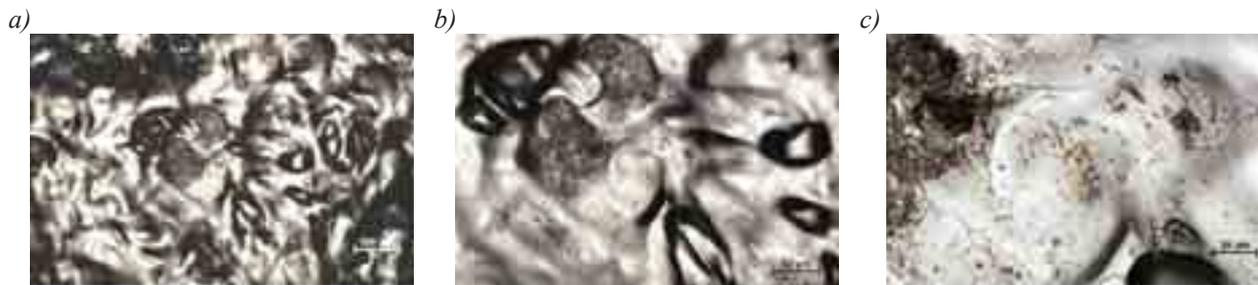
Images obtained by metallographic microscopy (Fig 3) illustrate the “weaves” i.e. areas of unwoven fabric between “over-pressed” spots. The fibres of this zone are highly molten and form a compact structure. One can only see a few pores, which are residua of the free spaces of nonwoven fabric produced prior to deposition of metal layers. The fibres are outlined with cracks on a metal layer, running across the fibres and extensive staining accumulated at elevations. This is probably an image of places where the metal layer was subjected to peeling or chipping.

Fig. 3. MM images of 2 (NiCuFe) sample surface a) the scale of 100 $\mu$ m, b) the scale of 50 $\mu$ m, c) the scale of 20 $\mu$ m

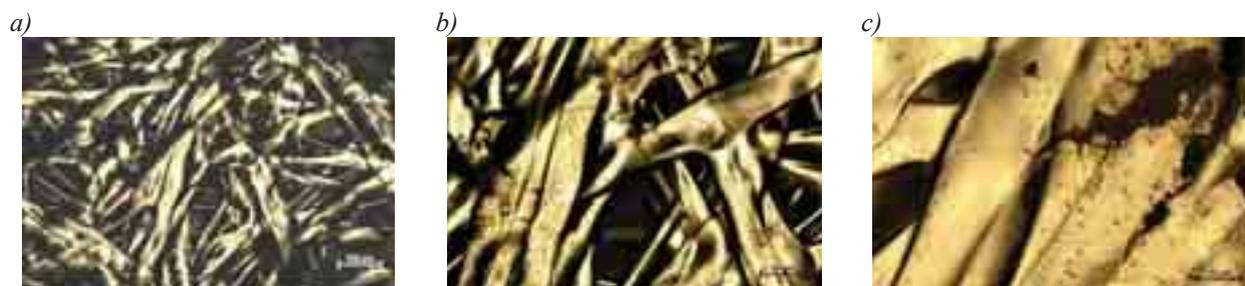
Images obtained by metallographic microscopy (Fig. 4 a, b, c) of the areas of unwoven fabric between locations of "overpresses" and "weaves" provide a confirmation of previous observations. They show that the dominant role in evolution of unwoven fabric morphology in the deposition process, in relation to the uncoated unwoven fabric, play two effects: partial melting and binding of the surface fibres forming "threads" and scaling leading to disruption of a deposited metal layer. Compared to the previously described layers, the temperature accompanying the Cu /Sn layer deposition process resulted in less deformation of their shape.

Fig. 4. MM images of 3 (CuSn) sample surface a) the scale of 100 $\mu$ m, b) the scale of 50 $\mu$ m, c) the scale of 20 $\mu$ m

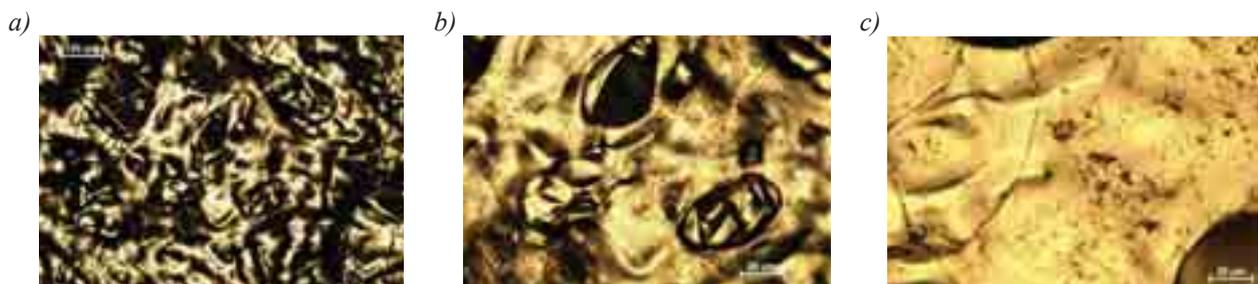
Images obtained by metallographic microscopy (Fig. 5 a, b, c) of the areas of unwoven fabric between locations of “overpresses” and “weaves” show that there was a total deformation of the fibres under the influence of temperature. The metal layer revealed cracks that run across the entire width of the fibres. There occurs local extensive scaling that exposed low-lying fibre fragments of fibres of lower deformation.

Fig. 5. MM images of 4 (three-layer system: CuZnNi / NiCuFe / CuSn) sample surface a) the scale of 100 $\mu$ m, b) the scale of 50 $\mu$ m, c) the scale of 20 $\mu$ m

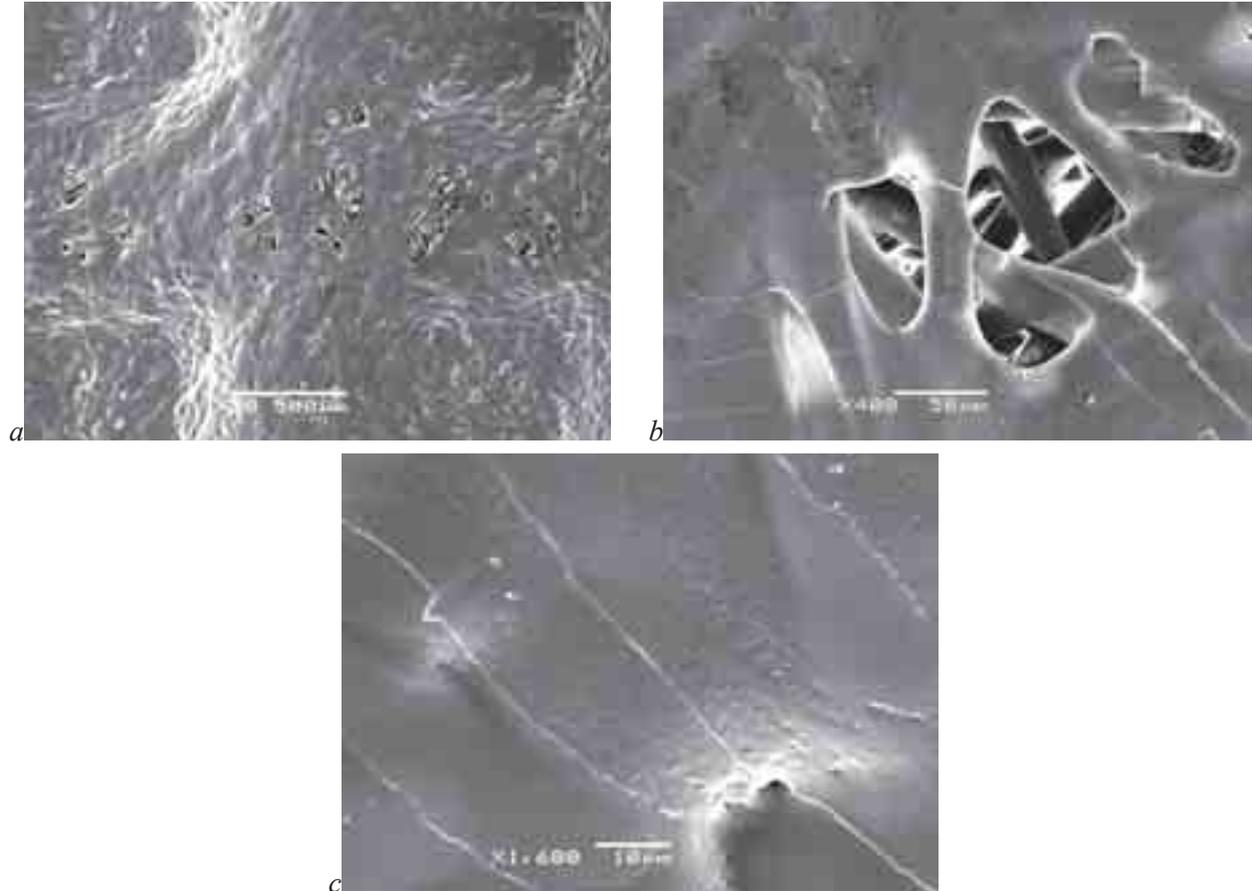
An image of “weave” (Fig. 6a) shows that there has been a fusion of fibres without the pressure. Both in the fusion zones of fibres and the preserved, non-deformed their fragments (Fig. 6b); there are cracks in a metal layer of isotropic orientation. There is also a tendency to accumulate the crack lines of layers around the holes that remained between non-melted fibres (Fig. 6c). A deposited layer despite the cracks is free of peeling and represents the shape of substrate.

Fig. 6a, b, c. SEM images of 1 (CuZnNi) sample surfaces

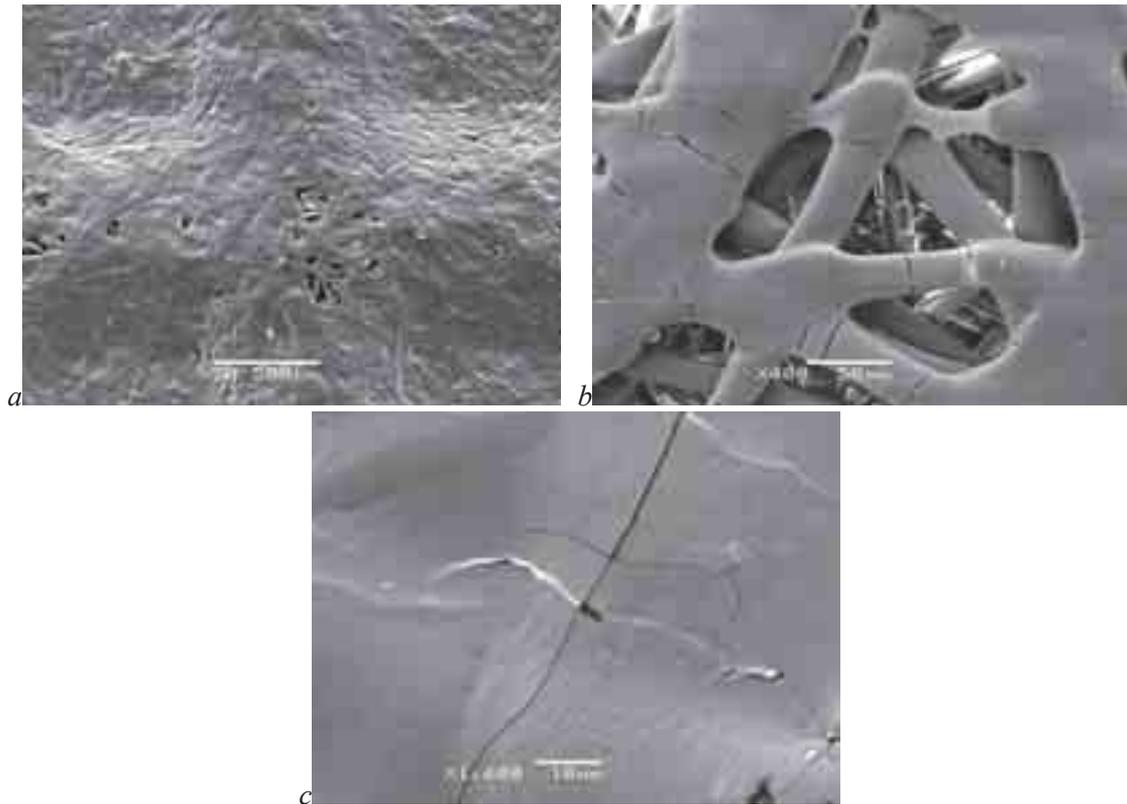
An image of “weave” (Fig. 7a) shows that, as a result of fibre melting the compact surface was produce also on “threads” forming “weave”. There are only a few fragments of the surface with perforations, with survived fragments of flattened and partially melted fibres (Fig. 7b). Deeper one can see parts of fibres less deformed, which may indicate a direct impact of high pressure forces to the surface of weave and its flattening. Numerous cracks peripheral in character confirm the small flexibility of a metal layer deposited on the fibres. There are also extensive chippings. In some places, the layer morphology is similar to orange peel (Fig. 7c). Based on the protruding parts of the layer, its thickness can be determined at 0.4 - 0.6  $\mu\text{m}$ .

Fig. 7a, b, c. SEM images of 2 (NiCuFe) sample surfaces

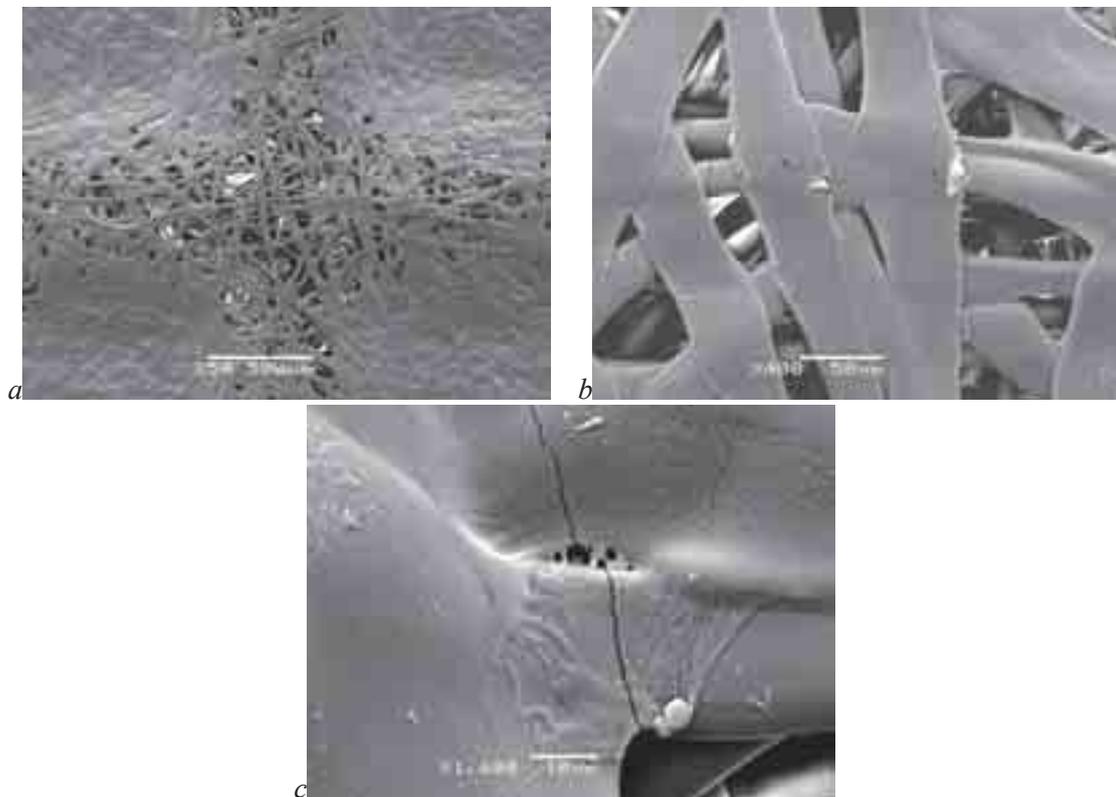
Visible fibres of “threads”, forming a “weave” indicate a much smaller effect of temperature on the process of their deformation and fusion (Fig. 8a). Flattening of the fibres indicate the influence of pressure forces (Fig. 8b). Deeper parts of fibres that can be seen are less deformed, because they are not subject to the direct impact of these forces, likely as in the coated samples (NiCuFe). Fig. 8 b, c shows that in the analyzed areas the metal layer is continuous, with few inclusions. This layer is relatively

little cracked; damages in the form of scaling occur only in places where fibres are overlapped and strongly flattened. Fig. 8c illustrates the junction of two fibres with traces of plastic flow and cure. The resulting crack in the layer may be due to temperature shrinkage or mechanical stress.

Fig. 8. a, b, c. SEM images of 3 (CuSn) sample surfaces

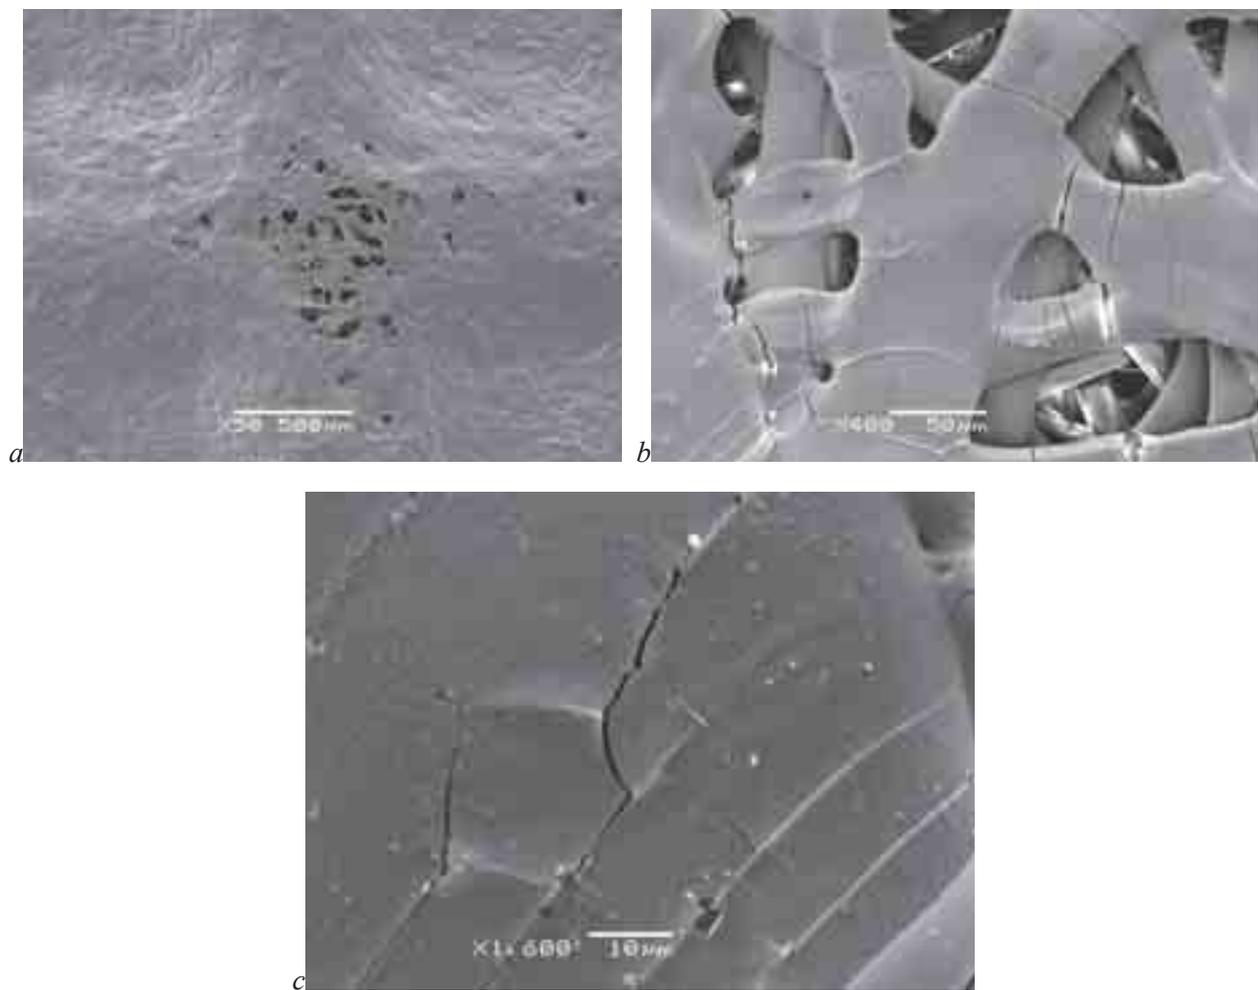
The area of “weave” - along with forming it “threads” preserves only a small part of the porous surface (Fig. 9a) with strongly deformed fragments of fibres. Deformation of the fibres as a result of prolonged exposure to heat in the remaining area has ensued to such an extent that by reason of complete fusion, their shape disappeared and they formed a compact surface structure (Fig. 9a, c). The preserved remains of fibres with a much-flattened shape also showed the impact of stress on the deformation in the process of melting. Enlarged images reveal (Fig. 9b, c) that the deposited layer has numerous cracks. Metallic cracks are linear and extend in directions transverse to fibres, presumably due to the occurrence of tensile stress. A fragment of fracture with overlapping layers (Fig. 9 c) suggests that the cause of this was sufficiently large deflection of the fibre. Sources of fibre bending should be sought in the stresses triggered by the fusion of fibres forming the top layer and the fibres lying below, which were not directly affected by temperature and pressure and preserved unchanged shapes and structure.

Fig. 9. a, b, c. SEM images of 4 (CuZnNi / NiCuFe / CuSn) sample surfaces

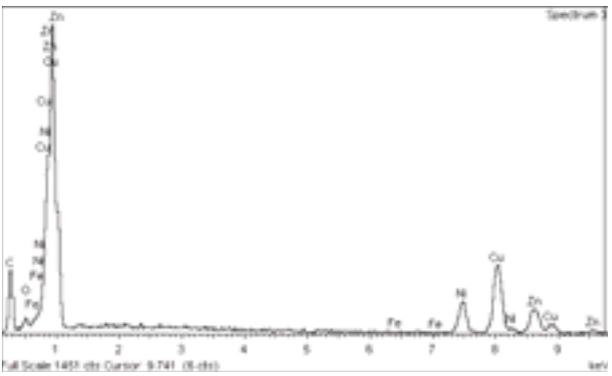
Type of target/ layer	Target composition (wt%)	Layer composition (wt%)	Spectrogram
<b>CuZnNi</b>	Cu (53.5-56.5) Zn (25-30) Ni (17-19)	C(6) O(4.02) Cu(49.23) Zn(25.57) Ni(15.08) Fe(0.1)

Table 3 presents the fraction of elements constituting the composition of the metal targets used for the layer deposition and elements forming the deposited layers. Fractions of elements forming the layers are the average selected from three arbitrarily selected points of measurement. Next to each set, there is a spectrogram from one of the measurement points.

It follows from these sets that the chemical composition of the analyzed area is composed mostly of carbon. It is identified for the most part, as a component of polymer substrate from which the unwoven fabric is made. There was also found the presence of small amounts of oxygen in all the analyzed layers. There was no presence of zinc in the three-layer system.

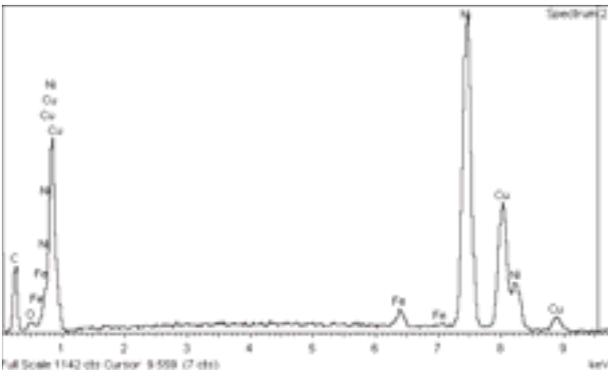
<b>NiCuFe</b>	Ni (65) Cu (33) Fe (2)	C(6) O(3.8) Ni(61.6) Cu(28.0) Fe(1.32)

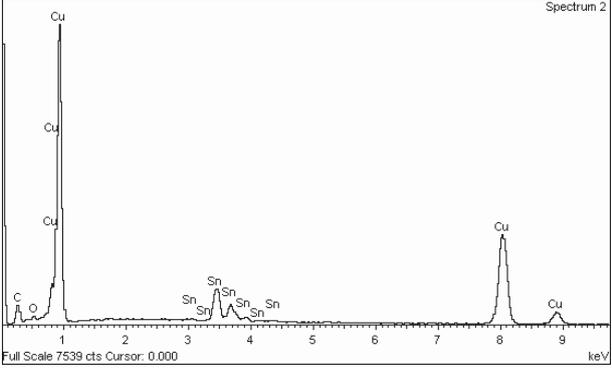
<b>CuSn</b>	Cu (80) Sn (20)	C(6) O(2.51) Cu(75.82) Sn(15.67)

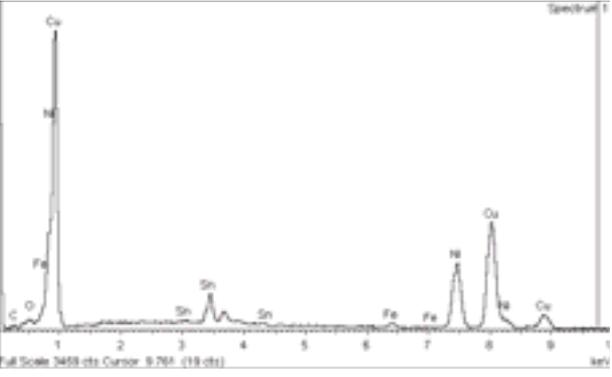
<b>CuZnNi/ NiCuFe/ CuSn</b>	(compositions as mentioned above)	C(6) O(1.7) Cu(56.0) Ni(28.0) Sn(7.6) Fe(0.7)
