## **SURFACE MODIFICATION OF POLYPROPYLENE NONWOVEN WITH COMPOSITE METALLIC LAYERS**

**Kazimierz Reszka, Ewa Dobruchowska**

### **Abstract**

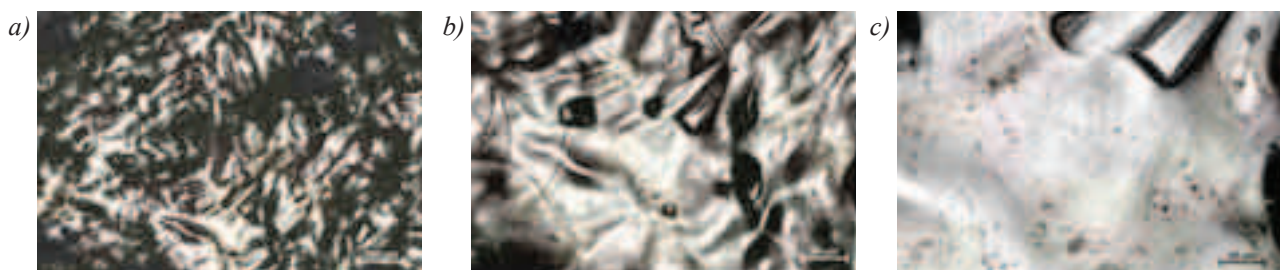
Images obtained by metallographic microscopy (Fig. 2) provide a monolithic surface of the nonwoven fabric, melted under the influence of temperature, and a few holes that are residues of free spaces characteristic of the design of non-deformed “weave”. A metal layer covering the molten substrate is continuous, marked by a few cracks, visible clearly in all sampling areas.

Fig. 2. MM images of 1 (CuZnNi) sample surface: a) the scale of 100μm, b) the scale of 50μm, c) the scale of 20μm

“Over-pressed” spots show a similar structure in all areas of the surface sampling. There are no visible signs of “flow” of substrate material. The deposited layer is uniform and smooth, and the visible points of discoloration may be a sign of initial chemical changes, possibly corrosive destroying of the layer.

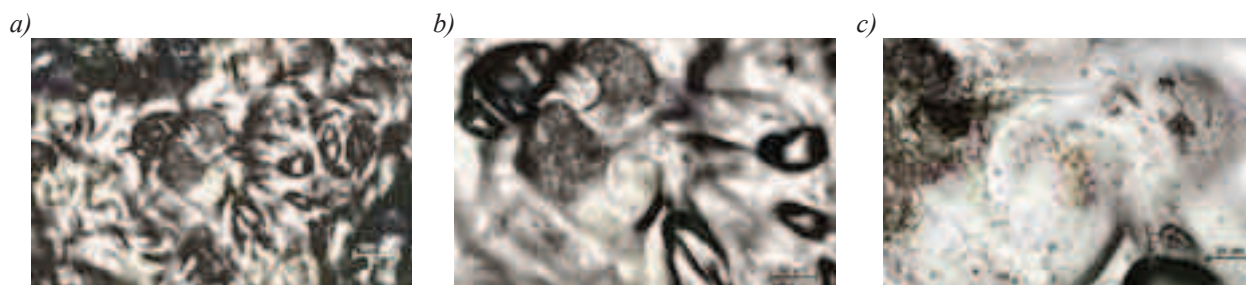
Images obtained by metallographic microscopy (Fig 3) illustrate the “weaves” i.e. areas of unwoven fabric between “over-pressed” spots. The fibres of this zone are highly molten and form a compact structure. One can only see a few pores, which are residua of the free spaces of nonwoven fabric produced prior to deposition of metal layers. The fibres are outlined with cracks on a metal layer, running across the fibres and extensive staining accumulated at elevations. This is probably an image of places where the metal layer was subjected to peeling or chipping.

Fig. 3. MM images of 2 (NiCuFe) sample surface a) the scale of 100μm, b) the scale of 50μm, c) the scale of 20μm

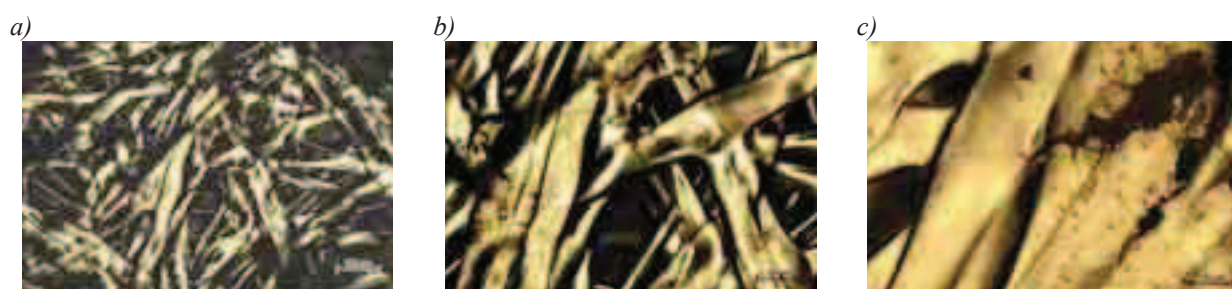
Images obtained by metallographic microscopy (Fig. 4 a, b, c) of the areas of unwoven fabric between locations of "overpresses" and "weaves" provide a confirmation of previous observations. They show that the dominant role in evolution of unwoven fabric morphology in the deposition process, in relation to the uncoated unwoven fabric, play two effects: partial melting and binding of the surface fibres forming "threads" and scaling leading to disruption of a deposited metal layer. Compared to the previously described layers, the temperature accompanying the Cu /Sn layer deposition process resulted in less deformation of their shape.

Fig. 4. MM images of 3 (CuSn) sample surface a) the scale of 100μm, b) the scale of 50μm, c) the scale of 20μm

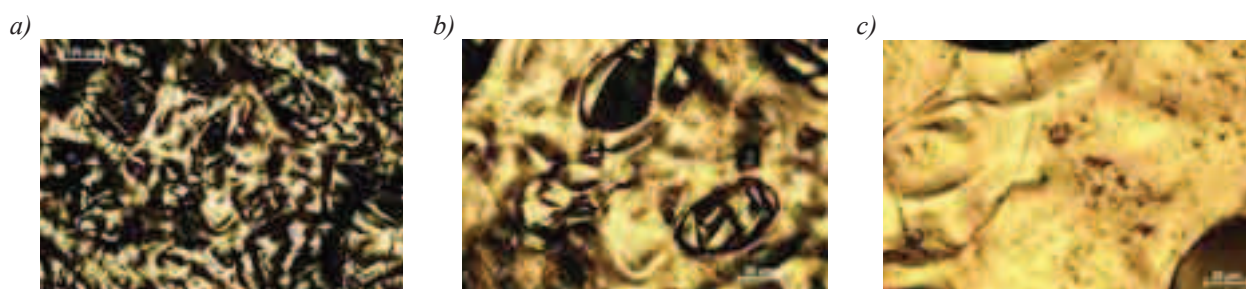
Images obtained by metallographic microscopy (Fig. 5 a, b, c) of the areas of unwoven fabric between locations of “overpresses” and “weaves” show that there was a total deformation of the fibres under the influence of temperature. The metal layer revealed cracks that run across the entire width of the fibres. There occurs local extensive scaling that exposed low-lying fibre fragments of fibres of lower deformation.

Fig. 5. MM images of 4 (three-layer system: CuZnNi / NiCuFe / CuSn) sample surface a) the scale of 100μm, b) the scale of 50μm, c) the scale of 20μm
