INDUCING COLLISION OF VEHICLES WITH THE INCOMPATIBLE ENERGY CONSUMPTION OF BODYWORKS IN DEFORMATION ZONES

Piotr Fundowicz, Hubert Sar

Warsaw University of Technology
Institute of Vehicles
Narbutta Street 84, 02-524 Warsaw, Poland
tel.: +48 22 2348410, fax: +48 22 8490303
e-mail: pfundow@simr.pw.edu.pl
e-mail: hubsar@wp.pl

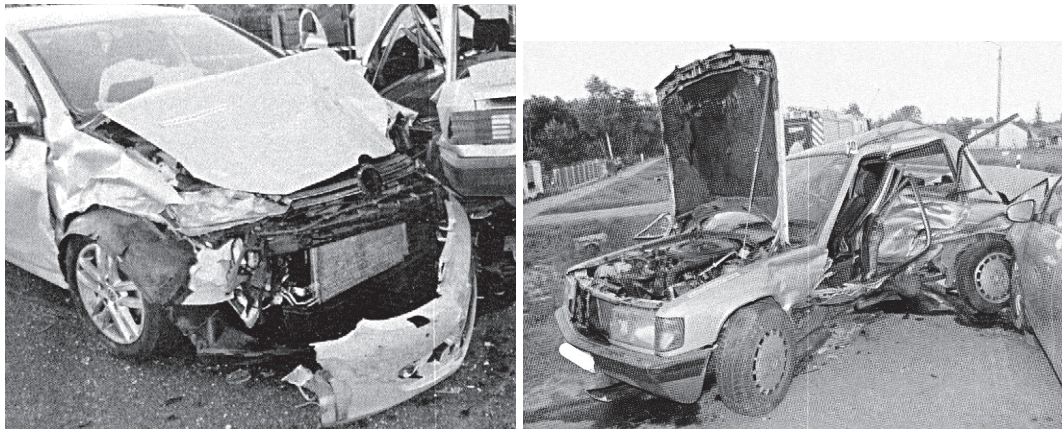
Fig. 2. Post-accident damage of vehicles

As a result of the collision the front part of the vehicle Volkswagen was damaged and the side part of the vehicle Mercedes – Fig. 2.

Relatively not high value of average deceleration of Volkswagen results from the fact, that Volkswagen hit the side of Mercedes, between its axles. The bodywork of the vehicle in side part has the lowest stiffness. Energy absorption of the structure of the bodywork when hitting its side part is even 5...10 times lower compared to the front part. Because of this, deep deformation of side part of Mercedes took place (see Fig. 2), practically to the half a width of the vehicle. It resulted in relatively slow increase of the deceleration of the vehicles in the impact phase.
