## ANALYSIS OF THE WEAR OF PISTON RINGS PROTOTYPE IN TERMS OF TEAM ENDURANCE TEST

Andrzej Kaźmierczak, Włodzimierz Dudziński, Łukasz Kaźmierczak

Technical University of Wrocław  
Department of Mechanical Engineering  
Wyspiańskiego Street 27, 50-370 Wrocław, Poland  
tel.: +48 71 3477918, fax: +48 71 3477918  
e-mail: andrzej.kaźmierczak@pwr.wroc.pl, wlodzimierz.dudzinski@pwr.wroc.pl,  
lukasz.kaźmierczak@pwr.wroc.pl

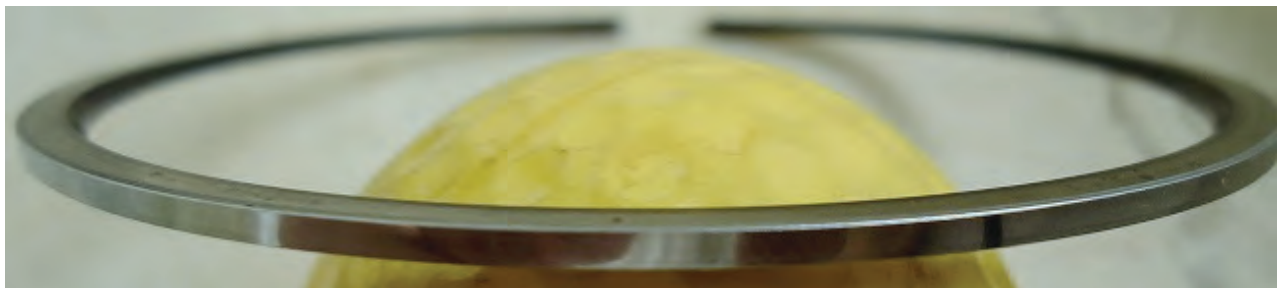
All of the rings shows the correct cooperation with the surface of the cylinders. The surface of the rings is evenly worn around the perimeter of the height of the rings (Fig. 2-5).

Fig. 2. View of side surface of the first ring of the cylinder No. 1

Average value of wear of the radial width of the ring 1/1 is equal to 0.003 mm. In all 10 measuring points on the circumference of wear ranging from 0.00 to 0.008 mm were measured. Also the rounding of the axial high is equal to 0.007 mm were measured. Was measured the weight gain equal to 0.0322 g, confirms the results of the wear of the width and height of the ring.

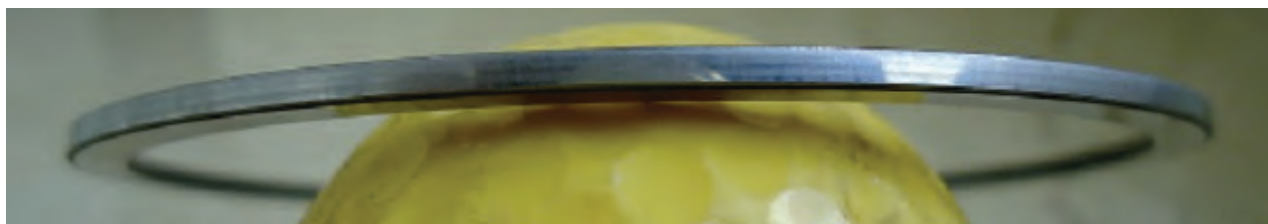
*Fig. 3. View of side surface of the first ring of the cylinder No. 2*

Average value of wear of the radial width of the ring 2/1 is equal to 0.004 mm. In all 10 measuring points on the circumference of wear ranging from 0.002 to 0.006 mm was measured. Average value of wear of the axial height is equal of 0.006 mm. Loss of weight of the ring 2/1 is equal to 0.0181 g and it confirms the results of the wear of the width and height of the ring.

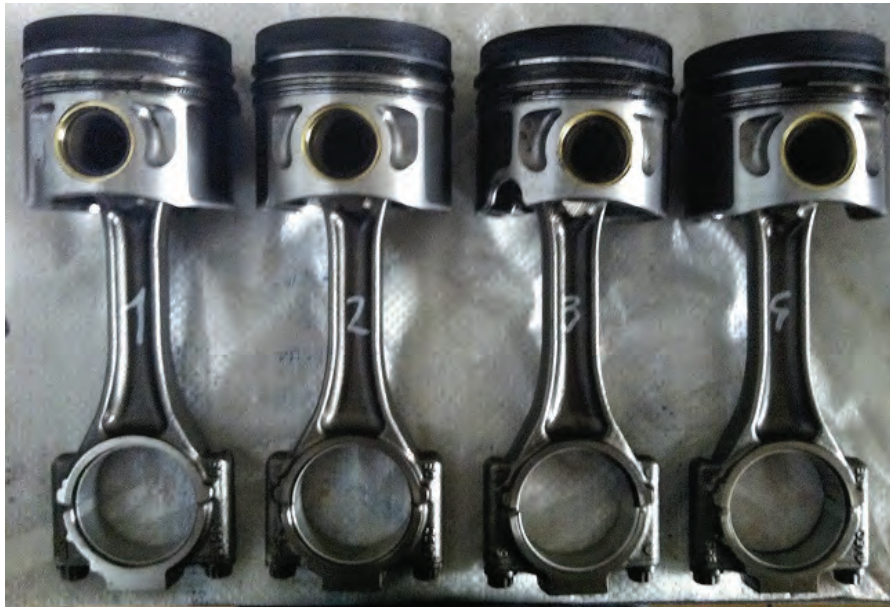
Pistons organoleptic tests showed no significant wear. Cooperation with the piston rings, cylinder liners as well was fine. It was found only a tiny imperceptible features on the piston surface in the section parallel to the axis of piston pin (Fig. 7).

*Fig.7. The view of the piston groups after the tests*
