## FAILURE'S IDENTIFICATION OF TURBOCHARGERS OF INTERNAL COMBUSTION ENGINES BY MEANS OF MULTI-FUNCTIONAL TEST STAND

*A turbocharger is a relatively simple, but very precisely made component working in conditions, which should be considered hard. Due to hard working conditions, among others: high exhaust temperatures, very high rotational speeds reaching up to 250 000 rpm, precise design and difficult assembly, turbochargers should be considered particularly subject to damage and failure. It is confirmed by data showing an increasing number of failures of such components, which is caused, among others, by the increasing number of vehicles equipped with turbochargers. The considerable cost of a new turbocharger and its relatively easy disassembly coupled with easy access to spare parts in Poland result in establishing of ever more new companies remanufacturing this type of device. The effectiveness of repairs carried out in such plants varies strongly, often being of poor quality due to lack of knowledge, both practical and theoretical, inadequate training of personnel, and many other factors. A common problem, faced by the companies remanufacturing turbochargers, is the lack of too

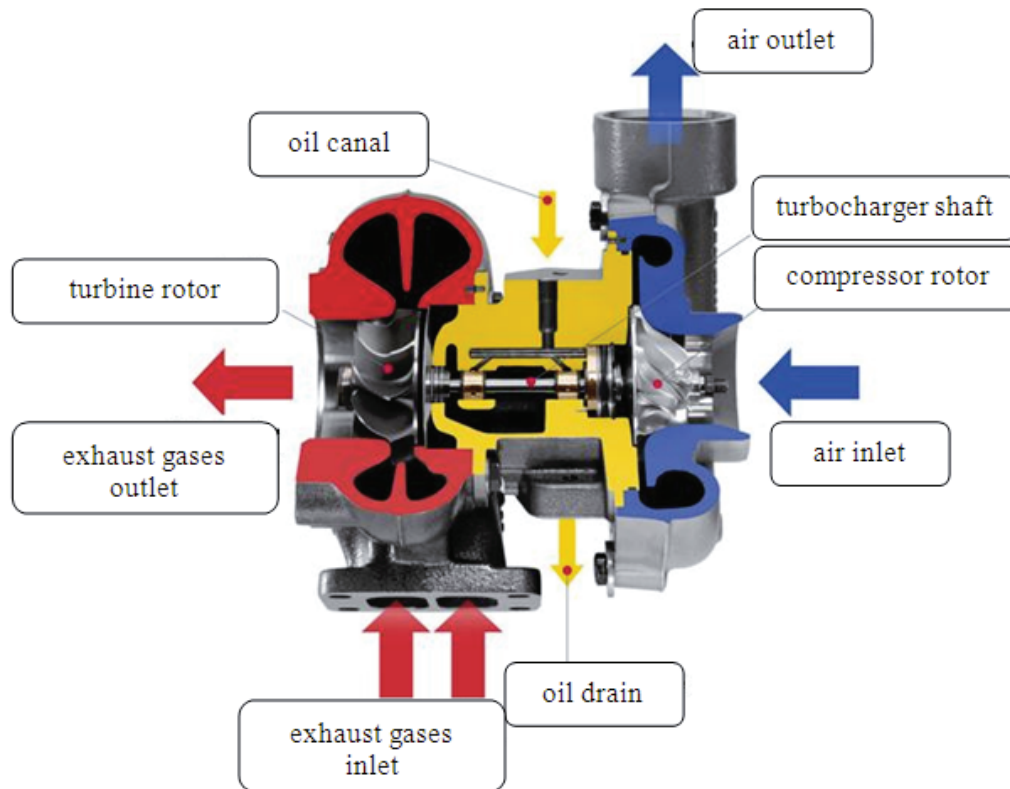
*Fig. 1. Cross section and principle of operation of turbochargers*

Supercharging the internal combustion engine is delivery of fresh charge of increased density into the cylinder, which enables supplying it with more fuel without altering the air-fuel ratio  $\lambda$ . The aim of the process is to maximize the unit power and efficiency of the engine but also to reduce unitary emission of toxic exhaust components. Turbocharging belongs to the category of compressor supercharging with a flow compressor. The main component is a turbocharger – fluid-flow machine in which the turbine and compressor rotors are mounted on a common shaft (Fig. 1).

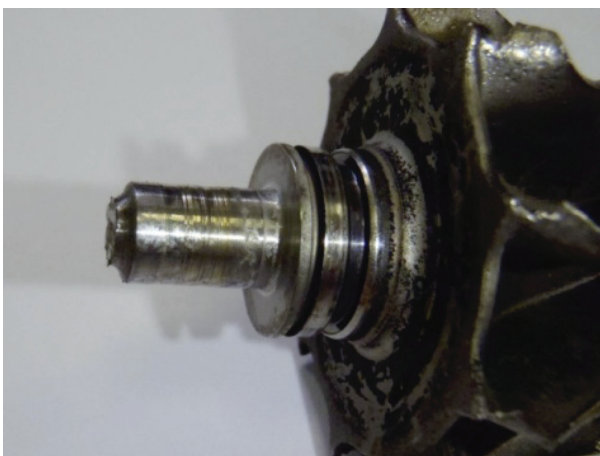
*Fig. 2. View of broken rotor’s shaft necks with deep scrapes*

Causes of damage to turbochargers done by oil of poor quality should be sought for in engine oil primarily of poor quality – not complying with the manufacturer’s recommendations. In addition, the oil filter may be inadequate, being of incorrect parameters or choked by soil. The most common cause in this type of failure is however, a result of a lack of periodical or distance-determined oil change according to the manufacturer’s recommendation. Turbocharger damage caused by oil of poor quality results in, among others, deterioration of the operating conditions of the axial and radial bearings, as a result of the diminishing of the diameter of oil holes. It can cause local overheating of the components and growth of the contact temperature, which can result in rapid damage of the turbocharger revealed by, among others, deep scrapes on the rotor’s shaft necks (Fig. 2) and bearing surfaces (Fig. 3), alteration of parameters of the outer contact layers (Fig. 4), decalibration of the holes for bearings in the inner housing or the ring seals becoming stuck in their grooves (Fig. 5).

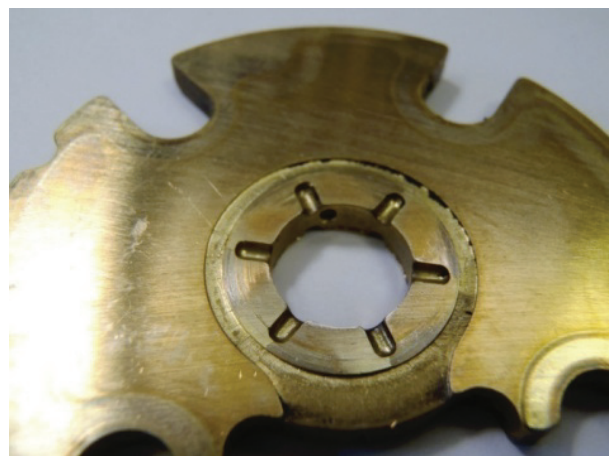
*Fig. 3. View of scraped surface of bearing*

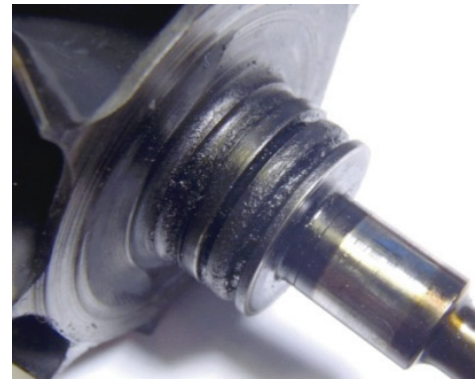
*Fig. 5. View of rotor's shaft with ring seals becoming stuck in their grooves*

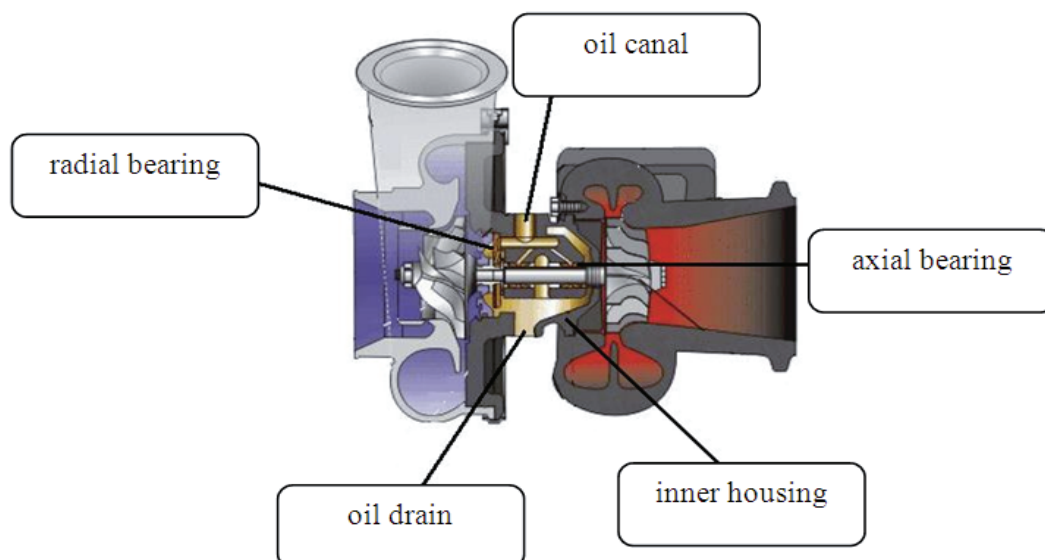
*Fig. 6. Cross section of turbocharger with visible inner housing and oil canal*

Consequences of improper oil parameters have been described above. Another failure type, also related to oil, is one caused by the change in its operating parameters, for instance pressure drop or a momentary lack of oil. Mechanical parameters are thus of importance – oil should be delivered to the turbocharger in adequate amount and at proper pressure. It is also important that the oil outflows sufficiently quickly out of the friction zone and the inner housing (Fig. 6).

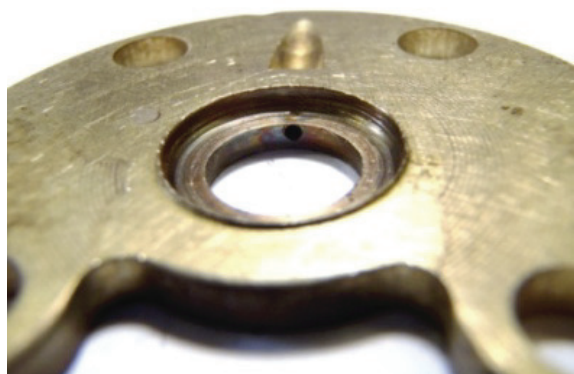
Fig. 11. View of bearing with hot tracks

Another type of failure identified is that caused by overheating. It has in principle two causes: too high exhaust temperature and sudden stoppage of the engine preceded by driving with considerable load and rotational speed [3]. Hot exhaust strongly heats the turbocharger's components – particularly cast iron housing of the turbine and the inner housing (Fig. 11).

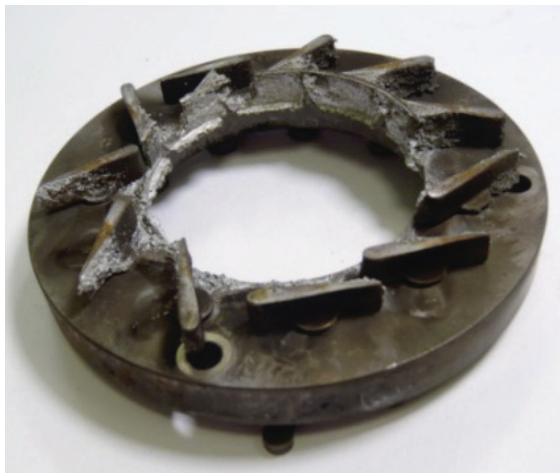
*Fig. 12. View of exhaust steering wheel with contaminations on surface*

The last common type of failure is that caused by foreign matter. This type of failure is a result of foreign matter working its way to the in- or outflow system (Fig. 12).

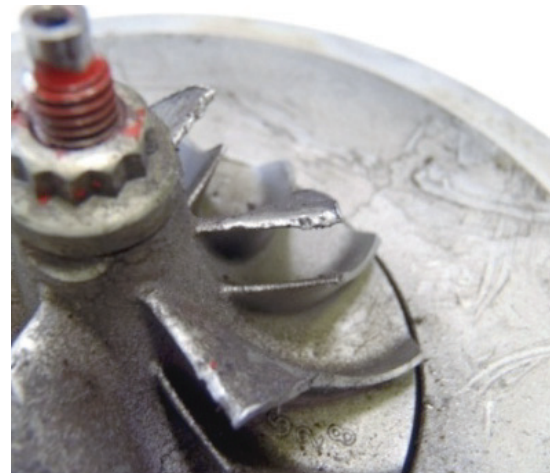
*Fig. 13. View of compression rotor with tracks caused by small body*

The failure is of an erosion type and depends on the size of the body reaching the rotors blades. Even the smallest body carried with the exhaust or air flow reaching the rotor strongly impacts the blades as a result of the high energy of the gas flow (Fig. 13).

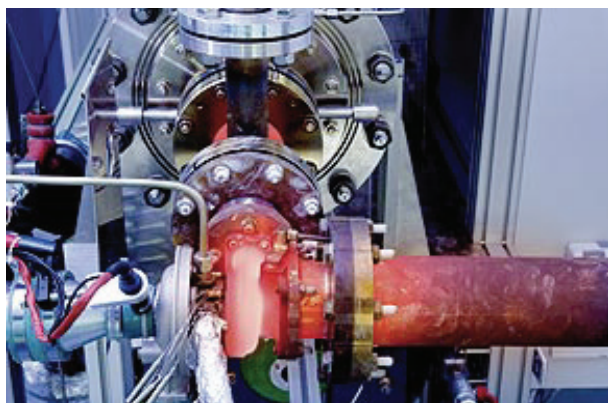
Fig. 14. View of devices which allows for turbochargers testing

On the basis of identification of described failures a conception of device which allows for turbochargers diagnostics have been elaborated. For the research of wear and destruction processes of turbochargers, and so their diagnostics, a test stand is needed which will enable to simulate the component's operating conditions, i.e. accelerating the turbocharger's rotor to a given speed, ensuring constant lubricant parameters and setting the desired parameters of the charging air. The companies specializing in design and examination of the manufactured turbochargers use devices enabling them to create flow characteristics of the turbine and compressor and which can be also adapted for research of destructive processes. Such devices use either compressed air from a tank, or hot combustion gases from an exhaust generator as power feed. The basic disadvantage of such solutions is the big volume of the air tank, being a result of a difference in energy states of air and exhaust. The exhaust, which in real conditions propels the turbocharger's rotor, has considerable energy, which derives mostly from its speed (around 500 m/s) and temperature (up to 1000°C). Moreover, the exhaust stream generated by the engine amounts to 0.1-50 m<sup>3</sup>/min, depending on the engine size and rotational speed. In practice such solutions are often abandoned and the rotor is driven by exhaust in the so-called hot gas test [4] (Fig. 14).

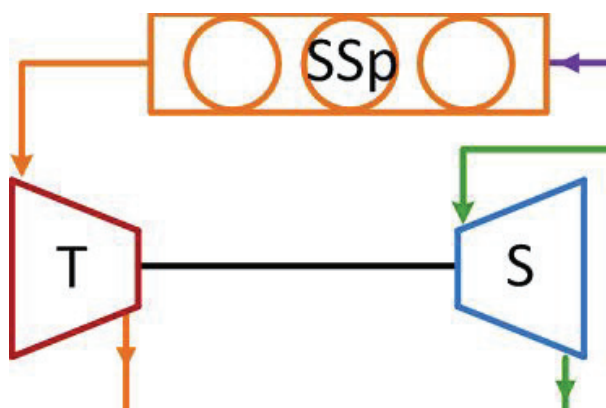
Fig. 15. Schematic diagram of turbochargers test stand

Based on the presented information, in the first phase a solution has been chosen, in which the turbocharger shall be propelled by an exhaust stream (Fig. 15). The research version of the stand uses a normally aspirated combustion engine being the exhaust generator. Spark-ignition engine coupled with a water brake, which receives the power, has been used for the purpose – such a device is in possession of engine test house of the Combustion Engines Laboratory of the Poznań University of Technology (Fig. 16).

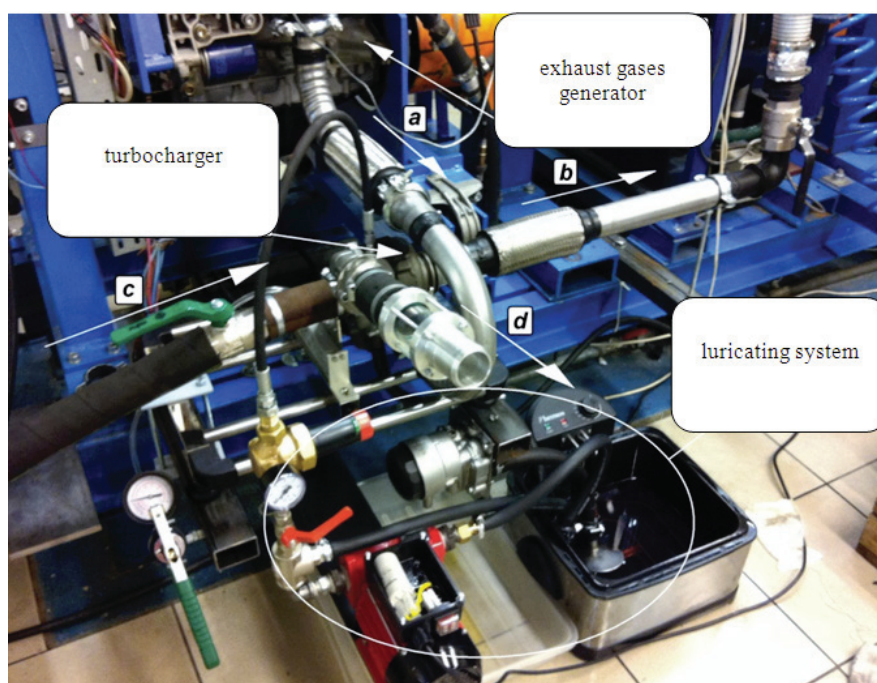
Fig. 16. View of turbochargers test stand
