# EXAMINATION OF THE DYNAMIC PROPERTIES OF 1<sup>ST</sup> STAGE ROTOR BLADES IN ONE-PASS ENGINE COMPRESSORS UNDER OPERATING CONDITIONS

Ryszard Szczepanik

Air Force Institute of Technology,  
Ksiecica Boleslaw Street 6, 01-494 Warsaw, Poland  
tel.: +48 22 6851101, fax: +48 22 8364471  
e-mail: ryszard.szczepanik@itwl.pl

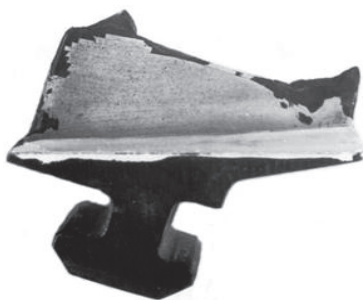
Fig. 1. Hammer root of 1st stage rotor blade in one-pass engine compressor before refurbishment

This article includes studies of vibration and stress amplitudes in the 1<sup>st</sup> stage rotor blades of jet trainer one-pass engine compressors before and after refurbishment in operating conditions. Before the refurbishment the 1<sup>st</sup> stage compressor blades were attached to the rim using the hammer root design (Fig. 10), whereas after the refurbishment the dovetail design was applied (Fig. 20).

The difference between the vibration amplitudes of 1<sup>st</sup> stage rotor blades in one-pass engine compressors before and after the refurbishment results from the difference in how the blades were attached to the disc. Before modernisation the hammer-type root was used (Fig. 1), whereas after refurbishment dovetail-type fittings were applied (Fig. 2).

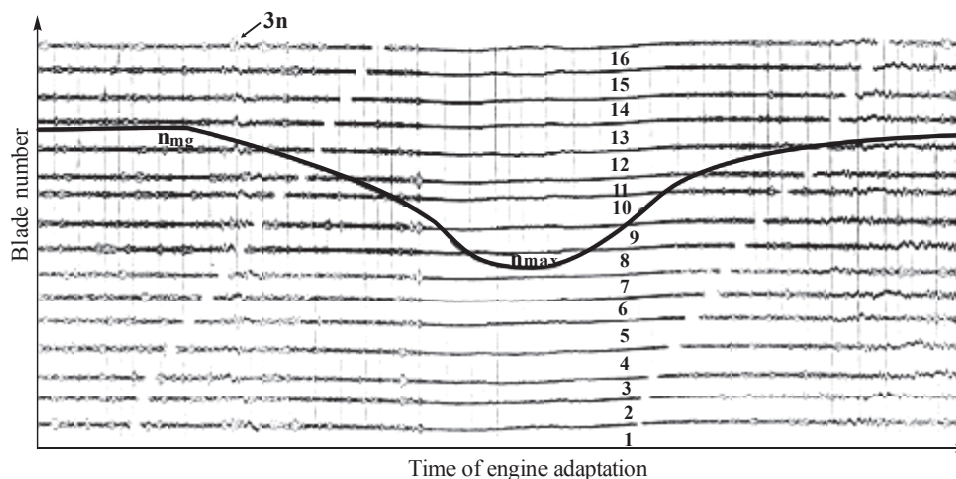
Fig. 5. Vibration spectrum of one-pass engine rotor blades after refurbishment (no. 1)

Example oscillograms from the vibration tests of the 16 blades are shown in Fig. 5-7. These show the vibrations of three randomly selected one-pass engines after refurbishment (marked 1, 2 and 3) out of a total of 50 engines. The engine vibration spectra cover the full rotation speed range.

Fig. 50 shows forced blade vibrations excited by the third engine order ( $3EO = 3n$ ) during acceleration from  $n_{mg}$ . This does not occur simultaneously in all the blades, which indicates free vibration frequency differences in the blades on the rim. Fig. 60 shows blade vibration forced by the 2<sup>nd</sup> EO ( $2n$ ) at a rotation speed close to  $n_{max}$ , where the vibrations of disc and blades appear during acceleration. In Fig. 70 disc and blade vibrations appear during reduction of rotation speed to  $n_{max}$ , and vibrations forced by the second and third excitation frequencies are also visible.

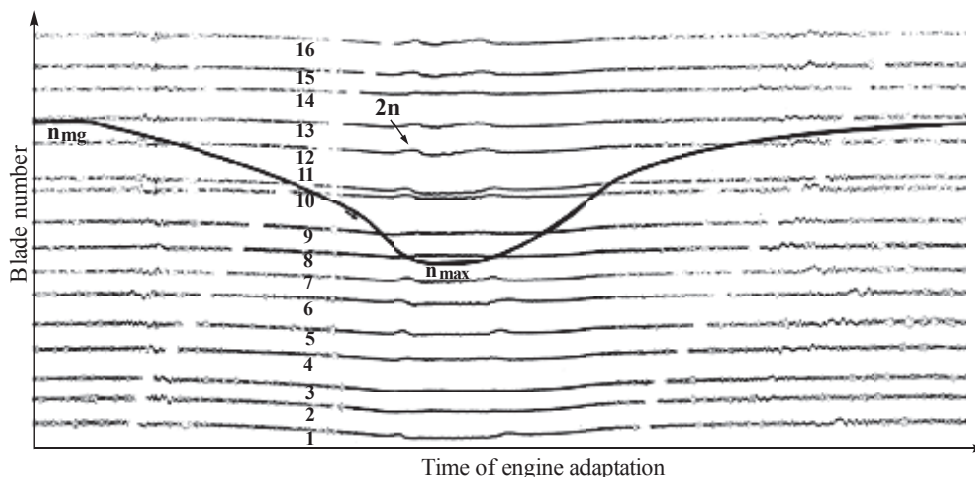
Fig. 6. Vibration spectrum of one-pass engine rotor blades after refurbishment (no. 2)

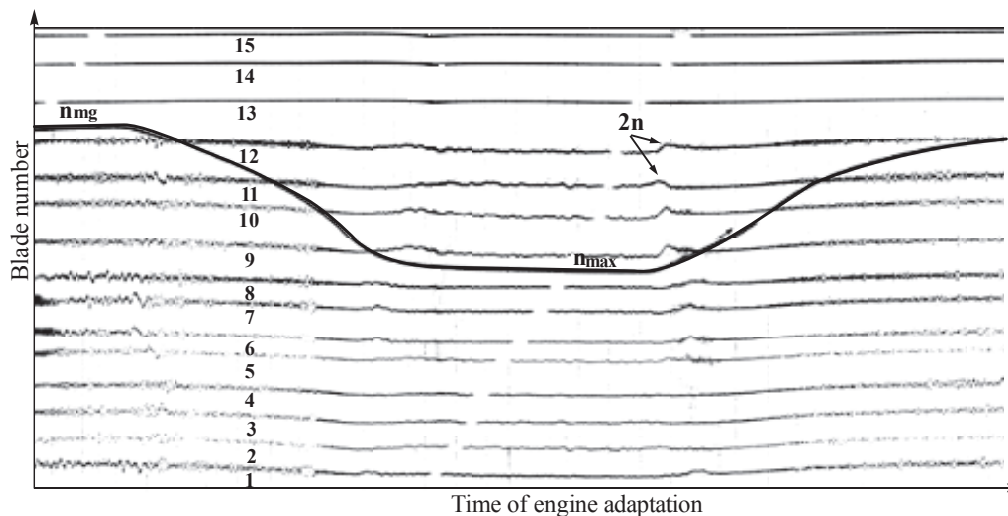
Fig. 7. Vibration spectrum of one-pass engine rotor blades after refurbishment (no. 3)

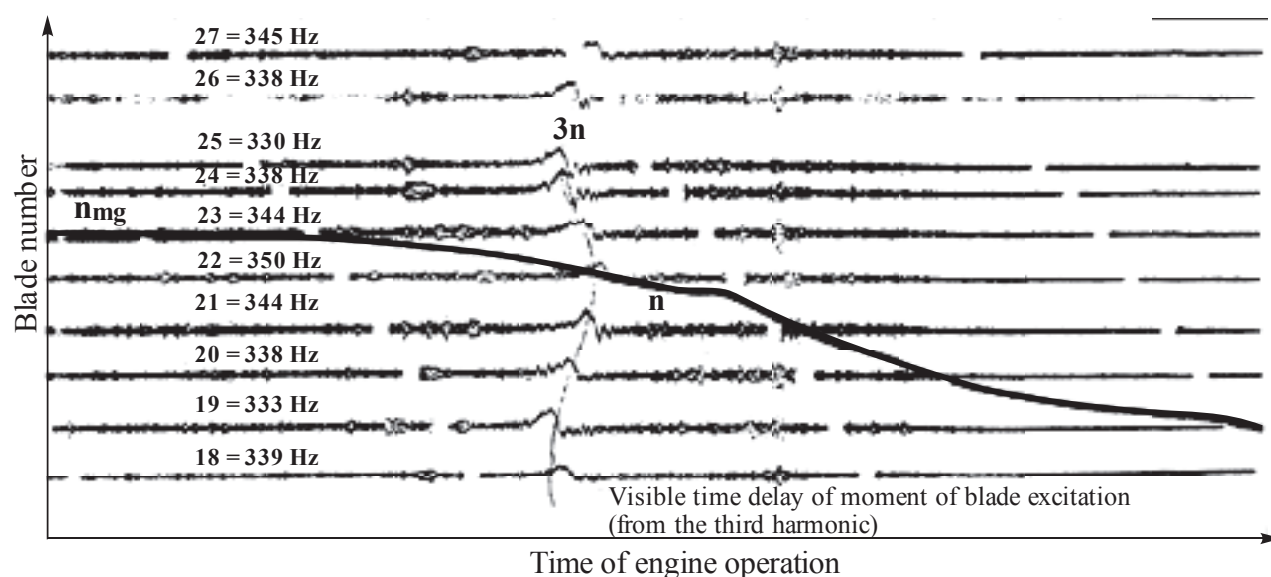
Fig. 8. Rotor blade vibration amplitudes. Visible excitations of blade vibration due to flow disruption by a sheet of paper lying flat on the guide vanes

Air flow through the engine inlet was disrupted by placing a piece of paper in the guide vanes of the compressor's 1<sup>st</sup> stage. The engine was started and its rotation speed was smoothly increased from  $n = n_{mg}$  to  $n = n_{max}$ . Blade vibrations were registered on a K12 oscilloscope (0). It turned out that at  $n = 8,000\text{ rpm}$  vibrations are forced by 3EO with a considerable amplitude. Subsequently, strong resonance vibrations (from the 3EO) occurred at  $n = 14,800\text{ rpm}$ .

Analysing the first resonance vibrations (from 3EO) one can clearly see that with the increase of rpm, the blades' resonance amplitudes form a sinusoid (0). This effect is used in a tip-timing analysis of blade vibration amplitudes to determine, on the basis of engine rotation speed, the vibration frequencies of synchronous blades. Knowing the exact rotation speed (excitation frequency), one can determine the free vibration frequency of blades subjected to mass force and working fluid flow.

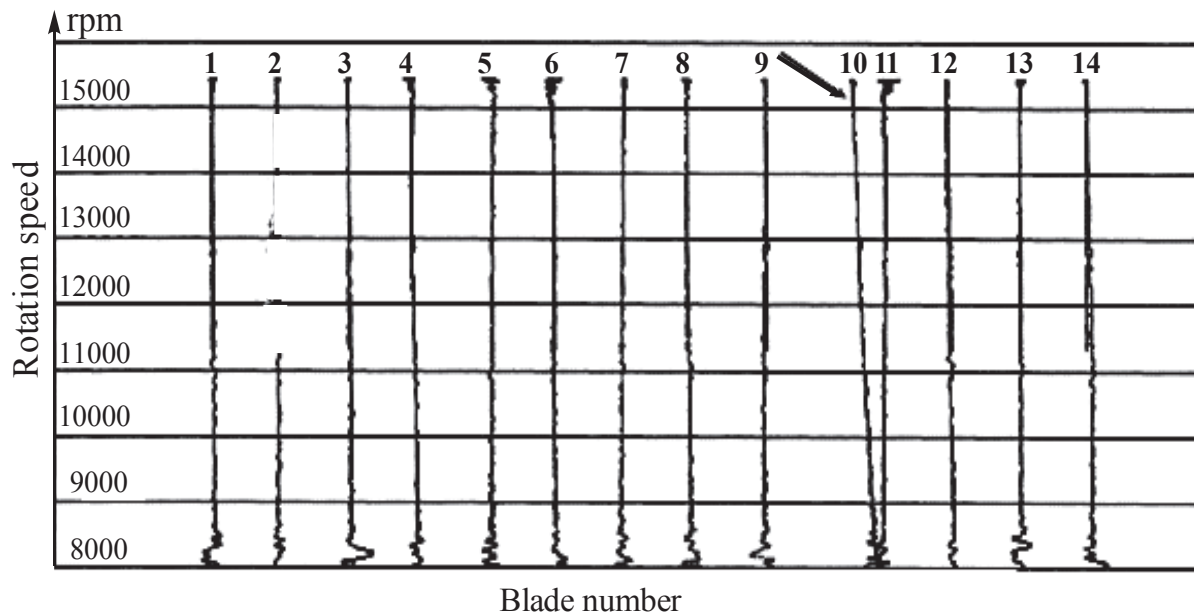
Fig. 10. Vibration amplitudes from 1<sup>st</sup> compressor stage rotor blades, with one rotor blade excessively deformed

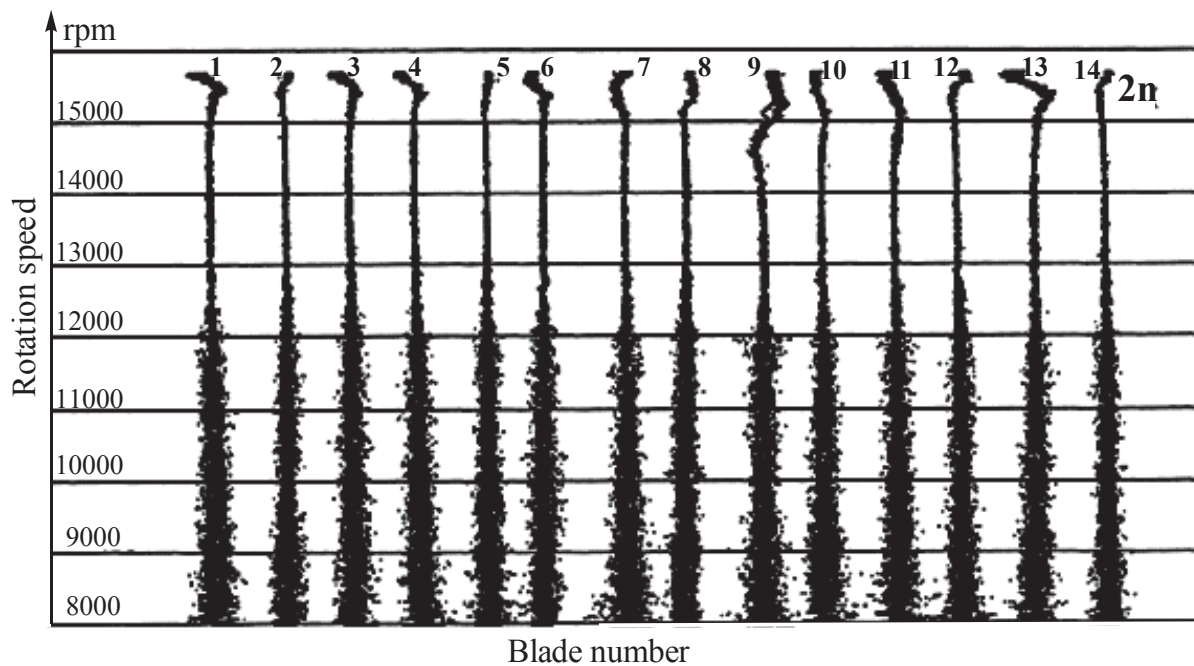
Fig. 11. Vibration amplitudes of one-pass engine compressor 1st stage rotor blades, with tendency to be excited by the second harmonic

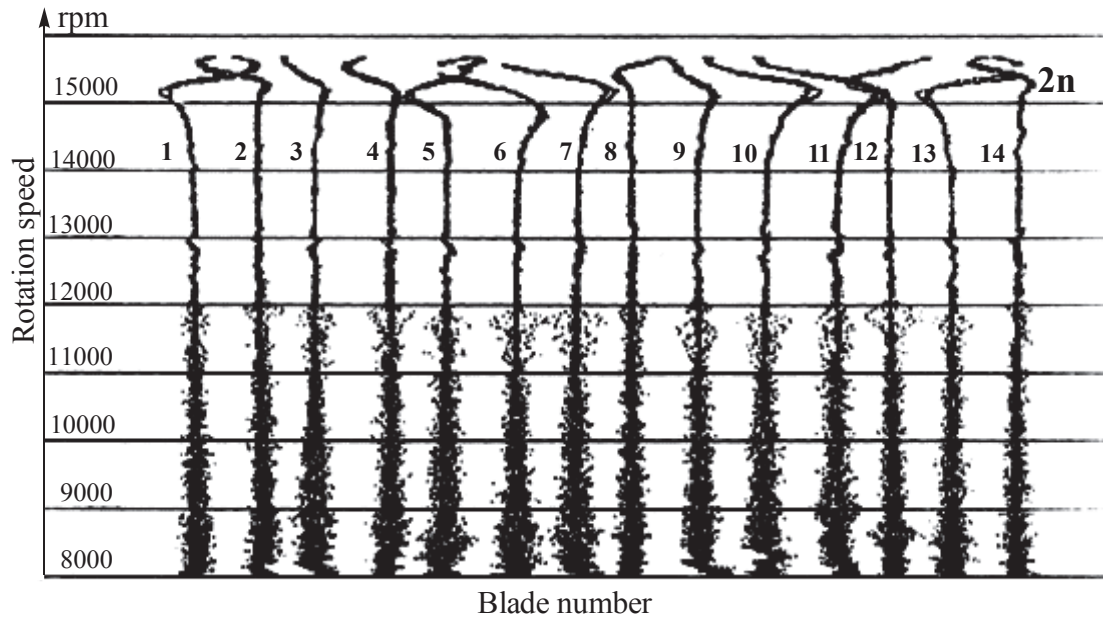
Fig. 12. Vibration amplitudes of compressor 1st stage rotor blades, with small foreign object on guide vanes

In the case of a foreign object, other flow asymmetry or rotor disruption the blades will have greater vibration amplitudes (Fig. 12), made apparent in vibrations excited by the second synchronous rotation speed (2n) at  $n = 14,800$  to 15,500 rpm. This effect is not observed for other rotor blades depicted in Fig. 9 at  $n = 14,800$ -15,200 rpm.

Figure 12 also shows increased blade vibration amplitudes at 11,000 to 12,000 rpm, indicating susceptibility to surges.

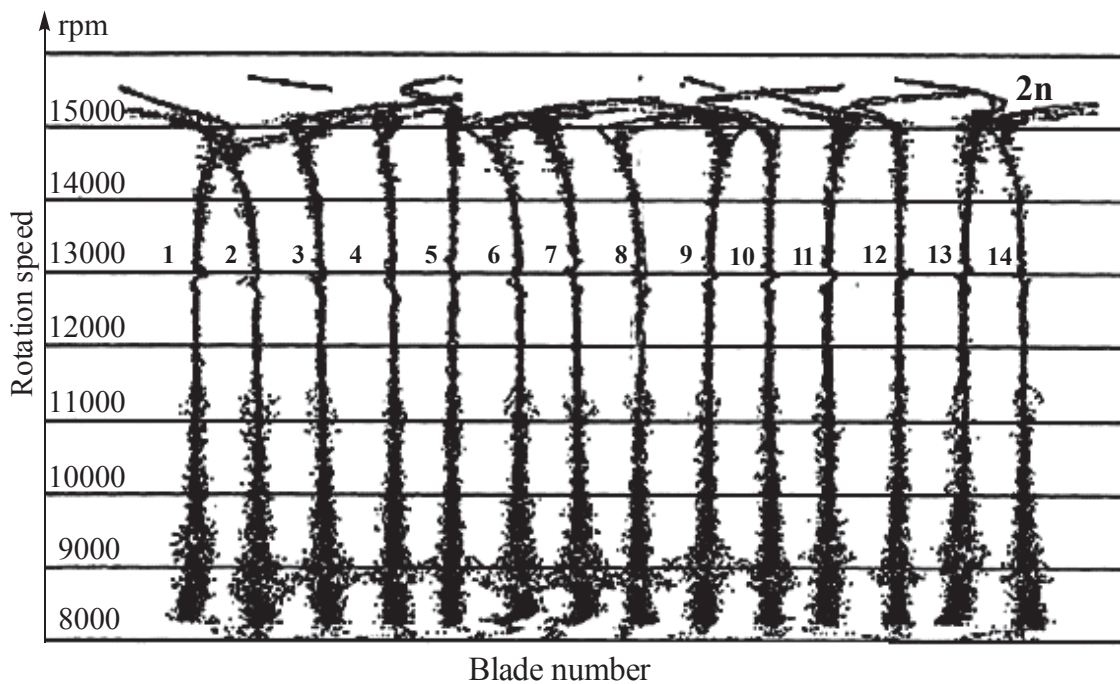
Figure 13, in turn, presents blade vibration amplitudes during a surge caused by a large foreign object on the rotor blades. It occurs at above 14,900 rpm and the blade vibration amplitudes are much higher than in the case of 2EO (2n) as shown in Fig. 12. Fig. 13 also shows large blade vibration amplitudes excited by the 3EO at 8,000 to 9,000 rpm.

Fig. 13. Vibration amplitudes of compressor 1st stage rotor blades, with surge caused by a large foreign object on the guide vanes

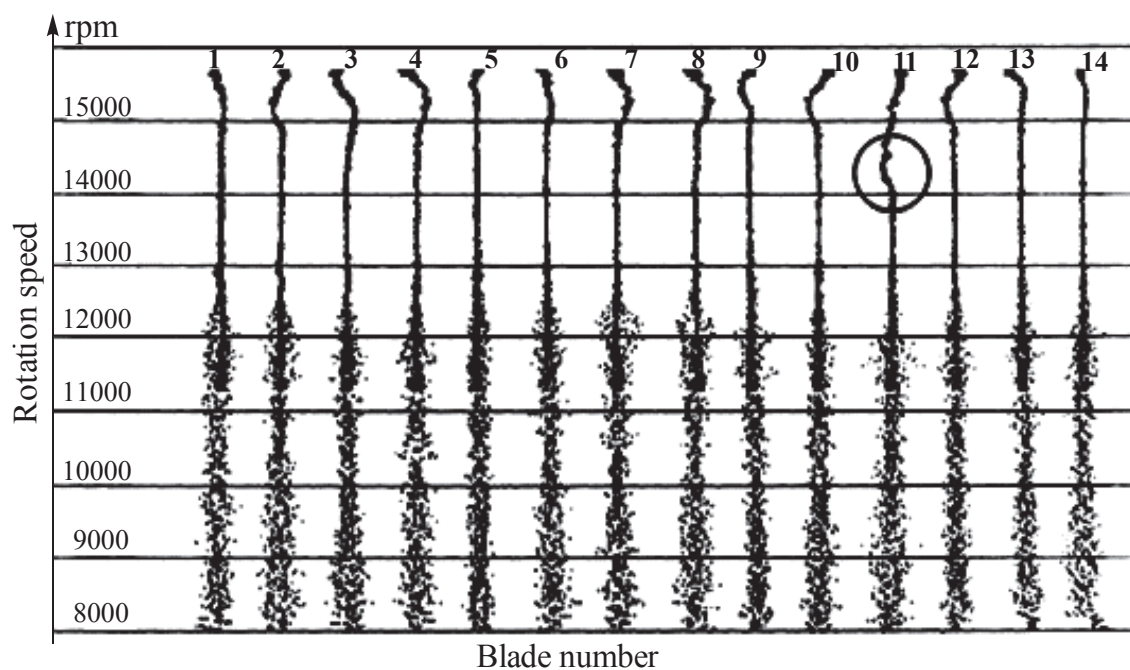
Figure 14 shows the course of rotor blade displacement with one blade cracked (marked with red circle). The initial cracking phase may be indicated by a reduction in the blade's vibration frequency or the appearance of resonance generated by 2EO at 14,300-15,000 rpm.

Fig. 14. Vibration amplitudes of compressor 1st stage rotor blades, with crack initiation in one of the rotor blades

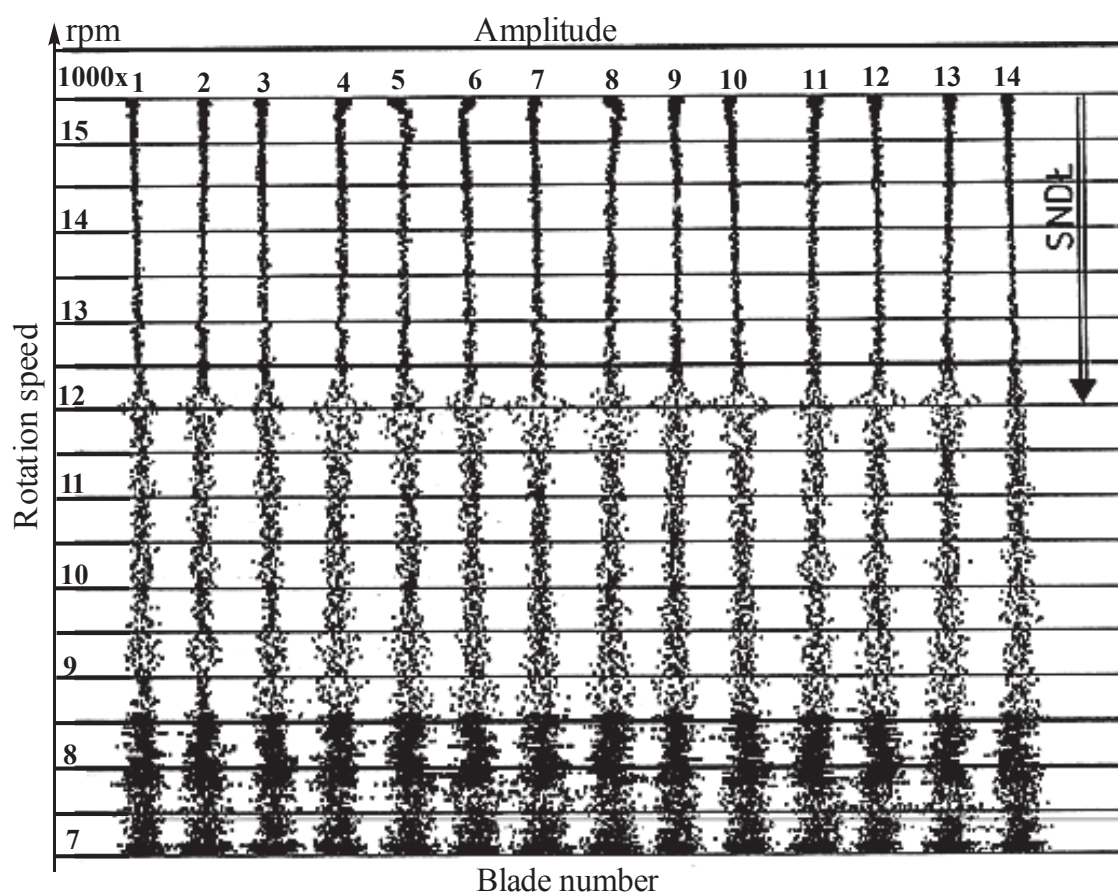
Fig. 15. Vibration amplitudes of compressor 1st stage rotor blades 1 and 14

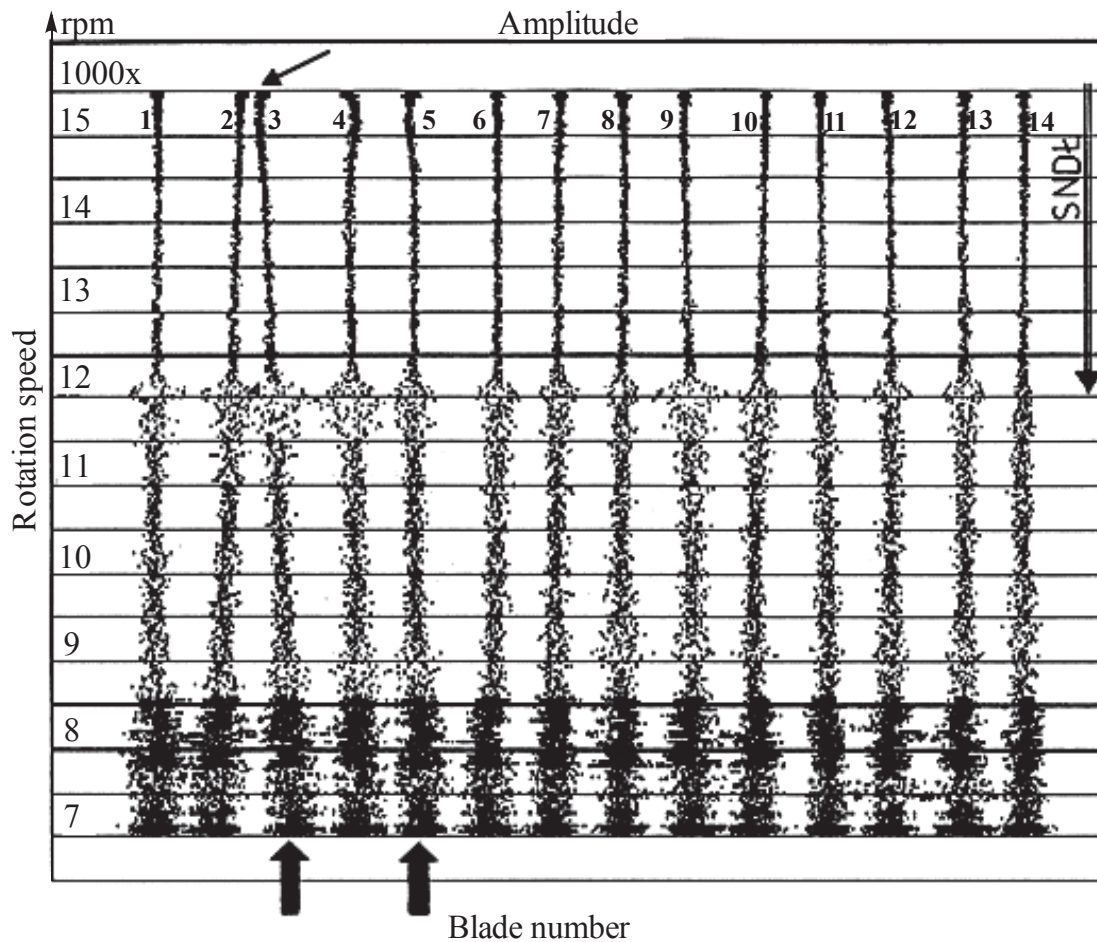
Fig. 16. Vibration amplitudes of compressor 1st stage rotor blades 15 to 28

The SNDL-1b and SPL-2b devices [2] make it possible to record increased blade stress amplitudes in working engines during aircraft flights. For instance, during one-pass engine trials [6] the compressor 1<sup>st</sup> stage rotor blade vibration amplitudes were additionally monitored by the SNDL-1b excessive vibration warning device. This test revealed (Fig. 15 and 16) that blade vibration amplitudes were larger at  $n = 7,000-8,000$  rpm than at  $n = 11,000-13,000$  rpm. It also showed that rotating stall zones disappear when rotation speed is increased to  $n = 13,200$  rpm. During repeated accelerations greater stress amplitudes appear at  $n = 12,000-12,500$  rpm than at 11,000 rpm. Two blades, marked in Fig. 16 with arrows, demonstrate different rigidity or mass distribution from the rest.
