INFLUENCE OF FUEL POLLUTANTS ON OPERATING PARAMETERS OF CONTEMPORARY FUEL INJECTOR

Tomasz Osipowicz, Tomasz Stoeck, Wawrzyniec Gołębiewski

Abstract

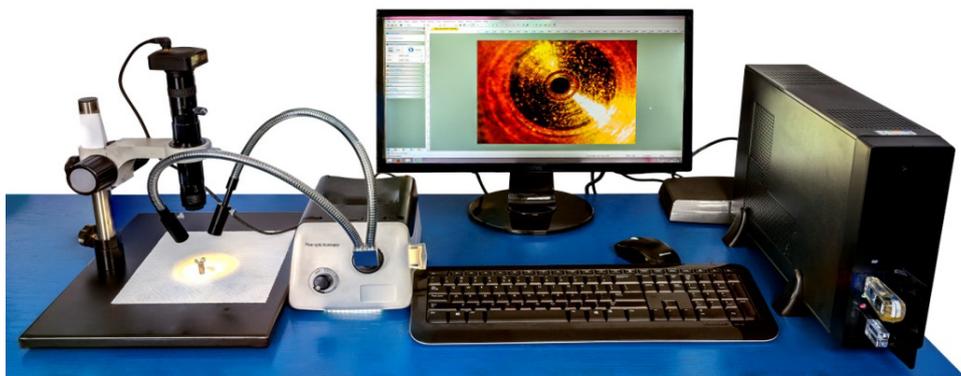
Fig. 2 Stereoscopic microscope used in laboratory researches

Analysis of subassemblies of researched fuel injector has been made by using stereoscopic microscope FL 150/70 equipped with the digital camera (Fig. 2).

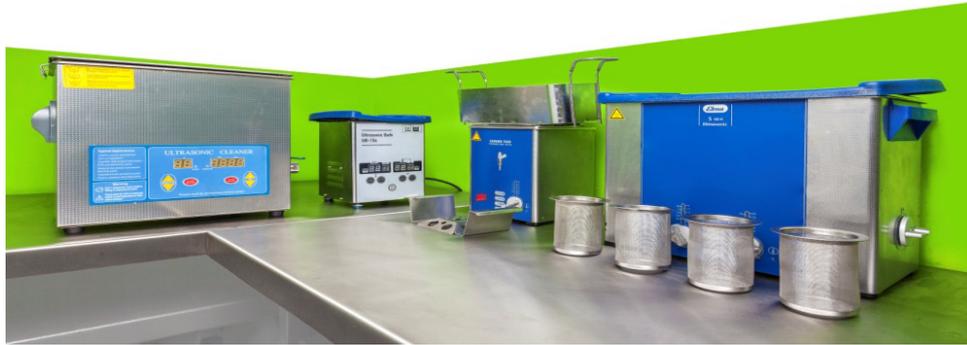
Fig. 3. Ultrasonic washers

Disassembled fuel injector has been cleaned in ultrasonic washers (Fig. 3). Then, the injector has been assembled and adjusted using special instruments. CR valve adjustment has been made and it was the third phase of repair. In Fig. 4, it has been shown this stage of researches.
