## DEVELOPMENT OF AN ON-LINE DAMAGE DETECTION, DISCRIMINATION AND TRACKING SYSTEM FOR THE SPIN RIG FACILITY

### **Abstract**

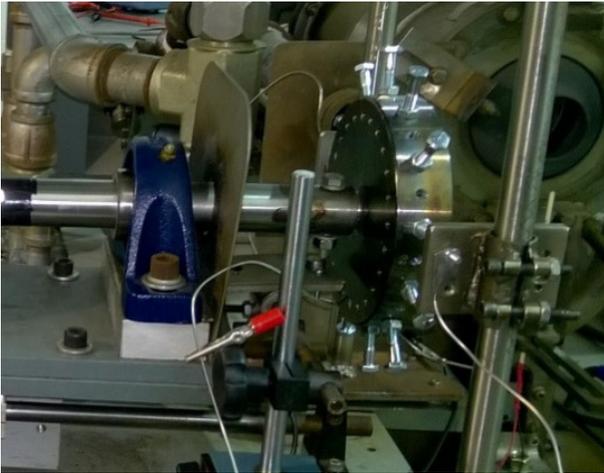
The rotor was powered from the drive system of the NRC-Aerospace burner rig facility, Fig. 1. The test rotor consisted of a 25.4 mm thick and 149 mm diameter disc with 12 bolts that could be turned into the disc threaded holes to extend or shorten the protruding parts of the bolts. These changes in the tip gap also created some change in the time of tip arrival. However, the latter was more difficult to discern and adjust because of the hexagonal head shape of the bolts. The disc and bolts dimensions were chosen in such a way that the external diameter of a rotor with bolts was

*Fig. 1. Test rotor powered from the burner rig rotor*

Test runs were performed using the test rig shown in Fig. 1-4 to check ability of the BVM system to measure changes of circumferential and radial position of rotating bolts that simulated blades.

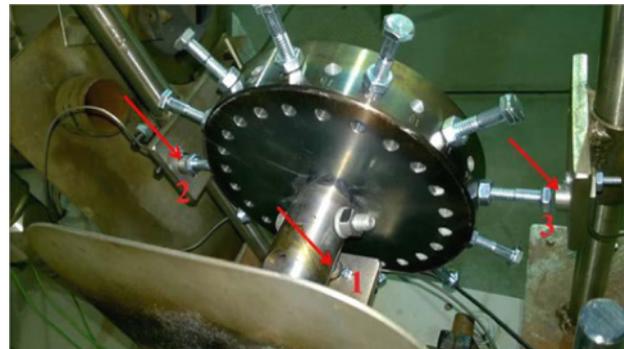
*Fig. 4. Sensor placement in proximity to the test rotor: Sensor 1 – one-per-revolution sensor; Sensor 2 and Sensor 3 – tip sensors*

Sensor 1 shown in Fig. 4 recorded the reference signal. It was installed in such a way that it only recorded one pulse per revolution, while Sensor 2 and Sensor 3 were placed at 180° angle on both sides of the rotor.

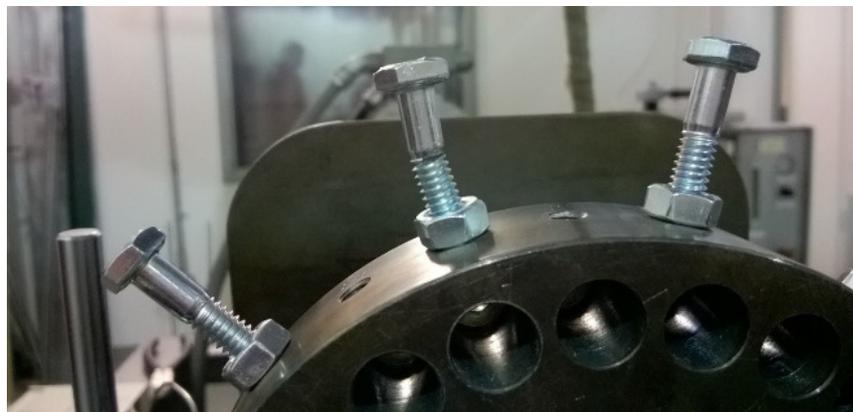
preliminary tests, characteristics of bolts #3 and #9 were modified. A notch was cut in bolt #9, so that the bolt could be bent back and forth in the circumferential direction (Fig. 7). In addition, bolt #3 was screwed into the disc one turn per step, total of four turns, which corresponded to total “shortening” the bolt by approximately 5 mm (0.2”). For efficiency, two seeded faults, for blade #3 and blade #9 were applied at the same time. The test steps are summarized in Tab. 1.

*Fig. 7. Bolt #9 notched and bent in the forward direction*

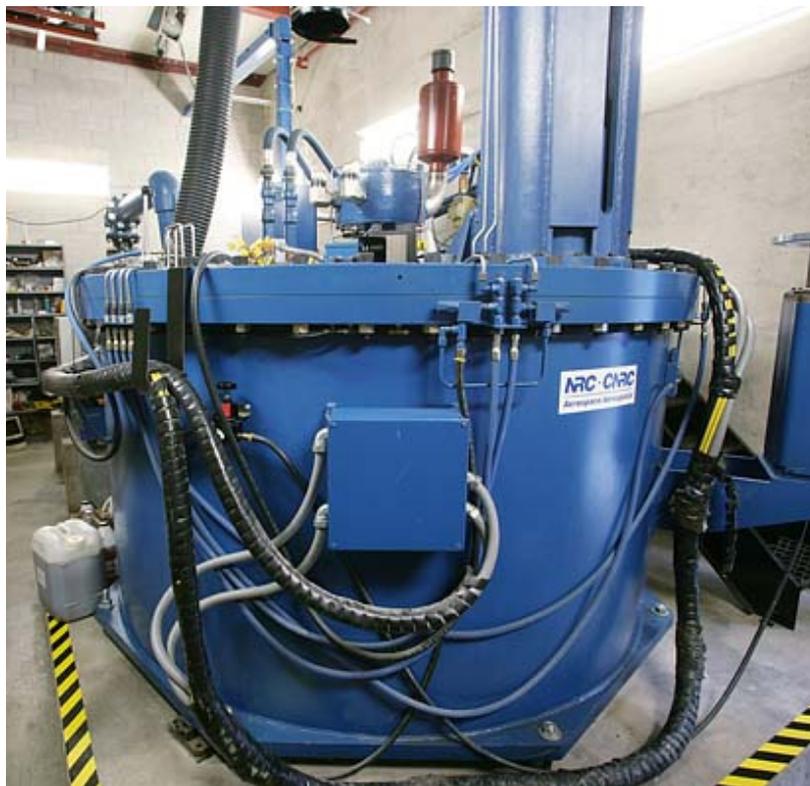
NRC-Aerospace’s spin rig test facility shown in Fig. 15 is located in the NRC campus in Ottawa, Ontario, Canada. The rig with a chamber of 1200 mm × 1200 mm in size (48” × 48”) allows testing of rotating components in vacuum in elevated temperatures up to 800°C. Two air turbines allow for exerting rotational speeds up to 40,000 rpm or 100,000 rpm. This rig is used to perform tests of bladed disc assemblies with the aim to investigate the process of crack formation and evolution in the critical rotating components. The tip-timing data acquisition system that was bench tested will be installed in this facility to detect incipient cracks and decrease the cost of testing.

*Fig. 15. Spin rig facility in NRC-Aerospace*
