THE IMPACT OF UNEVENNESS AND INSTABILITY OF FLUE GAS TEMPERATURE ON THE TECHNICAL CONDITION OF GAS TURBINE BLADES

Józef Błachnio, Artur Kułaszka, Jerzy Perczyński

Air Force Institute of Technology Ksiecia Boleslawa Street 6, 01-494 Warsaw, Poland tel.: +48 261 851393 e-mail: jozef.blachnio@itwl.pl, artur.kulaszka@itwl.pl jerzy.perczynski@itwl.pl

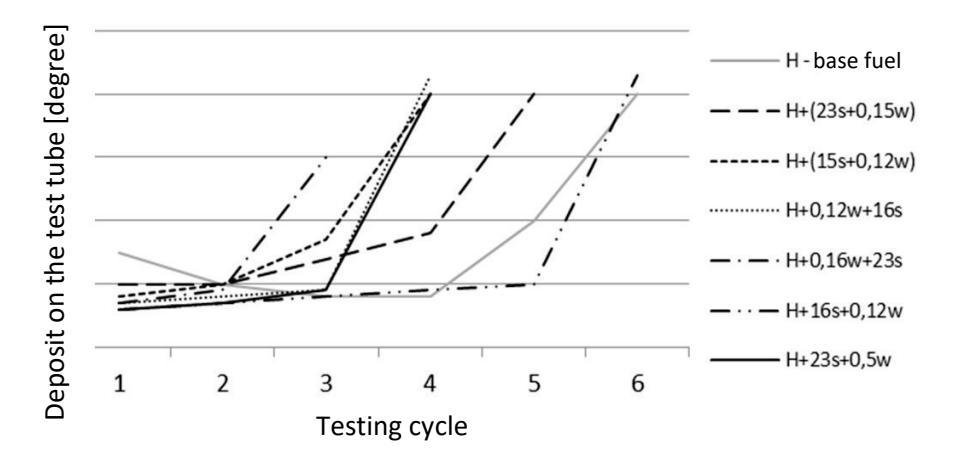
Fig. 1. Results of the test measuring the impact of additive dosage technology on fuel thermal stability (H – means hydro raffinate-based fuel, 15 s, 16 s, 23 s – content of additive s in mg/kg, 0.12 w, 0.15 w, 0.16 w, 0.5 w – content of additive in %(V/V), parenthesis means that the additives were added simultaneously, in the absence of the parenthesis – additives were introduces successively, a week apart) [2]

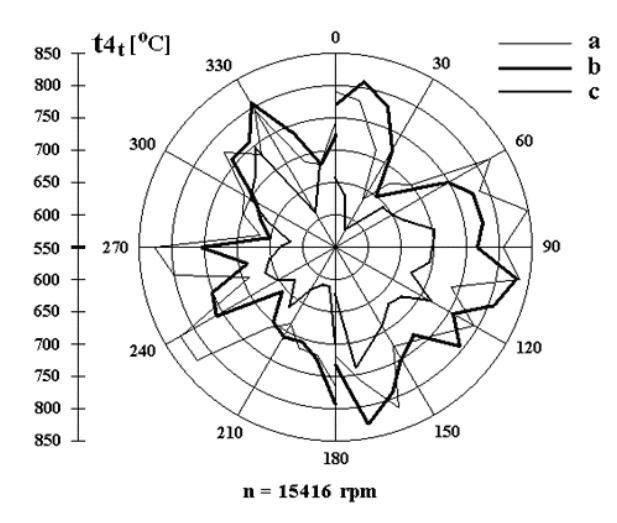
An example of a temperature field peripheral distribution in the outlet nozzle of a K-16 engine is shown in Fig. 3. In reality, the flue gas stream exiting the chamber is characterised not only by peripheral uniformity of the temperature field in the combustion outlet section but also the radial non-uniformity of flue gas temperature and pressure (Fig. 4). Therefore, a flue gas stream exiting the chamber is peripherally and radially non-uniform. This last parameter is called the averaged flue gas temperature profile along the turbine blades height. The value characterizing the profile temperature distribution is the so-called temperature non-uniformity profile coefficient [9]:

Fig. 3. Example results for measurements of the temperature field non-homogeneity within the working agent inside the jet nozzle of the K-16 engine: a – nearby the outer wall, b – in the middle of the gas duct radius c – nearby the inner wall [14]

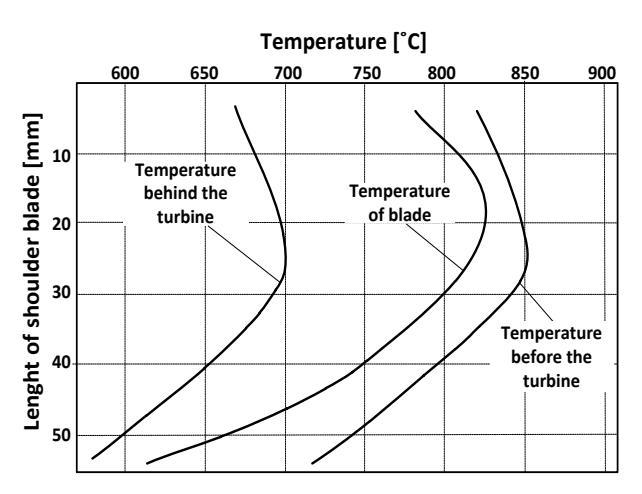
Examples of flue gas temperature distribution radial profiles for an annular combustion chamber upstream and downstream of the turbine and their impact on the distribution of temperature in the blade material are shown in fig. 3. The peripheral and radial temperature profiles adversely influence the reliability of the combustion chamber and the turbine. [4, 8, 9]. Based on analyses of the studies [4-6] and the operation of turbine engines, it can be concluded that:

Fig. 4. Examples of flue gas temperature distribution radial profiles for an annular combustion chamber upstream and downstream of the turbine and their impact on the distribution of temperature in the blade material [9]
