IMPACT OF THE VIBRATION AMPLITUDE ON THE FATIGUE LIFE OF COMPRESSOR BLADES WITH MECHANICAL DEFECTS

Lucjan Witek, Arkadiusz Bednarz

Rzeszow University of Technology, Department of Aircraft and Aircraft Engines
Powstancow Warszawy 8, 35-959 Rzeszow, Poland
tel.: +48 178651324, +48 177432348
e-mail: lwitek@prz.edu.pl, abednarz@prz.edu.pl

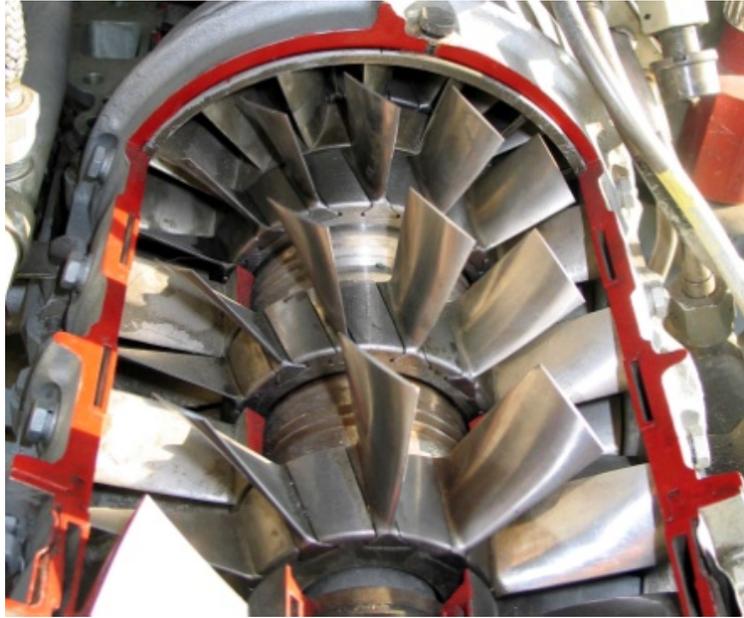
Fig. 1. View of first stages of compressor

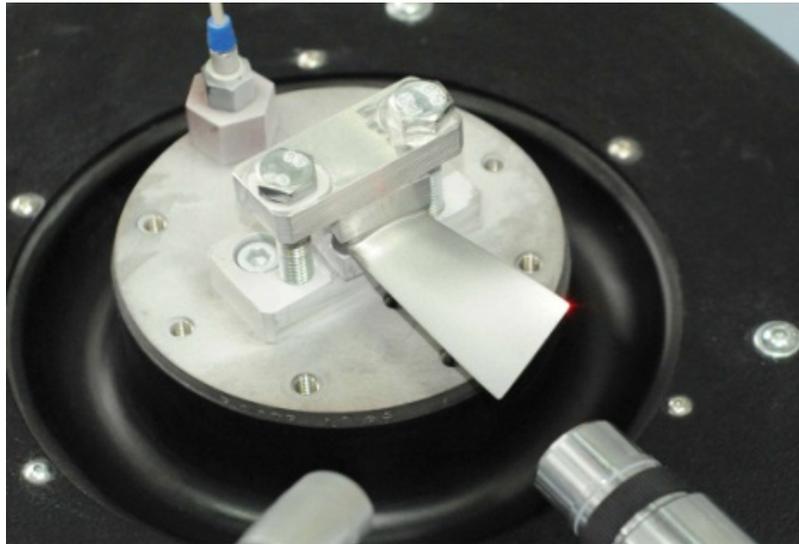
The crack initiation and modal analysis of the blade were performed with the use of Unholtz-Dickie UDCO-TA-250 vibration system at Laboratory of Turbomachinery in Rzeszów University of Technology (Fig. 3). For control the amplitude of the blade tip displacement the laser scanning vibrometer POLYTEC PSV-H400S were used. To measure the crack length (a dimension in Fig. 4) a non-destructive fluorescent penetrant inspection was utilized (Fig. 5). In all tests, the intensity of excitation of 15 g was defined (where 1g equals 9.81 m/s^2). During the investigations, the first mode of transverse vibration was only considered. The blade consists the V-notch located on the

Fig. 3. Compressor blade during vibration test
