DIAGNOSTIC OF THE PISTON ROD GLAND'S FAILURE OF MARINE SLOW SPEED MAIN ENGINE

Lech Murawski, Do Van Doan

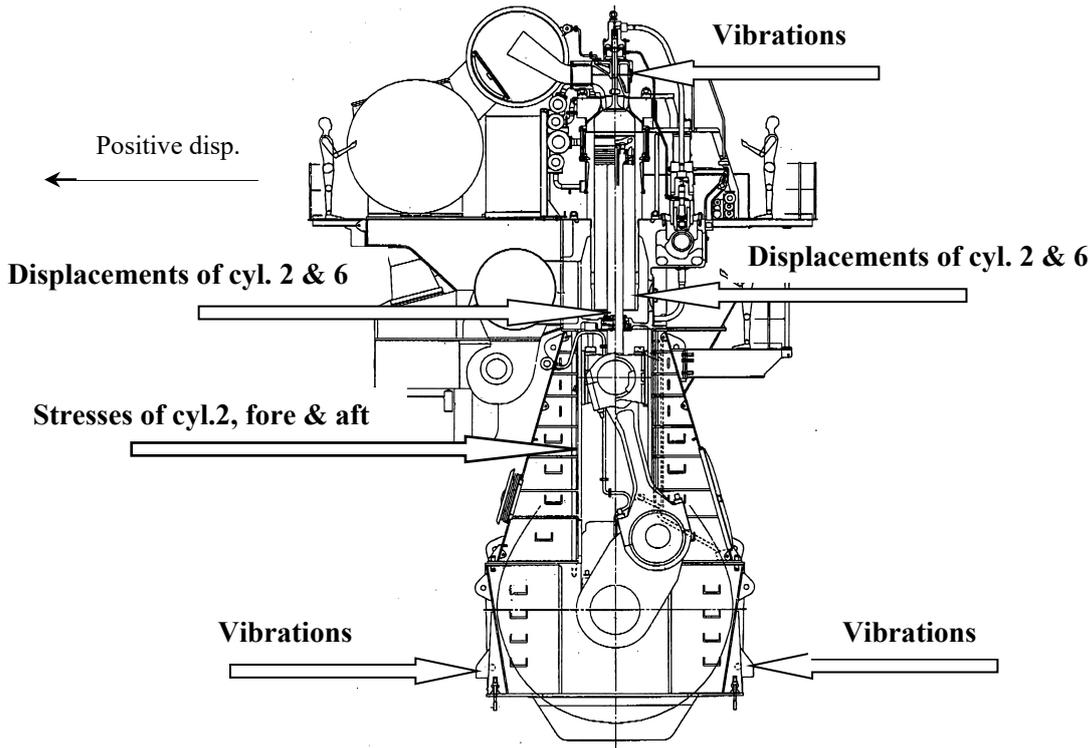
Fig. 1. An arrangement of the measuring points

An arrangement of the measuring points is presented in Fig. 1 [6]. Engine rpm was measured at the same time as the above-mentioned values in order to enable accurate analysis of the measurement results. All the measured values were digitally recorded with use of analogue-digital card. The stresses were measured with use of strain gauge method by means of 16-channel bridge HBM. The displacements were measured by means of contact sensors HBM. The vibration velocity was measured by means of portable meter B&K with piezoelectric sensors.
