THE ASSESSMENT OF CHANGES IN THE MICROSTRUCTURE OF A GAS TURBINE BLADE WITH A NON-DESTRUCTIVE THERMOGRAPHIC METHOD

Artur Kułaszka, Józef Błachnio

Abstract

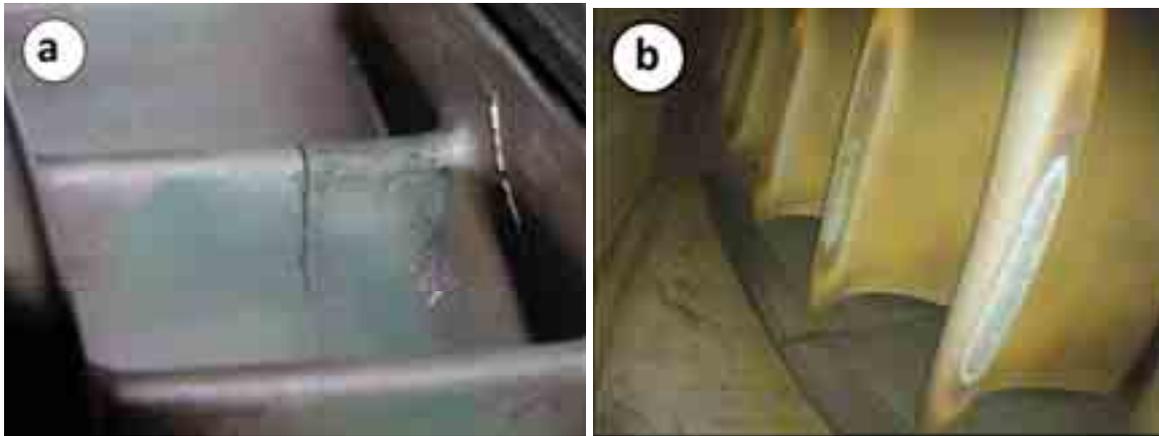
Fig. 1. Forms of thermal deterioration of gas turbine blades: a) overheating of the blade material visible as discoloration of surface colour to pale blue and glaucous, b) local melting of the protective coating

Deterioration of protective coatings (Fig. 1) that covers turbine blades, with simultaneous impact of high temperature and aggressive effect of exhaust gas leads to overheating of the blade parent material. Further operation of the turbine with such defects entails total damage of turbine blades and presents a hazard to operation safety of engines.

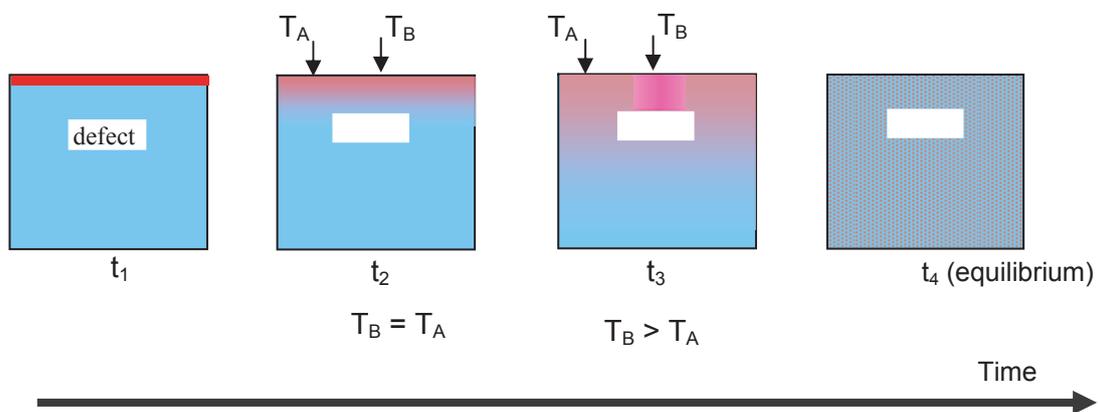
Fig. 2. Variation of the surface temperature of a sample after stimulation with an external pulse of heat [5]

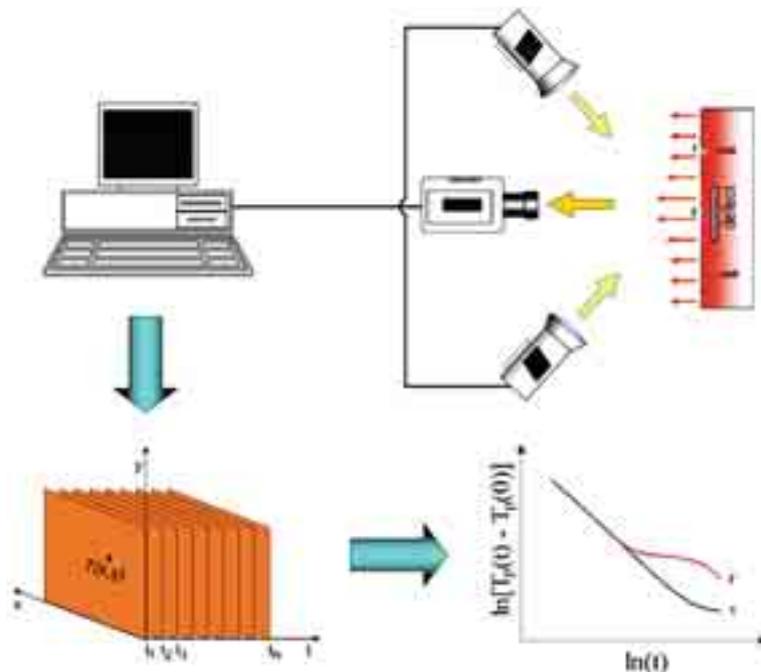
Fig. 3. Application diagram for the pulsed thermography [5]

The *pulsed thermography* is considered as a relatively simple technique of the active thermography. It consists in determination and analysis of the temperature distribution over the surface under test when it is being cooled down after preliminary uniform heating by means of a thermal pulse (Fig. 3). Monitoring of the temperature field on the surface of the cooling sample makes it possible not only to analyze discontinuities in the cooling sample but also to detect unfavourable amendments to the microstructure of the material under test.

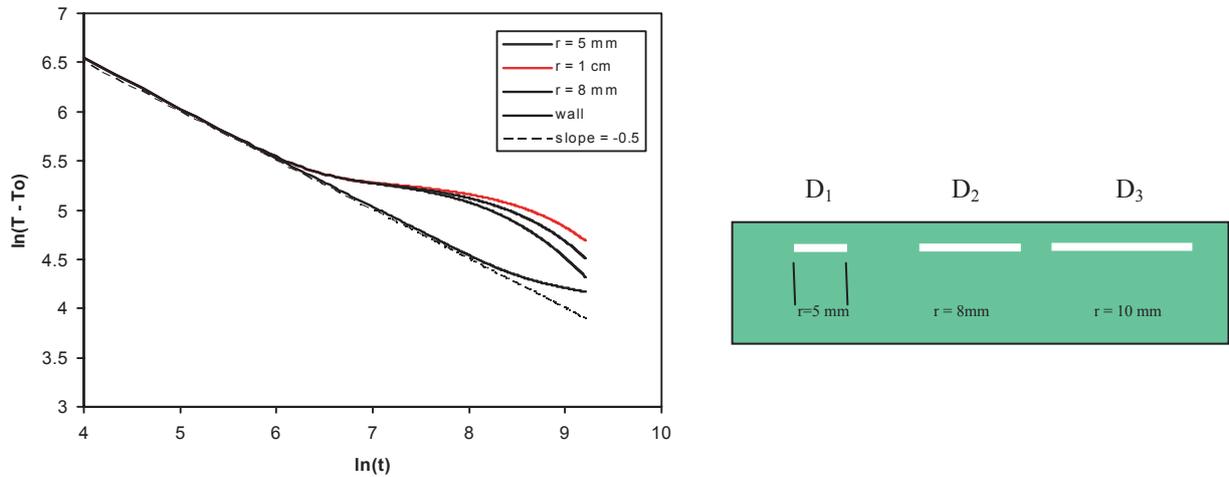
Fig. 4. Detection of delamination by means of the pulsed thermography [5]

When the material comprises flaws, diffusion velocity drops down. Consequently, the surface temperature over a flaw is different from the temperature of areas that are free of flaws – the foregoing interrelationship changes its nature. For instance, such a defect as delamination of plies in sandwich materials can be revealed by plotting the corresponding graph $\ln(T - T_0) = \ln(t)$ (Fig. 5). For homogenous materials, the graph presents a straight line with its slope of 1/2.

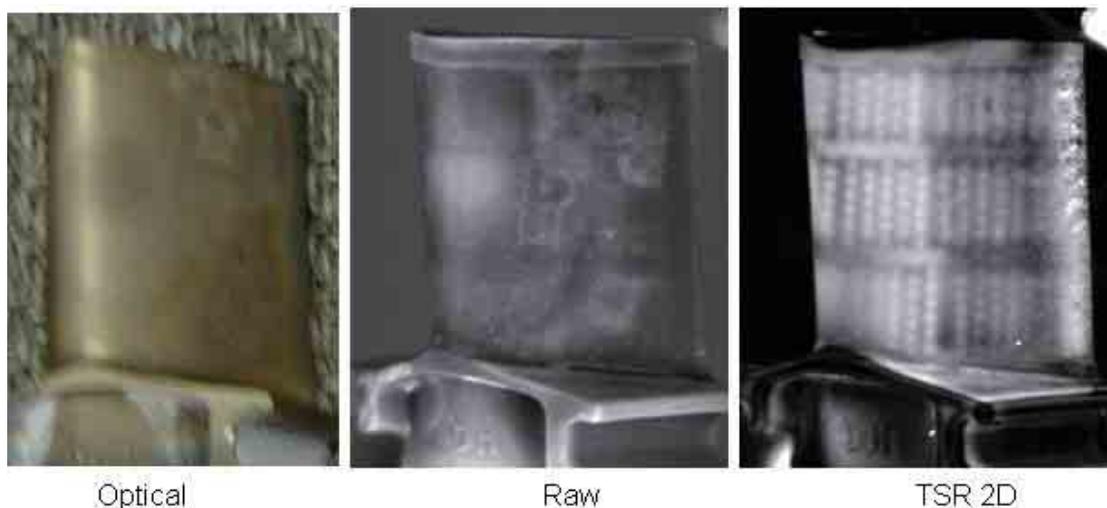
Fig. 5. Images for blades of high-pressure (HP) turbine incorporated into an avionic engine and examined with use of various methods: visual (optical) inspections, RAW and TSR techniques [5]

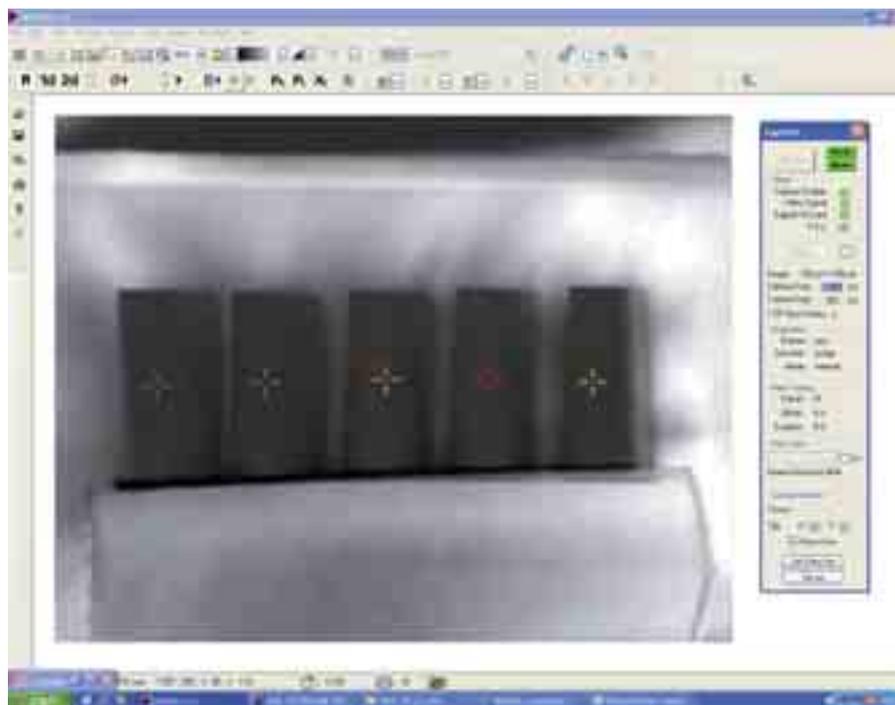
Fig. 6. Images of turbine blades examined with use of the Echo Therm System workbench

New blades were subjected to the effect of a very short thermal pulse and the thermal response was acquired by means of measuring and recording instruments to find out temperature variation on the surface under test within the selected areas. Then the blades were heated in an oven at presence of exhaust gases from combustion of aviation kerosene, where the heating temperature ranged from 1123 to 1523K. After heating the examination, procedure in a thermographic apparatus was repeated. The completed investigations made it possible to find out differences in thermophysical response received from examined blades before and after heating at various temperatures (Fig. 6, Fig. 7).

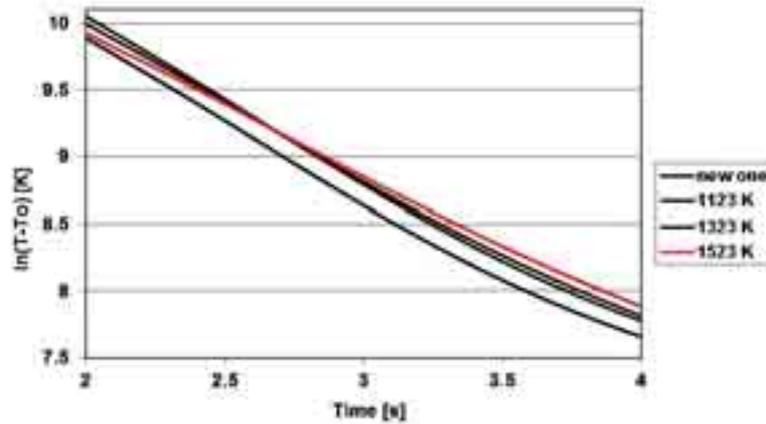
Fig. 7. The graph $\ln(T-T_0) = \ln(t)$ for the response of turbine blades to a heat pulse – a new one and the blades heated at the temperatures of 1123 K, 1323 K and 1523 K

Searching for a non-destructive test method suitable for assessment of technical status demonstrated by the material of turbine blades has led to establishing the thermographic technique as the most beneficial one. Application of that method made it possible to find out differences in thermophysical responses received from examined blades before heating and after heating at various temperatures (Fig. 7).

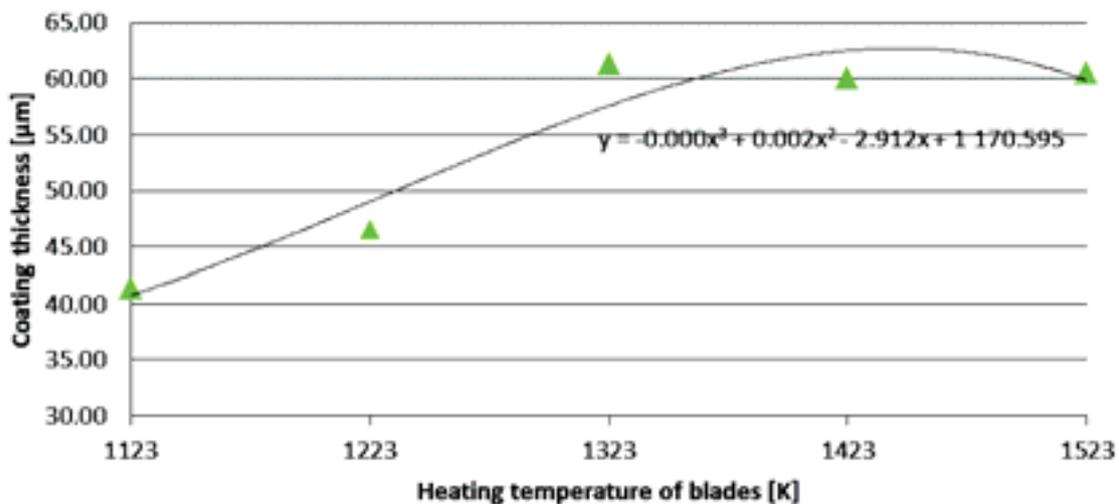
Fig. 8. The graph for the thickness of aluminium coating on turbine blades – a new one and the blades heated at the temperatures of 1123 K, 1323 K and 1523 K

The completed metallographic investigations of blades heated at various temperatures evidenced that high temperature leads to alterations of microstructures, both of the coating material and the EI-867 WD alloy, where gradual growth of the aluminium protective coating is observed in pace with the temperature growth (Fig. 8).

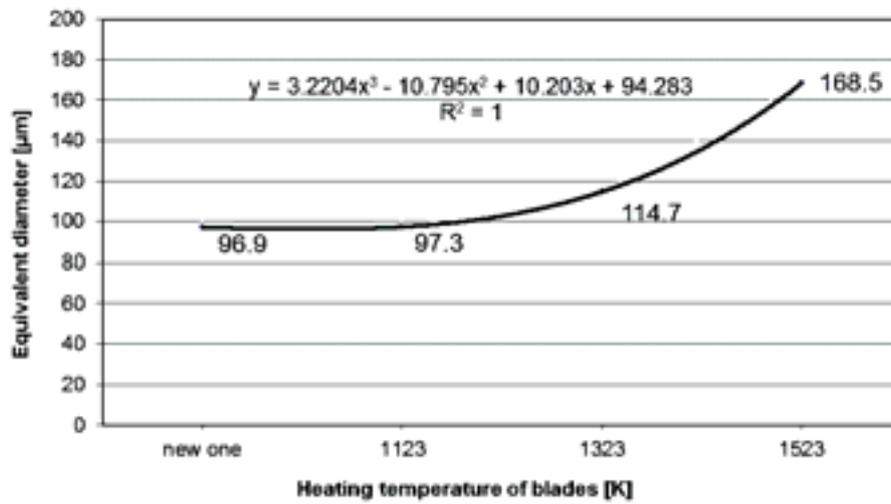
Fig. 9. Alteration of the average grain size for the EI-867WD alloy used to manufacture the turbine blades, for a new blade and blades heated at various temperatures. The average grain size is expressed as the diameter of an equivalent circle with the same surface as of the grain

The graph demonstrated that heat resistance of blades subjects to deterioration. The growth of grains by more than 50% is observed in the alloy microstructure (Fig. 9), which adversely affects mechanical properties of the alloy [4, 13]. In particular, these alterations are clearly visible within the reinforcing γ' phase as modification of the structure is observed for that phase (Fig. 10, 11). The temperature of 1123 K is conducive to growth of small particles within the γ' phase. At the temperature of 1323 K, mid-sized particles of that phase expand. Finally, at the temperature of 1523 K the particles with the largest initial size exercise further growth due to coagulation. In consequence, the number of particles with the fines sizes gradually decreased in pace with the temperature growth and is much less than in the material of new blades and the ones subjected to heating at the temperature of 1123 K. At the same time the distance between individual particles of the γ' phase is getting larger and larger. The revealed growth, clustering and corrugation of particles within the γ' phase leads to substantial deterioration of heat resistance demonstrated by

The relationship between the thermal response of the blade material, expressed as the function $\ln(T-T_0) = \ln(t)$ (Fig. 8) related to alterations of average grain size (Fig. 9) as well as the average size of the γ' particles precipitated during tests (Fig. 11) make it possible to infer about amendments to the material microstructure. These relationships, with consideration of limit

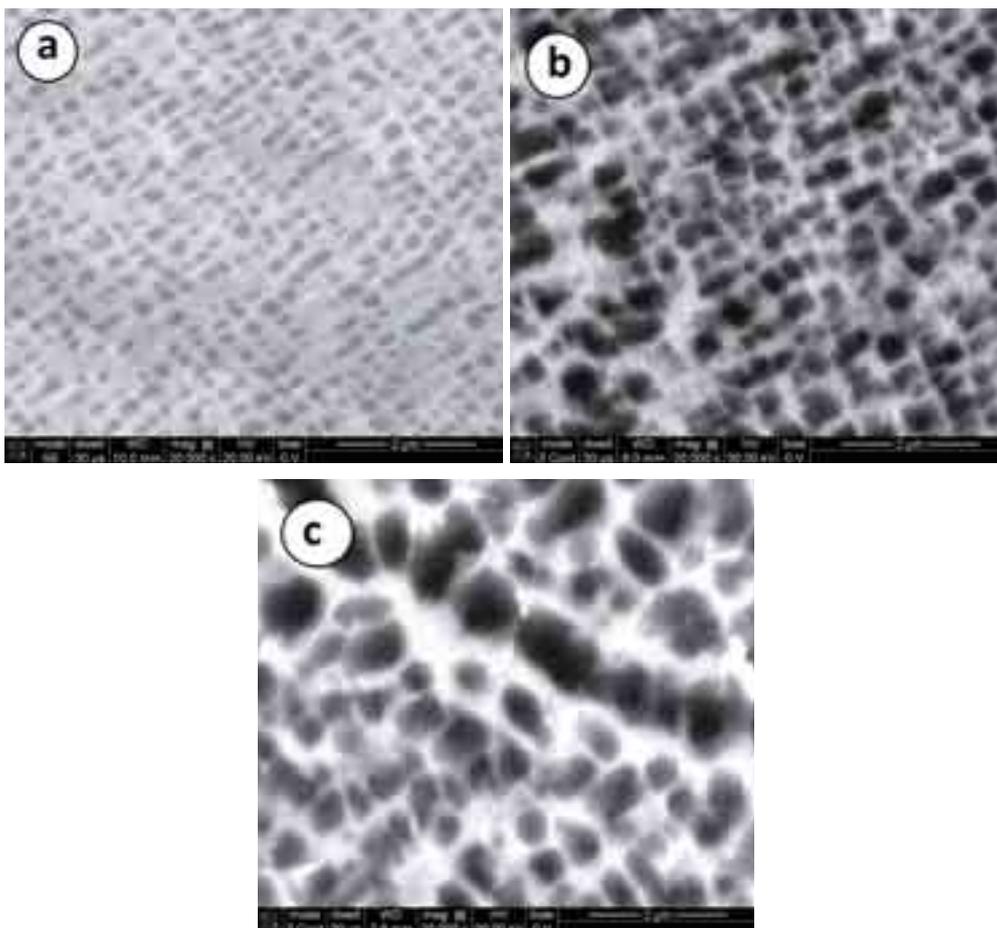
Fig. 10. The microstructure of blades heated for 2 hours at the temperatures of a) – 1123K, b) - 1323K, c) – 1523K (magn. $\times 20,000$) – visible effects of coagulation, alteration of particle shapes and corrugation of particles within the γ' phase

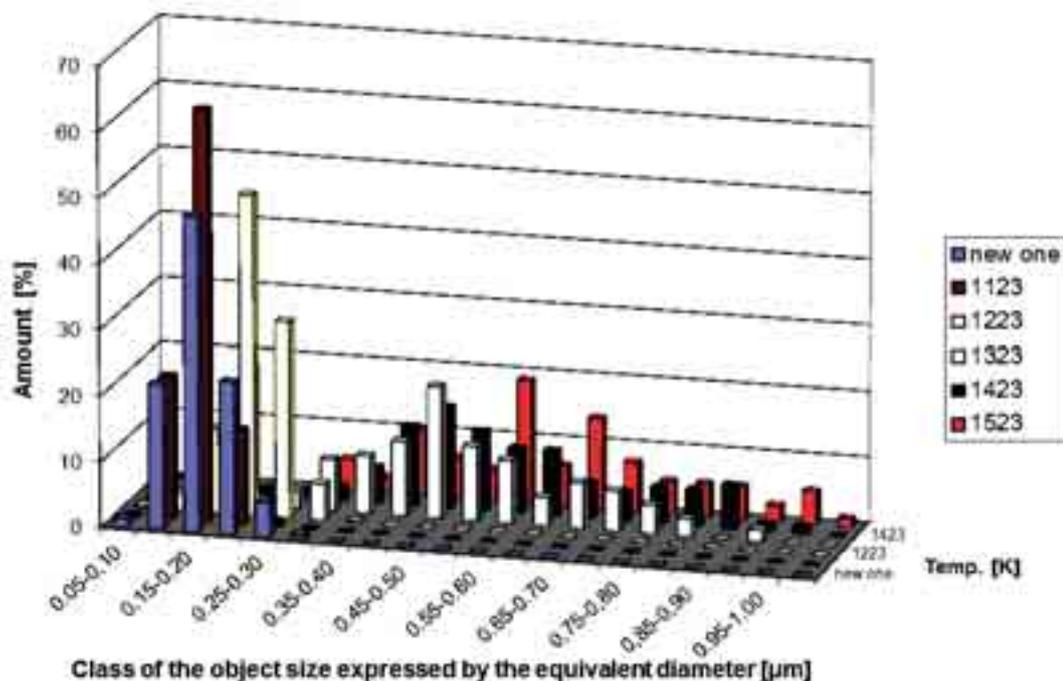
Fig. 11. Number of precipitations within individual size classes of γ' phase particles for the material of turbine blades, for a new blade and blades heated to the temperatures of 1123 K, 1323 K and 1523 K
