## ANALYSIS OF APPLICABILITY OF THERMOGRAPHY TO ASSESS HEALTH OF GAS TURBINE BLADES

**Artur Kułaszka**

**Józef Blachnio<sup>1,2</sup>**

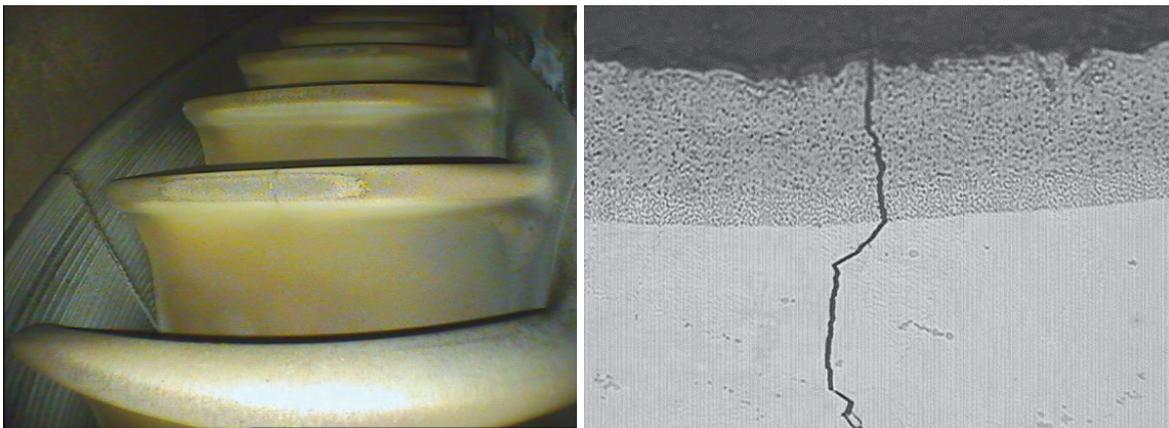
Fig. 1. Image of a crack of the protective coating with crack propagation into the parent material of the blade body [5]: videoscopic image – a) microscopic image, magn. x 450

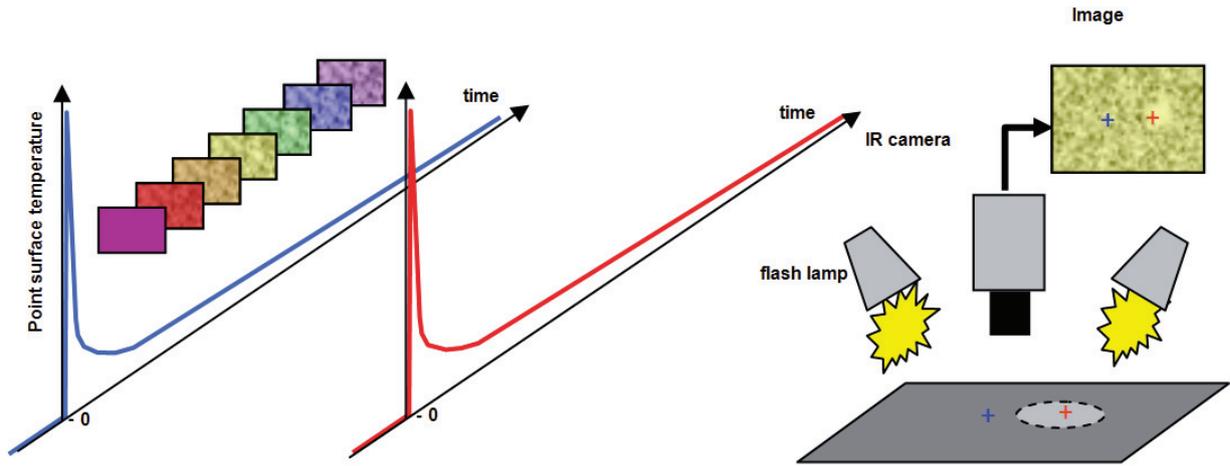
Fig. 2. The diagram for application of the Pulse Thermography [3]

When an amount of energy is applied to the material surface, e.g. in the form of a heat pulse (Fig. 2) the surface temperature rises rapidly. After the pulse, the surface temperature decays because the thermal front propagates by diffusion under the surface. Later, the presence of a subsurface defect (i.e. the areas that differ in thermal and physical properties) alters the diffusion rate. Consequently, monitoring of the surface temperature, such as subsurface defect appears on the surface that is cooling down at the moment as an area of different temperature. Therefore, the method offers the possibility not only to analyse discontinuities that occur inside the material body but also to reveal undesired microstructure alterations in the material under test. [2, 7].

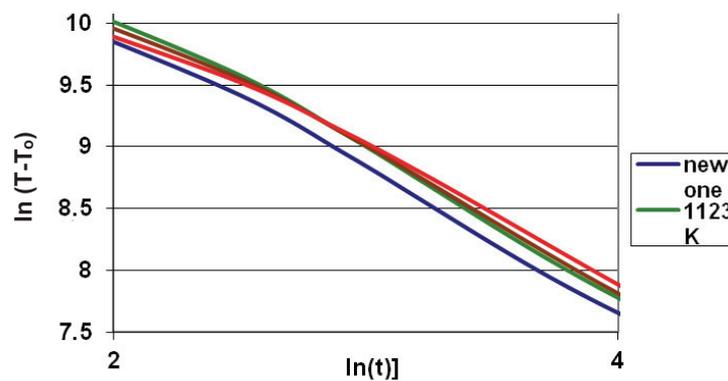
Fig. 3. Results for the response of the blade material to a thermal pulse for new and preheated blades

The blades were heated up with a very short heat pulse and the thermal response (echo) of the material was recorded (variations of temperature on the examined surface) for selected areas with use of thermographic measuring and logging instruments. Additionally, the blades were heated in an oven in the presence of exhaust gas from combustion of aircraft kerosene at various temperatures (from 1123K to 1523K) and then subjected to the same investigation procedure on the thermographic workbench. As a result from the completed investigations the difference in thermal and physical response was revealed for the blades under test before and after heating at various temperatures (Fig. 3).

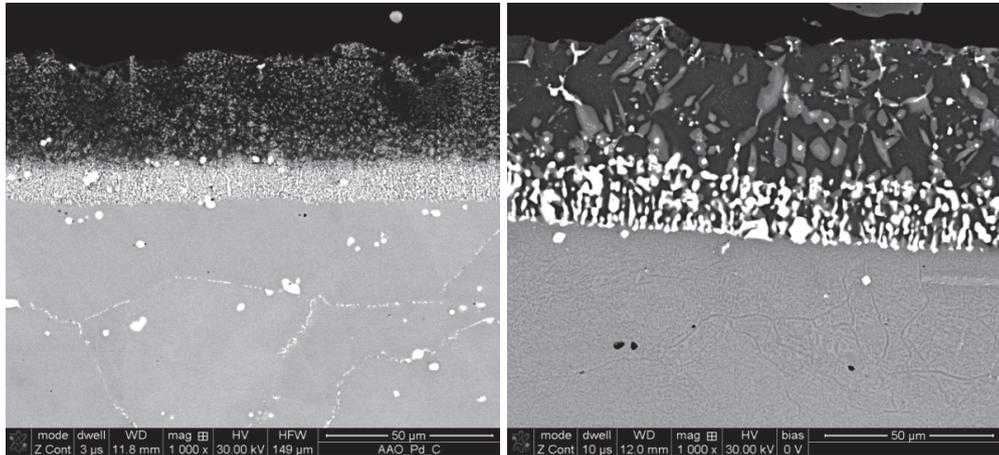
Fig. 3. Surface layer of a new blade and the one preheated to the temperature of 1423K

The completed metallographic investigations of blades previously subjected to heating at various temperatures demonstrated that high temperature induces changes in microstructure of both the coating material and the parent alloy EI-867 WD. The thickness of the aluminum protective coating increases with growth of the heating temperature (Fig. 3, 4) with simultaneous deterioration of its heat resistance. The process of grain growth takes place in the alloy (Fig. 5) that adversely affects its mechanical properties [1]. The alterations are particularly visible within the reinforcing  $\gamma'$  phase since modification of the structure is observed for that phase (Fig. 6). The temperature of 1123 K is conducive to growth of small particles within the  $\gamma'$  phase. At the temperature of 1323 K, mid-sized particles of that phase expand. Finally, at the temperature of 1523 K the particles with the largest initial size exercise further growth due to coagulation. In consequence, the number of

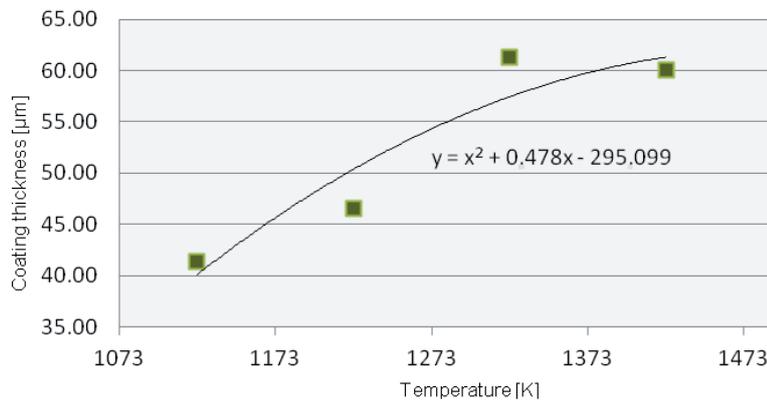
Fig. 4. Graph for variation of the aluminum coating for blades subjected to preheating

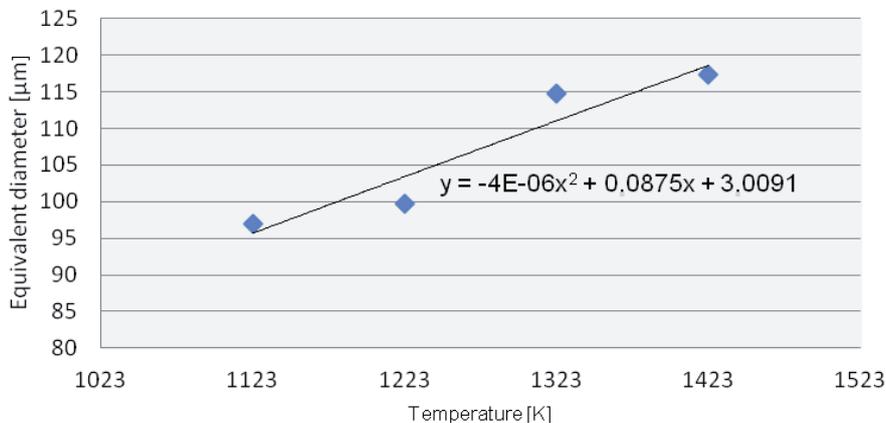
Fig. 5. Alteration of the average grain size for the EI-867WD super alloy used to manufacture the turbine blades, for a new blade and blades heated at various temperatures. The average grain size is expressed as the diameter of an equivalent circle with the same surface as of the grain

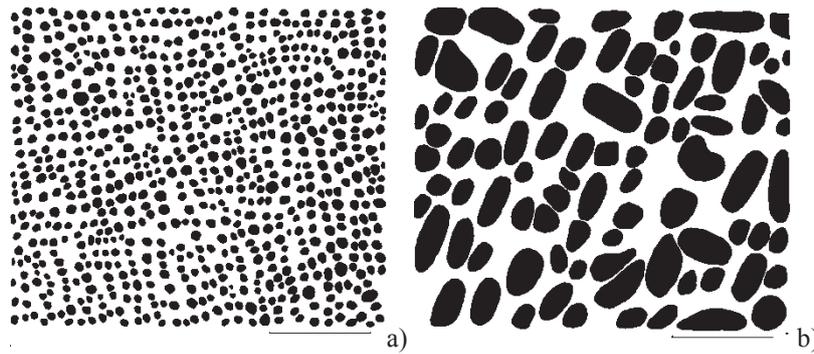
Fig. 6. The microstructure of turbine blades after heating at temperatures: a) - 1123 K, b) - 1423 K (magn. x20000) – one can see coagulation, alteration of shapes and corrugation of the  $\gamma'$  phase formations.

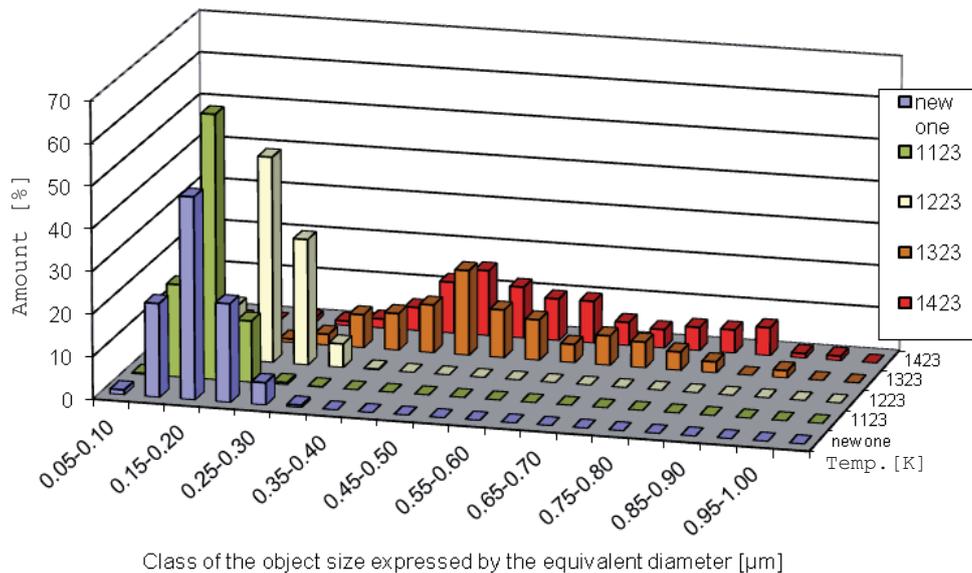
Fig. 7. Number of precipitations within individual size classes of  $\gamma'$  phase particles for the material of turbine blades, for a new blade and blades heated to the temperatures from 1123 K to 1523 K

particles with the largest sizes gradually decreased with the temperature growth and is much less than in the material of new blades and the ones subjected to heating at the temperature of 1123 K (Fig. 7). At the same time the distance between individual particles of the  $\gamma'$  phase became larger. The revealed growth, clustering and corrugation of particles within the  $\gamma'$  phase lead to substantial deterioration of heat resistance demonstrated by the alloy [1]. When the number of particles developed to the  $\gamma'$  phase is adopted as the criterion of the material applicability for further operation, one is able to determine a threshold limit for the blade lifetime.
