THE RATE OF DECOHESION OF A GAS TURBINE BLADE AS ASSESSED WITH THE X-RAY COMPUTED TOMOGRAPHY (CT)

Marek Chalimoniuk, Ryszard Szczepanik

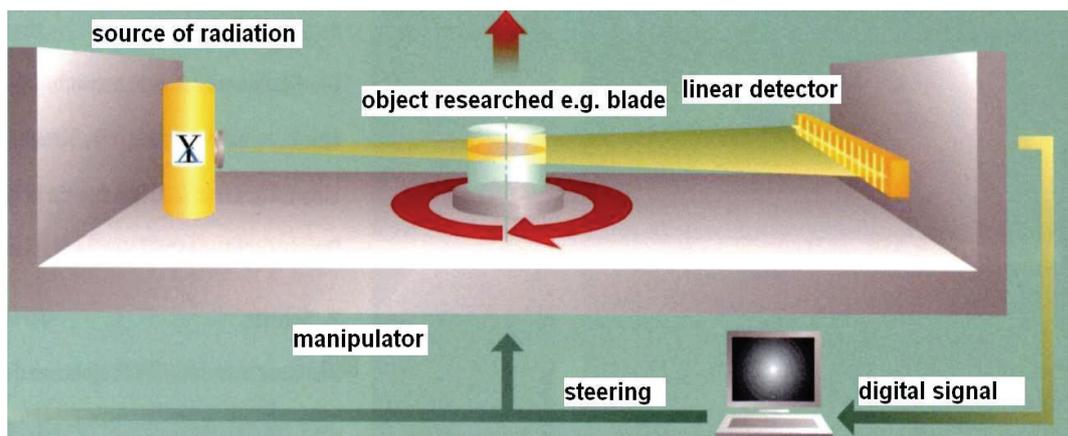
Fig. 1. The example of a tomography investigation with use of a linear detector [6]

As it is generally known, the Computed Tomography (CT) is a kind of X-ray tomography but it enables acquisition of 3D images from investigations when objects under tests are multiply X-rayed from various directions. The device for Computer Tomography is referred to as a tomograph, usually a Computer-Assisted Tomograph (CAT) and the acquired images - tomograms. The principle for development of 3D images is explained in Fig. 1.

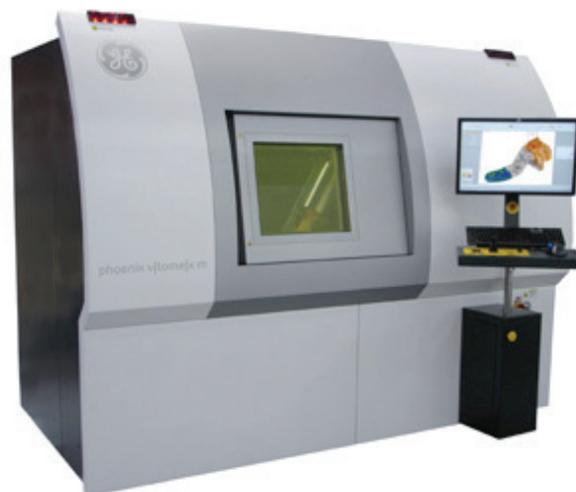
Fig. 2. The V/Tome/x m 300 tomograph purchased from GE

In 2012, the Air Force Institute of Technology (ITWL) was awarded the grant from the Ministry of Science and Higher Education for purchase of research equipment. Owing to the grant, ITWL was able to purchase a tomograph (Computer-Assisted Tomograph - CAT) from ITA-Polska, the representative of GE Phoenix. The device type is v/tome/x m 300 (Fig. 2) and its tube is operated with the maximum power of 500W at 300 kV voltage. It has also a tube for nanotomography with the power of 15W at 180 kV. Purchase of that cutting edge equipment made it possible to launch research studies on a wide spectrum of materials that are used in avionic industry, such as various steel grade, alloys of non-ferrous materials (including titanium), polymers, elastomers, fiber and aggregate composites, ceramic and electronic materials, etc. Non-destructive tests (NDT) can be carried out with unsurpassed resolution. The tomograph is capable of detecting defects with the size below 0.5 μm with use of the lamp for the 180 kV voltage or flaws in materials with high density, e.g. titanium blades of avionic turbojet engines when the lamp for the 300kV voltage is employed. The maximum weight for parts to be examined is up to 50 kg. The time intervals necessary to examine engine components, e.g. turbine blades, range from 20 to 30 minutes.

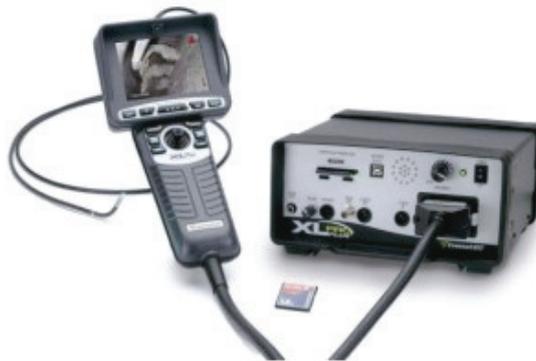
Fig 3. The optoelectronic device – the videoendoscope [3]

The illuminated surface of turbine blades can be examined by a light-sensitive detector (a CCD matrix along with an optical system – an optoelectronic system) owing to the source of secondary light reflected by the blade surface. The CCD matrix counts the number of photons that reach the matrix area, i.e. it can measure the energy of light beams that arrive to each individual pixel. In case of computer-based visual systems, the images are acquired from the environment by means of an optoelectronic device – a videoendoscope (Fig. 3). Such an approach enables indirect diagnosing of the object under investigation through processing and analysis of data acquired in the form of digital images.

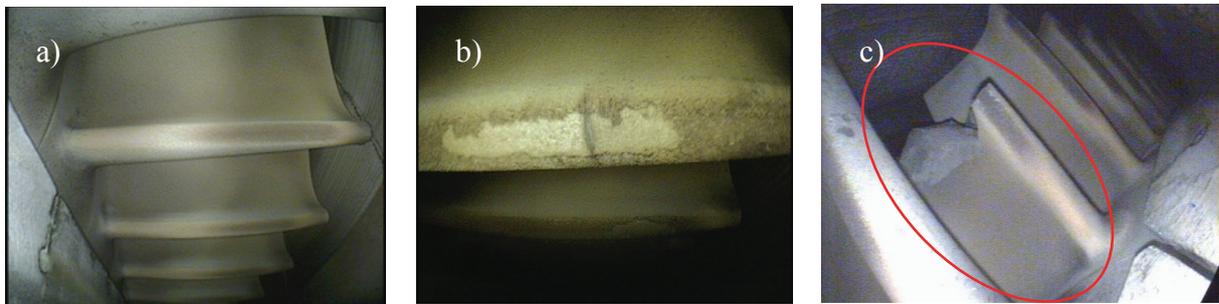
Fig. 4. Examples of defects affecting rotor blades of a gas turbine: a) overheating of the material on the edge of attack; b) flaking of the blade surface and a crack on the edge of attack on the blade leaf; c) tear out of a blade leaf

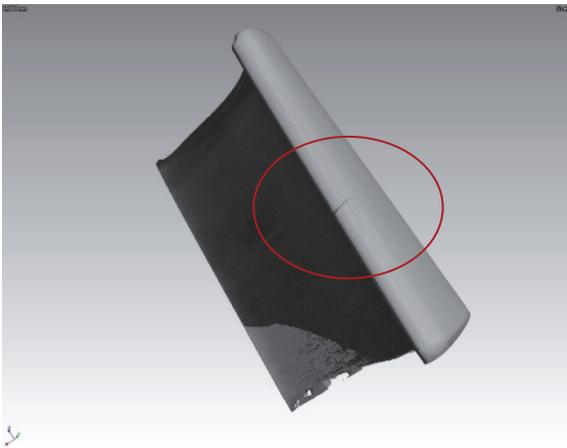
Fig. 5. Crack on the edge of attack

Figure 5 and 6 present a turbine blade where a crack is detected on its edge of attack and explain how to measure the crack size.

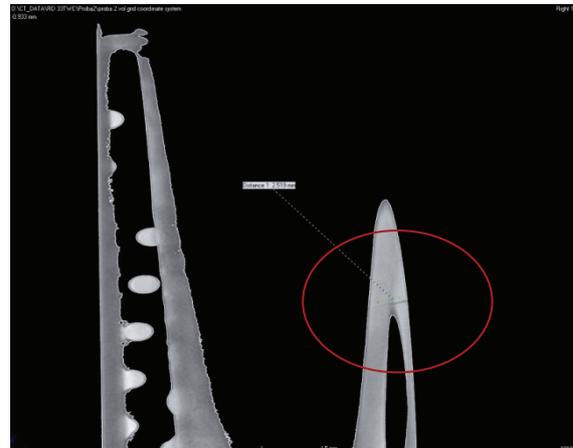
Fig. 6. Dimensioned crack on the edge of attack

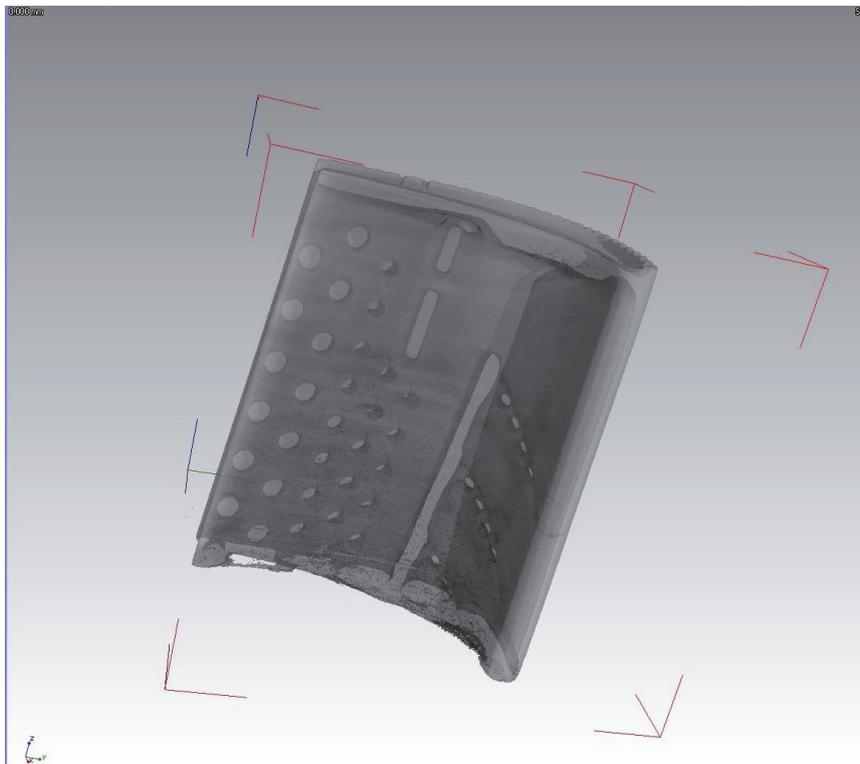
Fig. 7. The example of the space inside the turbine blade

Currently the efficiency of cooling ducts for turbine blades and lack of obstruction is checked during repairs by measurements of water flow intensity where water passes through the inner space of a blade over a specific time. It is a time-consuming method that provides quite poor accuracy. Application of the Computer Tomography method makes it possible to achieve 3D image of turbine blades in a very short time and the images can be analysed in any cross-section and up to any depth. It provides a very realistic image of inner ducts designed for cooling of blades (Fig. 8, 9). Reliability and trustworthiness of such verification is extremely important since in case of any errors any inaccuracies may lead to thermal failures of blades during turbine operation.

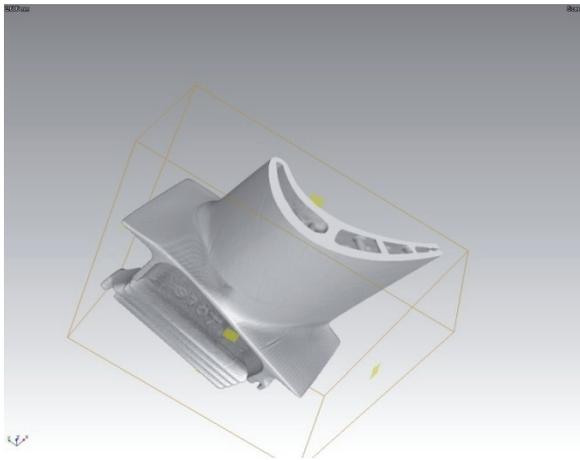
Fig. 8. The blade cross-section with the view of the inner space

The software for analysis of images acquired as a result of tomographic examination offers the functionality to inspect the parts under tests to the desired depth. The advanced tools for processing examination results are able to 'remove' slices of material to the depth as required by the operator. It is the method that provides high accuracy in determination of the surface roughness, both on the outer and inner sides of turbine blades (Fig. 8, 9).

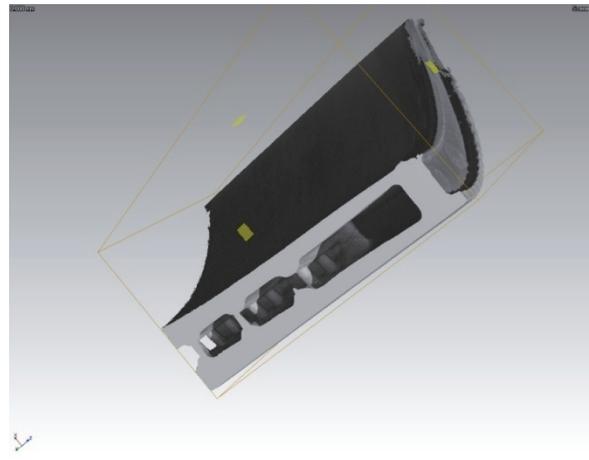
Fig. 9. The blade cross-section with the view of the inner space

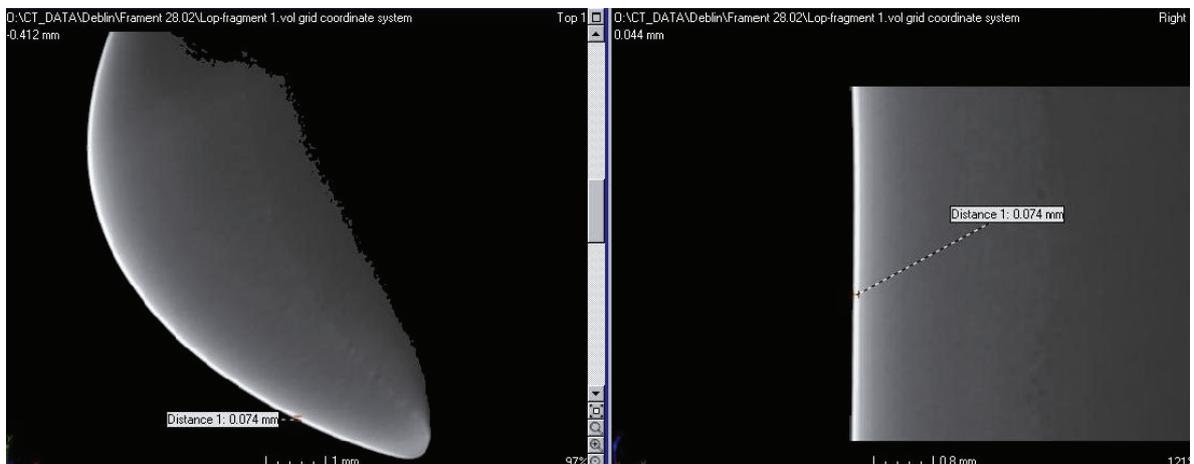
Fig. 10. View of protective coatings applied onto a leaf of a turbine blade and examples for measurements of the coating thickness

The next application area of computer tomography is the possibility to evaluate thickness of protective coatings applied onto blades of both the turbine and the compressor (Fig. 10). The obtained results enable drawing of the conclusion that it is feasible to find out how much the protective coatings are deteriorated due to flaking or erosion. Such examinations have already been possible exclusively with the use of destructive testing by means of metallographic microsections.

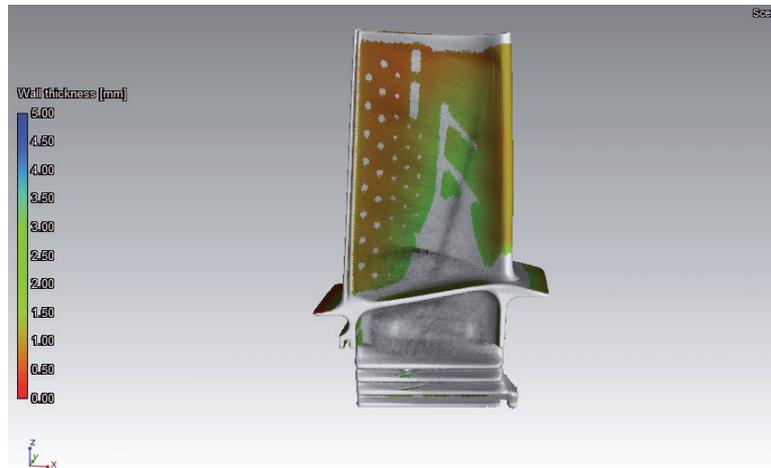
Fig. 11. The example of the image for the thickness of coating applied onto a leaf of a gas turbine blade acquired by means of a tomograph [7]

Computer tomography enables monitoring of actual wall thickness, also in case of inner or invisible ones. It is extremely important for verification of machine parts, e.g. castings. Upon reconstruction of the real part the operator can measure the casting dimensions and carry out automatic analysis of the wall thickness. It is the tool that automatically indicates deviations from the assumed dimensions specified in engineering drawings. The distribution of the thickness parameter can be presented in the graphic manner with the use of the scale of colours. It enables immediate verification whether the blade is manufactured correctly or not (Fig. 11).
