# EXAMINATION OF CHANGES IN THE MICROSTRUCTURE OF GAS TURBINE BLADES WITH VISUAL AND THERMOGRAPHIC METHODS

Józef Błachnio, Artur Kulaszka, Łukasz Kornas, Marek Chalimoniuk

*Air Force Institute of Technology  
Księcia Bolesława Street 6, 01-494 Warsaw Poland  
tel.: +48 22 6851-213 fax: +48 22 6851 041  
e-mail: jozef.blachnio@itwl.pl, artur.kulaszka@itwl.pl,  
lukasz.kornas@itwl.pl, marek.chalimoniuk@itwl.pl*

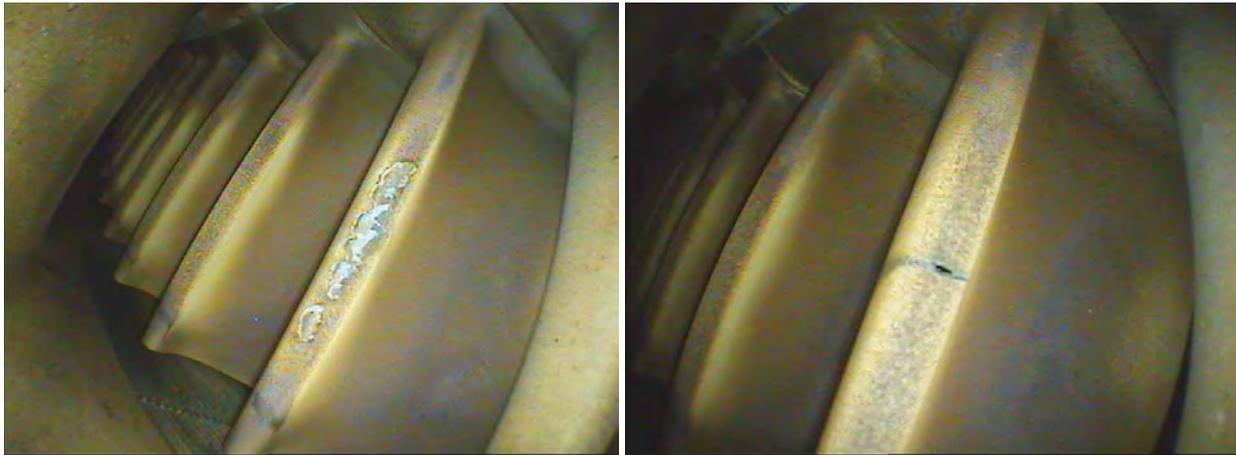
Fig. 1. Temperature-attributable damages to edges of attack of turbine rotor blades, exemplary videoscope records [1]

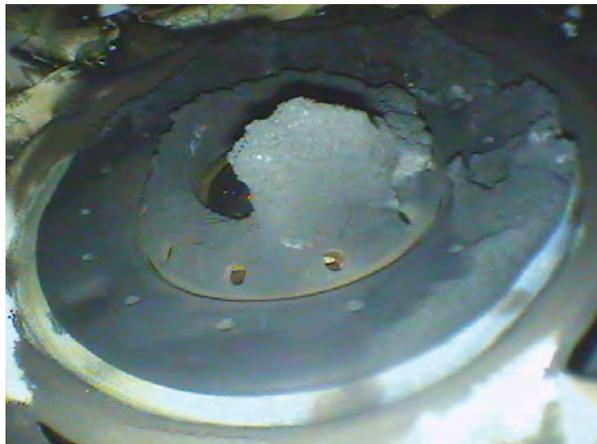
Fig. 3. Carbon deposit on the fuel injector in the gas turbine engine [2]

Improper fuel pressure, physical and chemical properties deteriorated due to impurities of any kind, fuel injector in the flame tube head out of position – all these significantly contribute to carbon deposit formation on the injector (Fig. 3) and other subassemblies. A direct consequence of the presence of carbon deposits is improper fuel spray pattern. This results in disturbances in both the combustion process, and hence, the thermal-field distribution in the engine's hot section (Fig. 4).
