# THE ASSESSMENT OF CHANGES IN THE MICROSTRUCTURE OF A GAS TURBINE BLADE WITH A NON-DESTRUCTIVE THERMOGRAPHIC METHOD

**Keywords:** gas turbine, blade, pulsed thermography diagnosing, health/maintenance status

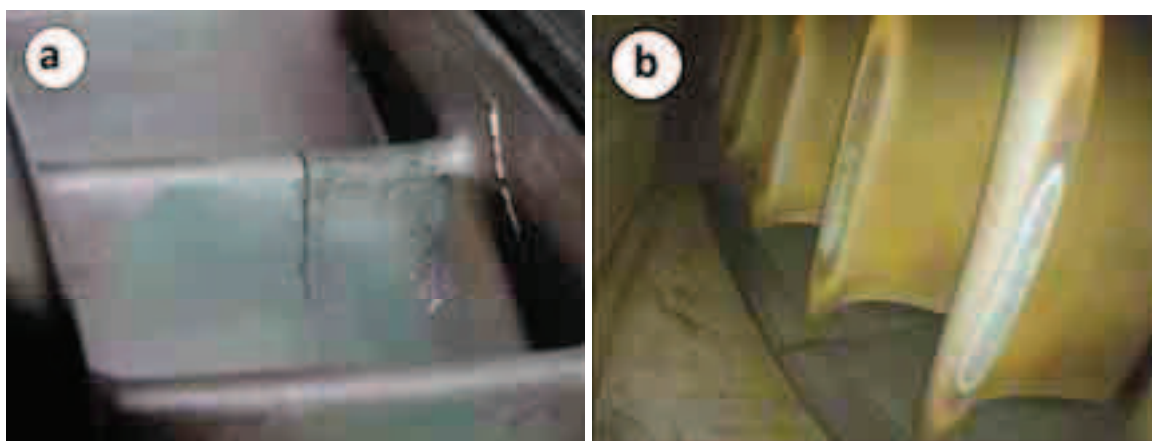
Fig. 1. Forms of thermal deterioration of gas turbine blades: a) overheating of the blade material visible as discoloration of surface colour to pale blue and glaucous, b) local melting of the protective coating

Deterioration of protective coatings (Fig. 1) that covers turbine blades, with simultaneous impact of high temperature and aggressive effect of exhaust gas leads to overheating of the blade parent material. Further operation of the turbine with such defects entails total damage of turbine blades and presents a hazard to operation safety of engines.
