ANOMALIES IN COMBUSTION OF HYDROGEN IN A SI ENGINE MODIFIED TO WORK AS A SUPERCHARGED ONE

Stanislaw Szwaja, Karol Cupial, Karol Grab-Rogaliński

Czestochowa University of Technology
Institute of Thermal Machinery
Dabrowskiego Street 69, 42-200 Czestochowa, Poland
tel.: +48 34 350555, fax: +48 34 3250555
e-mail: szwaja@imc.pcz.czest.pl, cupial@imc.pcz.czest.pl, grab@itm.pcz.czest.pl

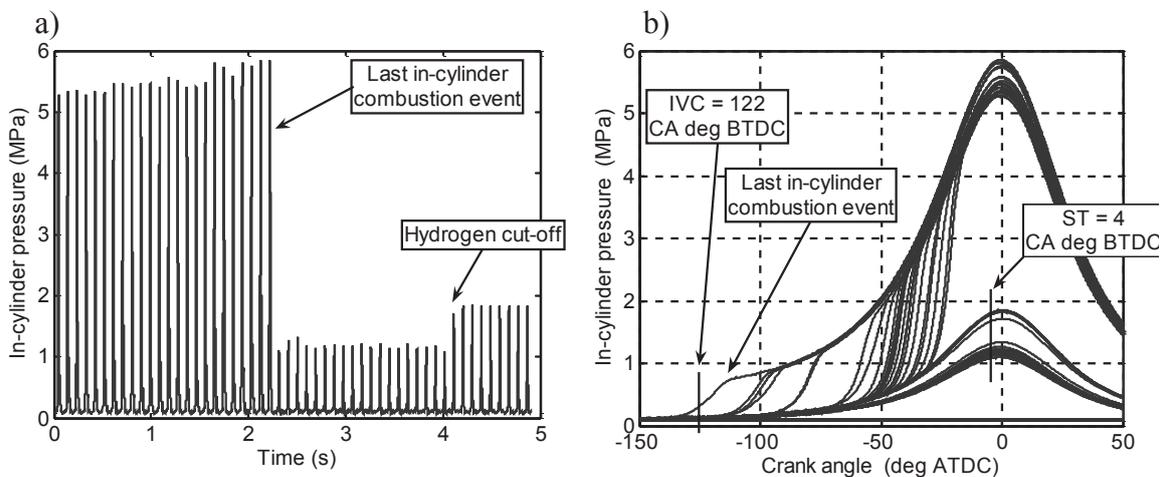
Fig. 1. Time based in-cylinder pressure (a), crank angle based in-cylinder pressure (b) from the hydrogen fuelled engine with supercharging of $p_{boost} = 0.2$ bar, $\lambda = 1$ and $ST = 4$ CA deg BTDC

The ignition is usually caused by hot exhaust gases residuals, deposits or hot surface. It starts after closure of the intake valve (IVC = 122 CA deg before TDC). The exemplary test combustion series were depicted in the Fig. 1.

As observed in the Fig. 1.b the start of combustion (SOC) varies in the range from approximately 25 to 110 CA deg BTDC. This pressure history corresponds to combustion events located in the first period of engine work of 2s, as shown in the Fig. 1.a. With increase in the average in-cylinder temperature the start of combustion (SOC) for following consecutive combustion events is systematically occurring earlier, that affects the in-cylinder temperature in positive feedback. Thus, cycle-by-cycle the SOC is moving towards the IVC.

As far as the SOC is not stabilized, the mentioned period of engine work should be treated as unstable one with continuous increase in the in-cylinder temperature. Due to early combustion initiation, the combustion is completed before the piston achieves its TDC location that leads to significant drop in IMEP, so does the engine torque and power. While the SOC occurs before the IVC as result of its tendency to become earlier and earlier, then flame rapidly ignites combustible mixture in the intake manifold as is typical for backfiring phenomena. Thus, hydrogen is entirely burnt there and the piston compresses only exhaust gases (nitrogen and steam/water). This phenomena is observed between the 2nd and the 4th second presented in the Fig. 1.a. Just pass the 4th second hydrogen was cut off, hence non-firing events are observed in further engine test.

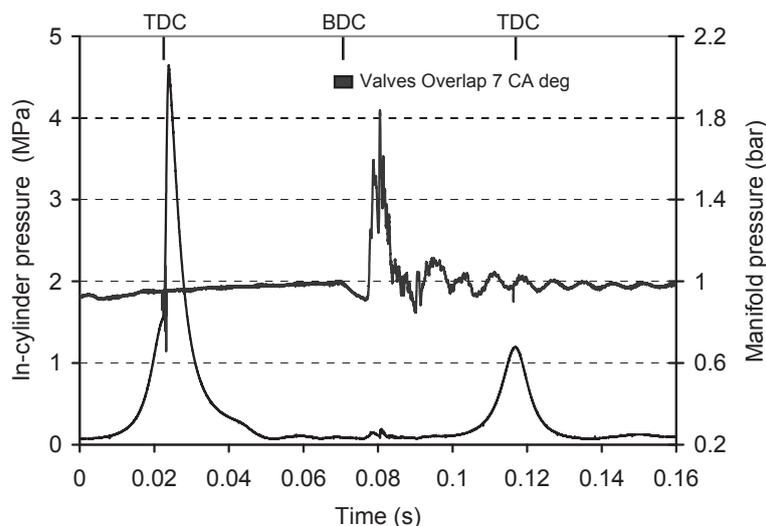
Fig. 2. In-cylinder pressure and intake manifold pressure in the hydrogen fuelled engine with supercharging $p_{boost} = 0.2 \text{ bar}$, $\lambda = 1$ and $ST = 4 \text{ CA deg BTDC}$

As depicted in the Fig. 2, just pass the proper combustion event (on the left) the next event features itself with remarkably lower peak pressure. The second trace shows pressure in the intake manifold.

Rapid increase in this pressure during valves overlap leads to conclusion that the mixture was ignited. Someone assumes that fresh hydrogen mixture, passing through the cylinder into the exhaust

manifold while overlapping, is ignited in the exhaust manifold by the O2 sensor hot surface and then flame propagates back at extremely high speed through valves overlap into the intake manifold.

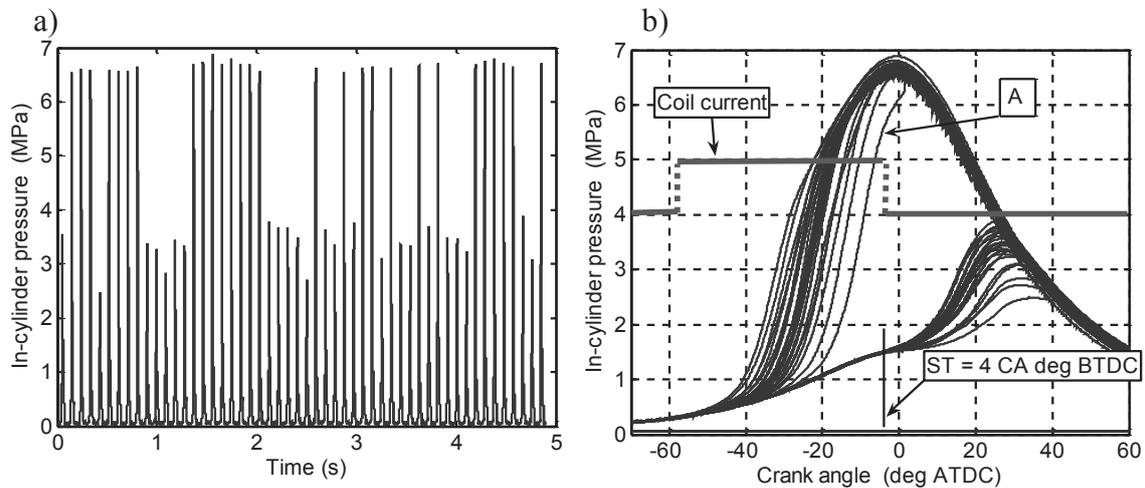
Fig. 3. Time based in-cylinder pressure (a), crank angle based in-cylinder pressure (b) from the hydrogen fuelled engine with supercharging $p_{boost} = 0.4$ bar, $\lambda = 1$ and $ST = 4$ CA deg BTDC

Hydrogen-air stoichiometric mixture features itself with extremely low minimum ignition energy of 0.017 mJ at NTP [9] that provides high probability of coincidental ignitions at various moments in time. For instance, gasoline minimum ignition energy is approximately 0.29 mJ. This unexpected ignition was observed while the ignition system applied to the engine generated short discharge resulted from positive slope of the current flowing through the ignition coil. Such discharge was unable to ignite gasoline mixture but it was found to be effective enough to initiate burning hydrogen. As shown in the Fig. 3.a these abnormal combustion events are randomly distributed over time. The Fig. 3.b depicts the same pressure history against the engine crank angle. These random combustion events start around the point located at 40 CA deg BTDC. At that time start of charging the coil, followed by rapid increase in the current, took place.

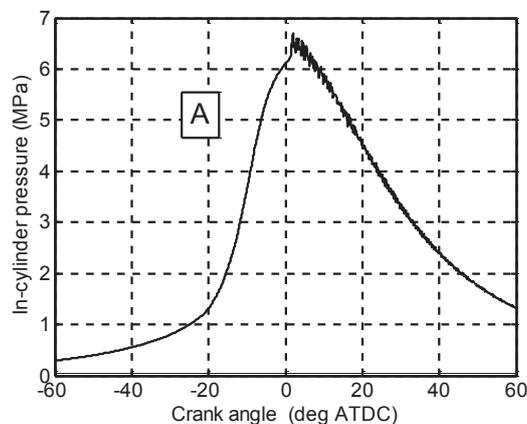
Fig. 4. In-cylinder pressure with knock symptoms in the hydrogen fuelled engine with supercharging $p_{boost} = 0.4$ bar, $\lambda = 1$ and $ST = 4$ CA deg BTDC

Such the advanced spark ignition can lead to knock. Following these expectation, some combustion events (e.g. cycle A) were found to be charged with the knock, as it was seen on the combustion pressure trace in the Fig. 4.

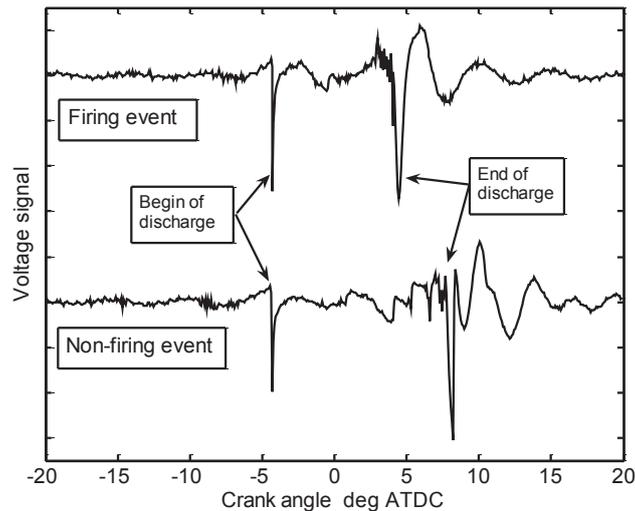
Fig. 5. Signal from a high-voltage probe for firing and non-firing event

Although abnormal combustion deals with firing events but non-firing events can be treated as the combustion anomaly leading to unstable engine work. It was observed that non-firing events could occur in the engine fed hydrogen even though the spark ignition system properly works and provides discharge between spark plug electrodes as depicted in the Fig. 5. Such phenomenon was observed while the engine was working with boosting pressure systematically increasing. Above the boosting pressure threshold of 0.5-0.6 bar the engine stopped working. As found the spark gap was too long. Hence, flame kernel was highly wrinkled by high turbulence and quickly extinguished with no chance to be re-ignited. By reducing the gap from 0.7 to 0.3 mm the engine was working stable at boost overpressure increased up to 1.6 bar.
