## ANOMALIES IN COMBUSTION OF HYDROGEN IN A SI ENGINE MODIFIED TO WORK AS A SUPERCHARGED ONE

### **Abstract**

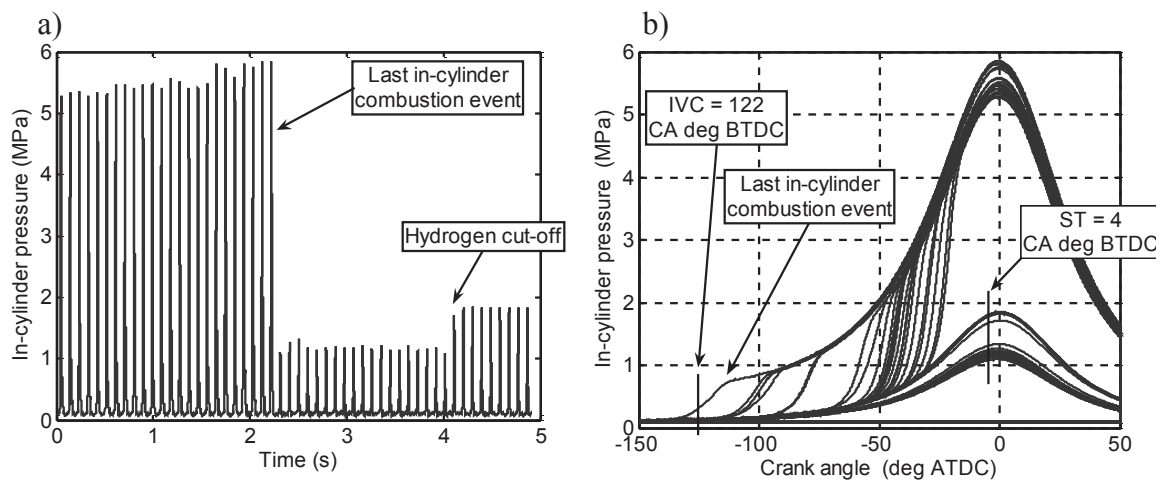
Fig. 1. Time based in-cylinder pressure (a), crank angle based in-cylinder pressure (b) from the hydrogen fuelled engine with supercharging of  $p_{boost} = 0.2$  bar,  $\lambda = 1$  and  $ST = 4$  CA deg BTDC

The ignition is usually caused by hot exhaust gases residuals, deposits or hot surface. It starts after closure of the intake valve (IVC = 122 CA deg before TDC). The exemplary test combustion series were depicted in the Fig. 1.

As observed in the Fig. 1.b the start of combustion (SOC) varies in the range from approximately 25 to 110 CA deg BTDC. This pressure history corresponds to combustion events located in the first period of engine work of 2s, as shown in the Fig. 1.a. With increase in the average in-cylinder temperature the start of combustion (SOC) for following consecutive combustion events is systematically occurring earlier, that affects the in-cylinder temperature in positive feedback. Thus, cycle-by-cycle the SOC is moving towards the IVC.

As far as the SOC is not stabilized, the mentioned period of engine work should be treated as unstable one with continuous increase in the in-cylinder temperature. Due to early combustion initiation, the combustion is completed before the piston achieves its TDC location that leads to significant drop in IMEP, so does the engine torque and power. While the SOC occurs before the IVC as result of its tendency to become earlier and earlier, then flame rapidly ignites combustible mixture in the intake manifold as is typical for backfiring phenomena. Thus, hydrogen is entirely burnt there and the piston compresses only exhaust gases (nitrogen and steam/water). This phenomena is observed between the 2<sup>nd</sup> and the 4<sup>th</sup> second presented in the Fig. 1.a. Just pass the 4<sup>th</sup> second hydrogen was cut off, hence non-firing events are observed in further engine test.

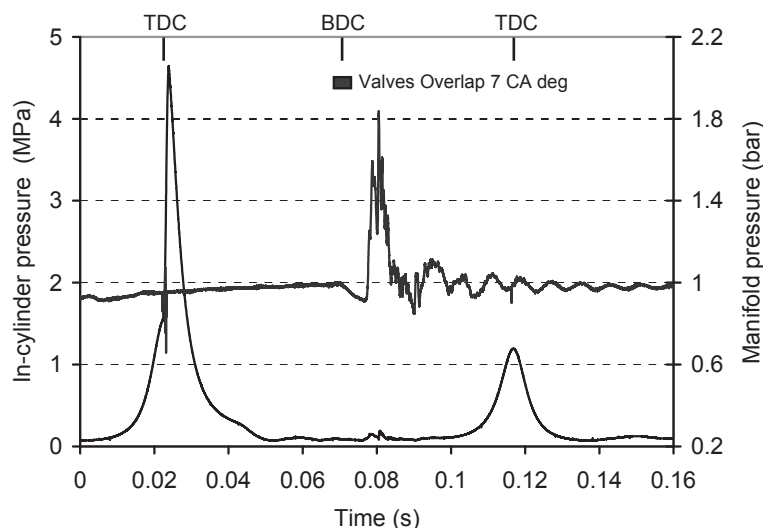
Fig. 2. In-cylinder pressure and intake manifold pressure in the hydrogen fuelled engine with supercharging  $p_{boost} = 0.2$  bar,  $\lambda = 1$  and  $ST = 4$  CA deg BTDC

As depicted in the Fig. 2, just pass the proper combustion event (on the left) the next event features itself with remarkably lower peak pressure. The second trace shows pressure in the intake manifold.

Rapid increase in this pressure during valves overlap leads to conclusion that the mixture was ignited. Someone assumes that fresh hydrogen mixture, passing through the cylinder into the exhaust

manifold while overlapping, is ignited in the exhaust manifold by the O<sub>2</sub> sensor hot surface and then flame propagates back at extremely high speed through valves overlap into the intake manifold.

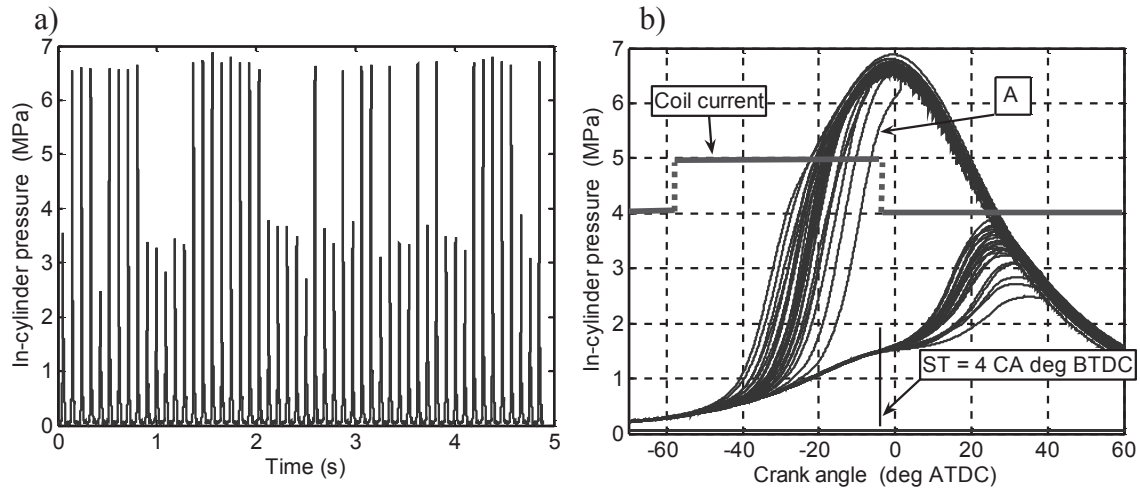
Fig. 3. Time based in-cylinder pressure (a), crank angle based in-cylinder pressure (b) from the hydrogen fuelled engine with supercharging  $p_{boost} = 0.4$  bar,  $\lambda = 1$  and  $ST = 4$  CA deg BTDC

Hydrogen-air stoichiometric mixture features itself with extremely low minimum ignition energy of 0.017 mJ at NTP [9] that provides high probability of coincidental ignitions at various moments in time. For instance, gasoline minimum ignition energy is approximately 0.29 mJ. This unexpected ignition was observed while the ignition system applied to the engine generated short discharge resulted from positive slope of the current flowing through the ignition coil. Such discharge was unable to ignite gasoline mixture but it was found to be effective enough to initiate burning hydrogen. As shown in the Fig. 3.a these abnormal combustion events are randomly distributed over time. The Fig. 3.b depicts the same pressure history against the engine crank angle. These random combustion events start around the point located at 40 CA deg BTDC. At that time start of charging the coil, followed by rapid increase in the current, took place.

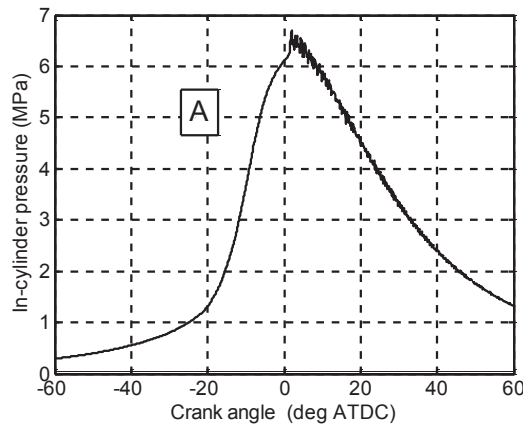
Fig. 4. In-cylinder pressure with knock symptoms in the hydrogen fuelled engine with supercharging  $p_{boost} = 0.4$  bar,  $\lambda = 1$  and  $ST = 4$  CA deg BTDC

Such the advanced spark ignition can lead to knock. Following these expectation, some combustion events (e.g. cycle A) were found to be charged with the knock, as it was seen on the combustion pressure trace in the Fig. 4.

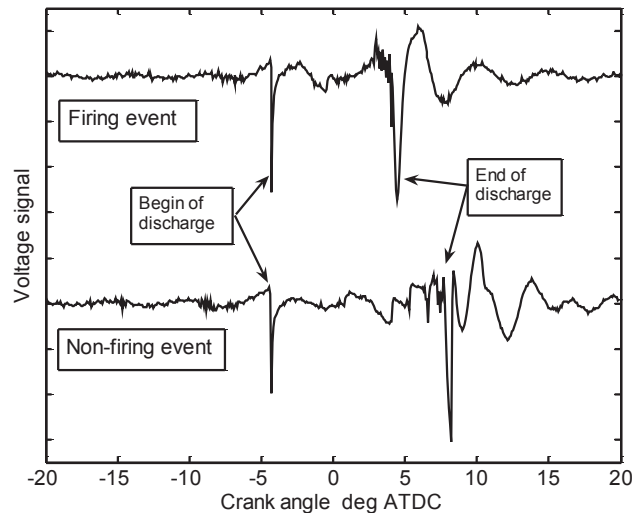
Fig. 5. Signal from a high-voltage probe for firing and non-firing event

Although abnormal combustion deals with firing events but non-firing events can be treated as the combustion anomaly leading to unstable engine work. It was observed that non-firing events could occur in the engine fed hydrogen even though the spark ignition system properly works and provides discharge between spark plug electrodes as depicted in the Fig. 5. Such phenomenon was observed while the engine was working with boosting pressure systematically increasing. Above the boosting pressure threshold of 0.5-0.6 bar the engine stopped working. As found the spark gap was too long. Hence, flame kernel was highly wrinkled by high turbulence and quickly extinguished with no chance to be re-ignited. By reducing the gap from 0.7 to 0.3 mm the engine was working stable at boost overpressure increased up to 1.6 bar.
