## DAMAGE DETECTION IN COMPOSITE CYLINDRICAL PANELS BASED ON FORCED VIBRATION

Marek Barski, Piotr Pająk

### Abstract

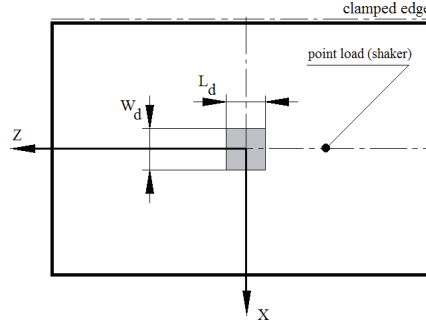
Fig. 2. Dimensions of damage

The damage is located in the geometrical center of the structure and is modeled as rectangular area, where the material stiffness is reduced. The magnitude of the damage is determined by the coefficient  $\beta$ . Here it is assumed that  $\beta = 0.85$ . It means that the material inside the damage is “weaker” about 15% in comparison with rest of the composite material. In the Fig. 2 there is shown the dimension of the damage. They are equal to  $L_d = 7.4$  [mm] and  $W_d = 5.8$  [mm]. The dimension  $W_d$  should be consider as the length of the arc in the circumferential direction.

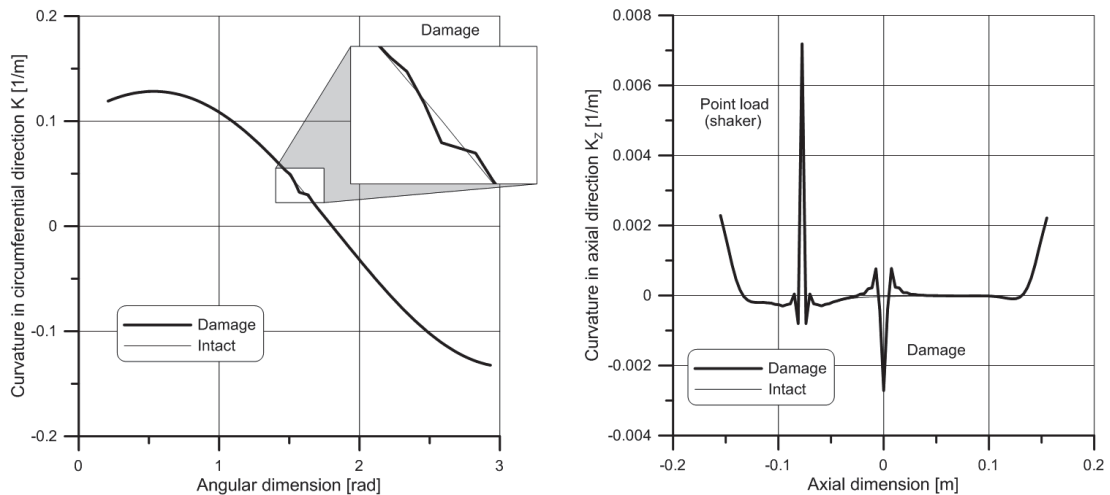
Fig. 4. Curvatures of the panels (description in text). First mode  $\nu=38.5$  [Hz]

In the Fig. 4, 5 and 6 the curvatures in the circumferential and axial direction of the considered panels are depicted. These diagrams are made along the following lines  $Z=0$  and  $X=0$ , so they pass through the center of the flaw. Moreover, they are prepared for the following natural frequencies, namely: 38.5 [Hz], 45 [Hz] and 129 [Hz]. These values correspond to the first three modes of the free vibrations. In the third case the damage is localized in the area, where the strain energy reaches the maximum, hence the local change of the curvature is the most visible. However, it should be stressed that the disturbance is not significant. It should be stressed that in the real experiment these local changes would be difficult to detect. Quite different situation is observed in the case of the axial curvature. Here two main disturbances can be observed. First of them is caused by the shaker and the second is connected with existence of the flaw. The position of the damage is clearly visible, especially in the Fig. 4. It seems that the observed local disturbance of the curvature in the axial direction gradually decays for the higher values of the natural frequency. In the Fig. 7 the final damage localization, according to the formula (3), is shown. The position and the size of the damage is clearly visible.
