# THE RATE OF DECOHESION OF A GAS TURBINE BLADE AS ASSESSED WITH THE X-RAY COMPUTED TOMOGRAPHY (CT)

*The paper delivers findings of the preliminary investigation into the assessment of health/maintenance status of gas turbine blades by means of the X-ray computed tomography. The results gained have been successfully verified using the metallographic examination techniques. It has been found that the radiographic imaging method enables recognition of types, sizes, and locations of internal faults in the blades while generating three-dimensional images thereof.*

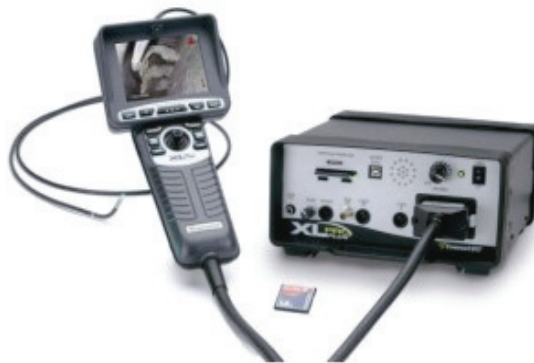
Fig 3. The optoelectronic device – the videoendoscope [3]

The illuminated surface of turbine blades can be examined by a light-sensitive detector (a CCD matrix along with an optical system – an optoelectronic system) owing to the source of secondary light reflected by the blade surface. The CCD matrix counts the number of photons that reach the matrix area, i.e. it can measure the energy of light beams that arrive to each individual pixel. In case of computer-based visual systems, the images are acquired from the environment by means of an optoelectronic device – a videoendoscope (Fig. 3). Such an approach enables indirect diagnosing of the object under investigation through processing and analysis of data acquired in the form of digital images.
