## VALIDATION OF REFERENCE SAMPLING FOR FAILURE DETECTION BY CRANKSHAFT ANGULAR SPEED ANALYSIS

Mirosław Dereszewski, Adam Charchalis

Gdynia Maritime University, Mechanical Faculty  
Morska Street 83, 81-225 Gdynia, Poland  
tel.: +48 58 6901398  
e-mail: [deresz1@o2.pl](mailto:deresz1@o2.pl), [achar@am.gdynia.pl](mailto:achar@am.gdynia.pl)

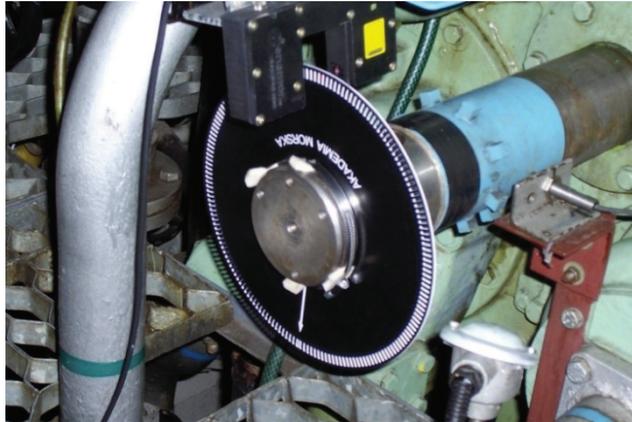
Fig. 1. Perforated disc and laser sensor mounted at crankshaft's free end

Angular speed measurement set consisting of perforated disc and optical sensor, (Fig. 1), data processing and storage block ETNP-10.
