## SURFACE TOPOGRAPHY OF OPERATED SLIDE JOURNAL MICRO-BEARINGS USED IN COMPUTER FANS

In this paper authors present results of measurements of slide journal bearings surface topography measured with a profilometer and an atomic force microscope (AFM).

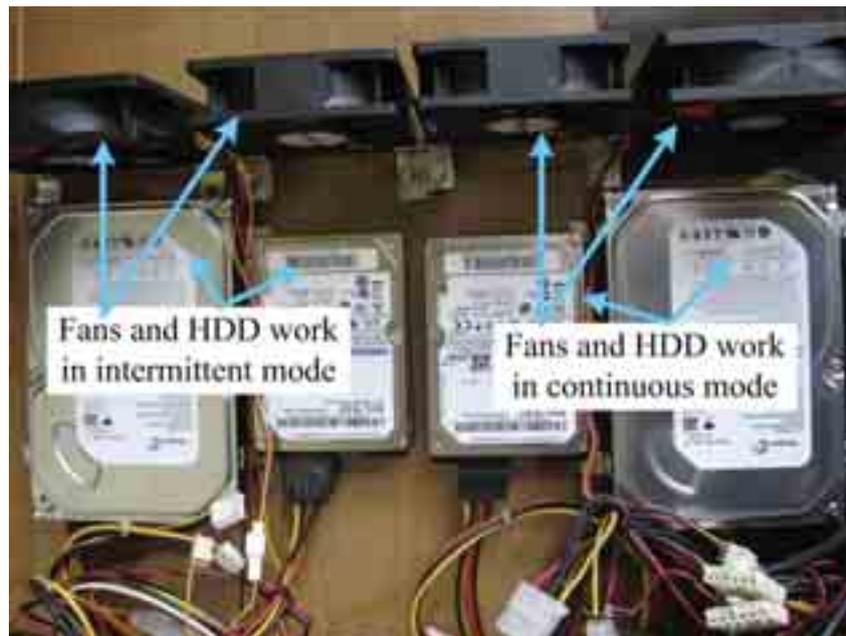
Figure 1 shows the working sets (first set - continuously, second set - intermittently) of computer hard disk drives and cooling fans.

Fig. 1. Working sets of computers hard disk drives and fans

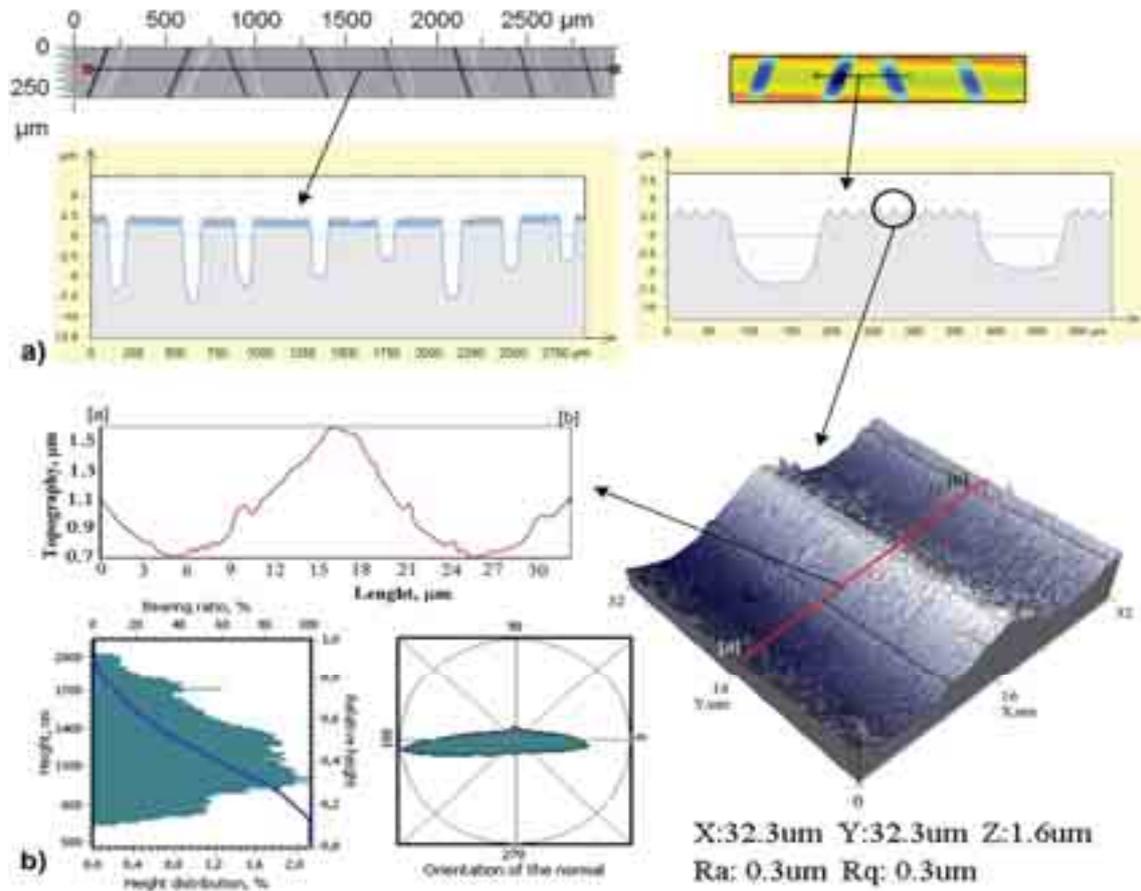
In Fig. 2, besides microgrooves, it can be observed the traces after turning as regular grooves with a width of about 19  $\mu\text{m}$  and depth of 1  $\mu\text{m}$ . The width of the fabricated microgrooves is around 100  $\mu\text{m}$ , depth 5-10  $\mu\text{m}$  and the distance between the grooves is about 300  $\mu\text{m}$ . Treatment traces of surface, presented in Fig. 3, is less evident. It proves the wear of bearing sleeve surface, which was operated in intermittent mode, to be greater.

Fig. 2. Bearing sleeve surface with microgrooves - bearing from Kama Flow SP0825FDB12H – continuous mode

The results of surface topography measurements of Kama Flow SP0825FDB12H fan micro-bearing *sleeve*, which was operated in continuous mode, are illustrated in Fig. 2. Fig. 3 shows the surface topography of Kama Flow SP0825FDB12H fan micro-bearing sleeve, which was operated in intermittent mode. Fig. 2a and 3a present the topographies of investigated surfaces, acquired with the profilometer, while Fig. 2b and 3b show results gained with the atomic force microscope. The surface topography is presented in two and three-dimensional graphs. Furthermore, some selected cross-sections, roughness height distribution and orientation are introduced as well.

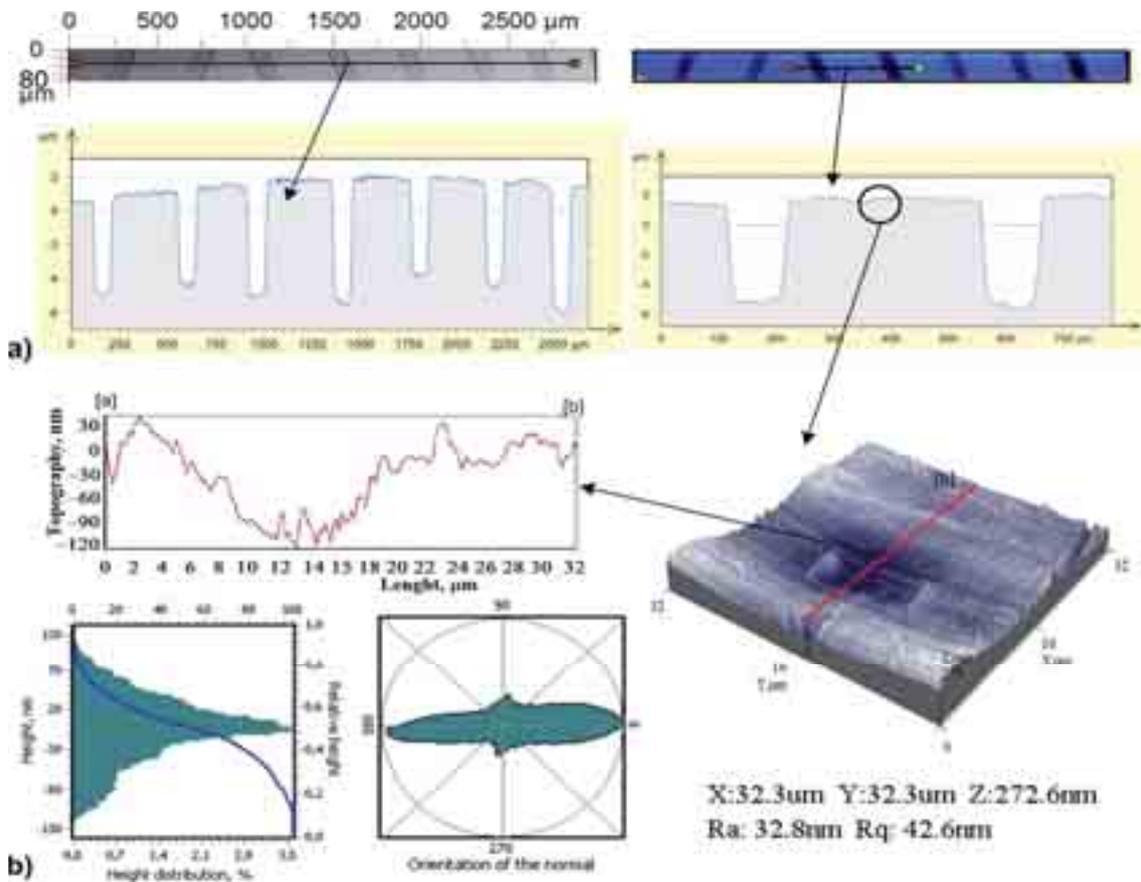
Fig. 3. Bearing sleeve surface with microgrooves - bearing from Kama Flow SP0825FDB12H – intermittent mode

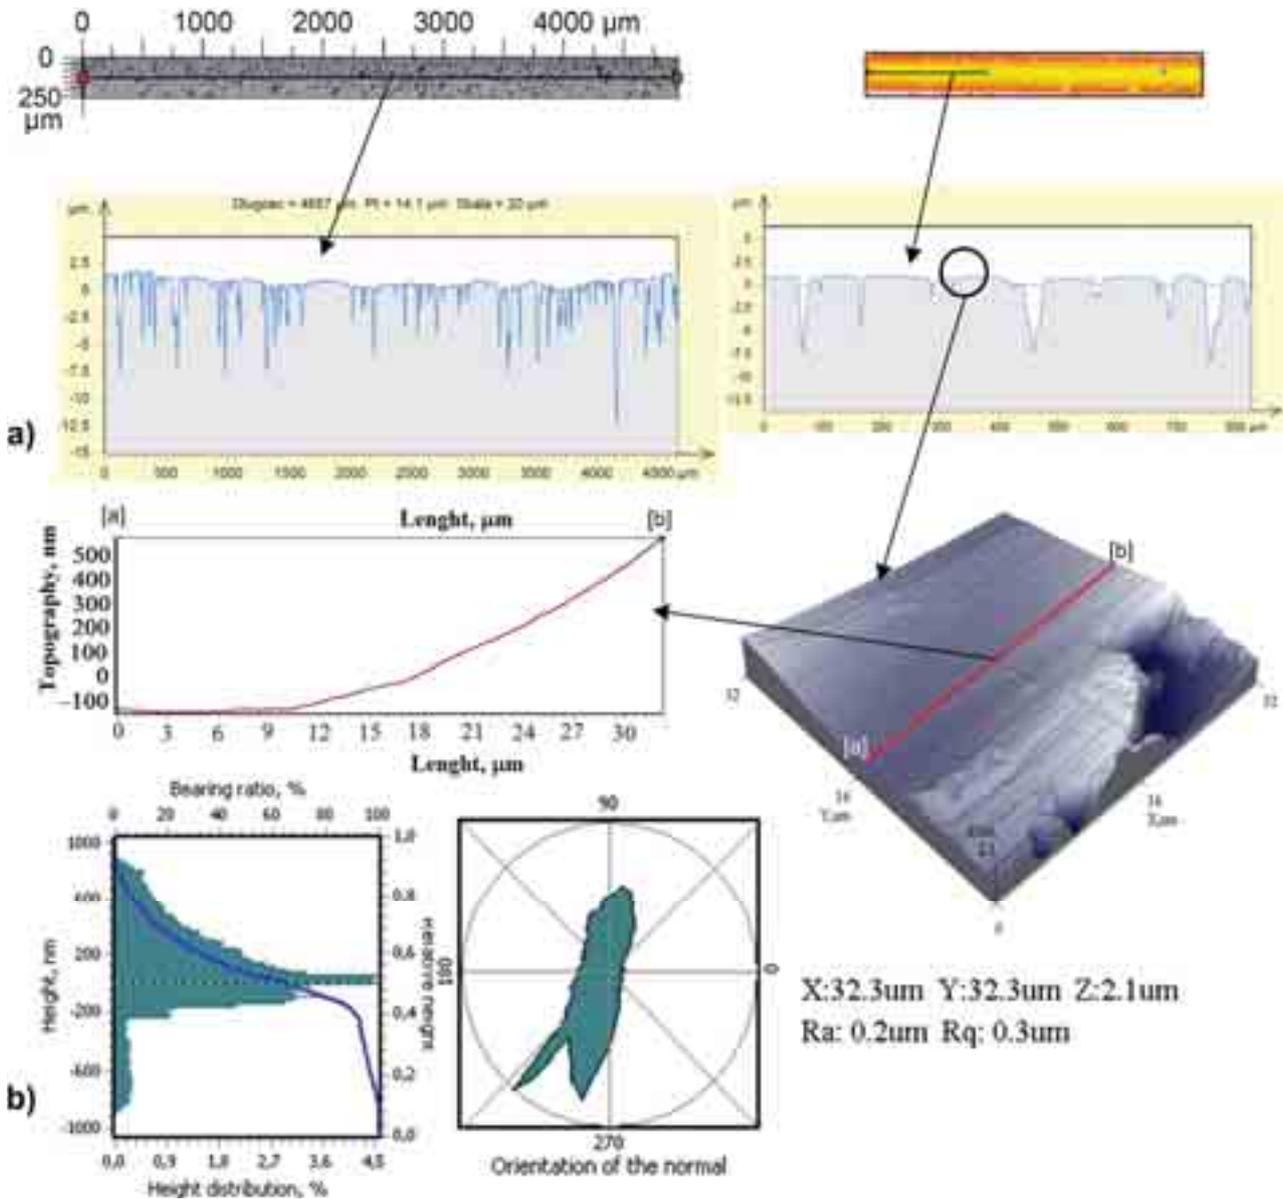
Xilence Case fan bearing sleeve is made of porous and sintered material. It can be seen in Fig. 4b and Fig. 5b as significant irregular cavities on bearing surface.

Fig. 4. Bearing sleeve surface without microgrooves - bearing from Xilence Case – continuous mode

The roughness values of surfaces presented in Fig. 4b and 5b are much higher, in comparison with roughness of other investigated surfaces. It is due to the fact that sleeve material is porous.

The results of surface topography measurements of classical slide micro-bearing, used in Xilence Case computer cooling fan, which worked in continuous mode, are presented in Fig. 4. Surface topography of the same bearing, but used in intermittent mode, is presented in Fig. 5. Fig. 4a and 5a present the topographies of investigated surfaces, achieved with the profilometer, Fig. 4b and 5b with the atomic force microscope.

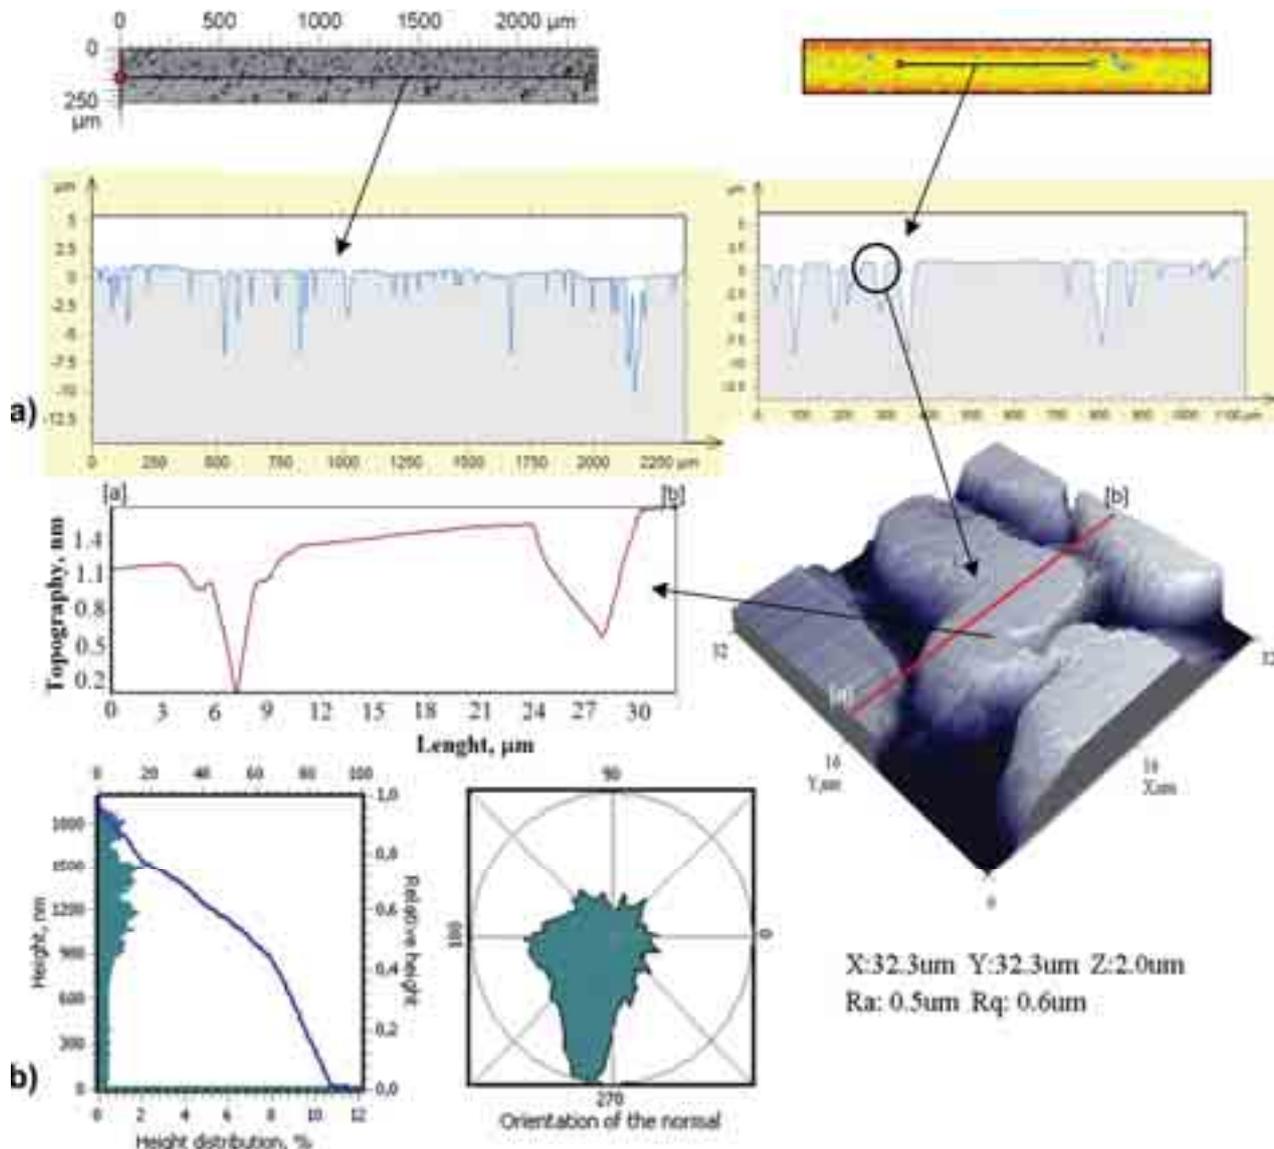
Fig. 5. Bearing sleeve surface without microgrooves - bearing from Xilence Case – intermittent mode

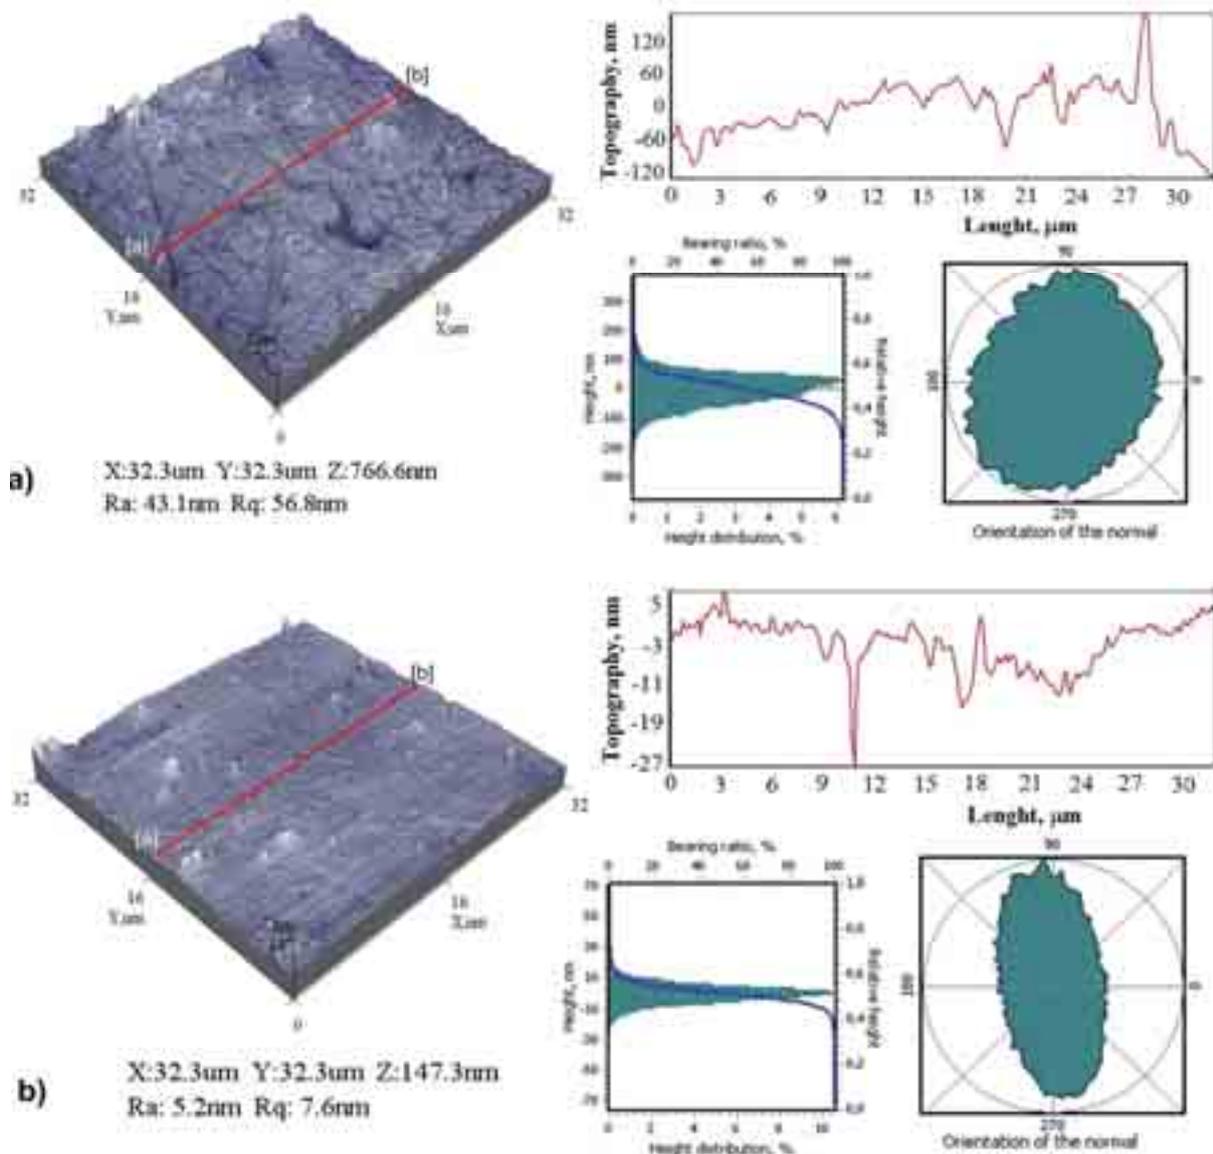
In Fig. 6a, 7a and 7b visible signs of wear of bearing journal (in the form of material loss or scratching) occur. It can be caused by hard inclusions that exist in slide bearing lubricating gap or may be a result of boundary friction between cooperating surfaces of slide micro-bearing.

Fig. 6. Bearing journal surface topography - bearing from Kama Flow SP0825FDB12H: a) continuous mode, b) intermittent mode

Surface topographies of investigated micro-bearings journals are presented in Fig. 6 and 7. Fig. 6 shows results received for Kama Flow SP0825FDB12H fan bearing journal, Fig. 7 presents results for Xilence Case fan bearing journal.

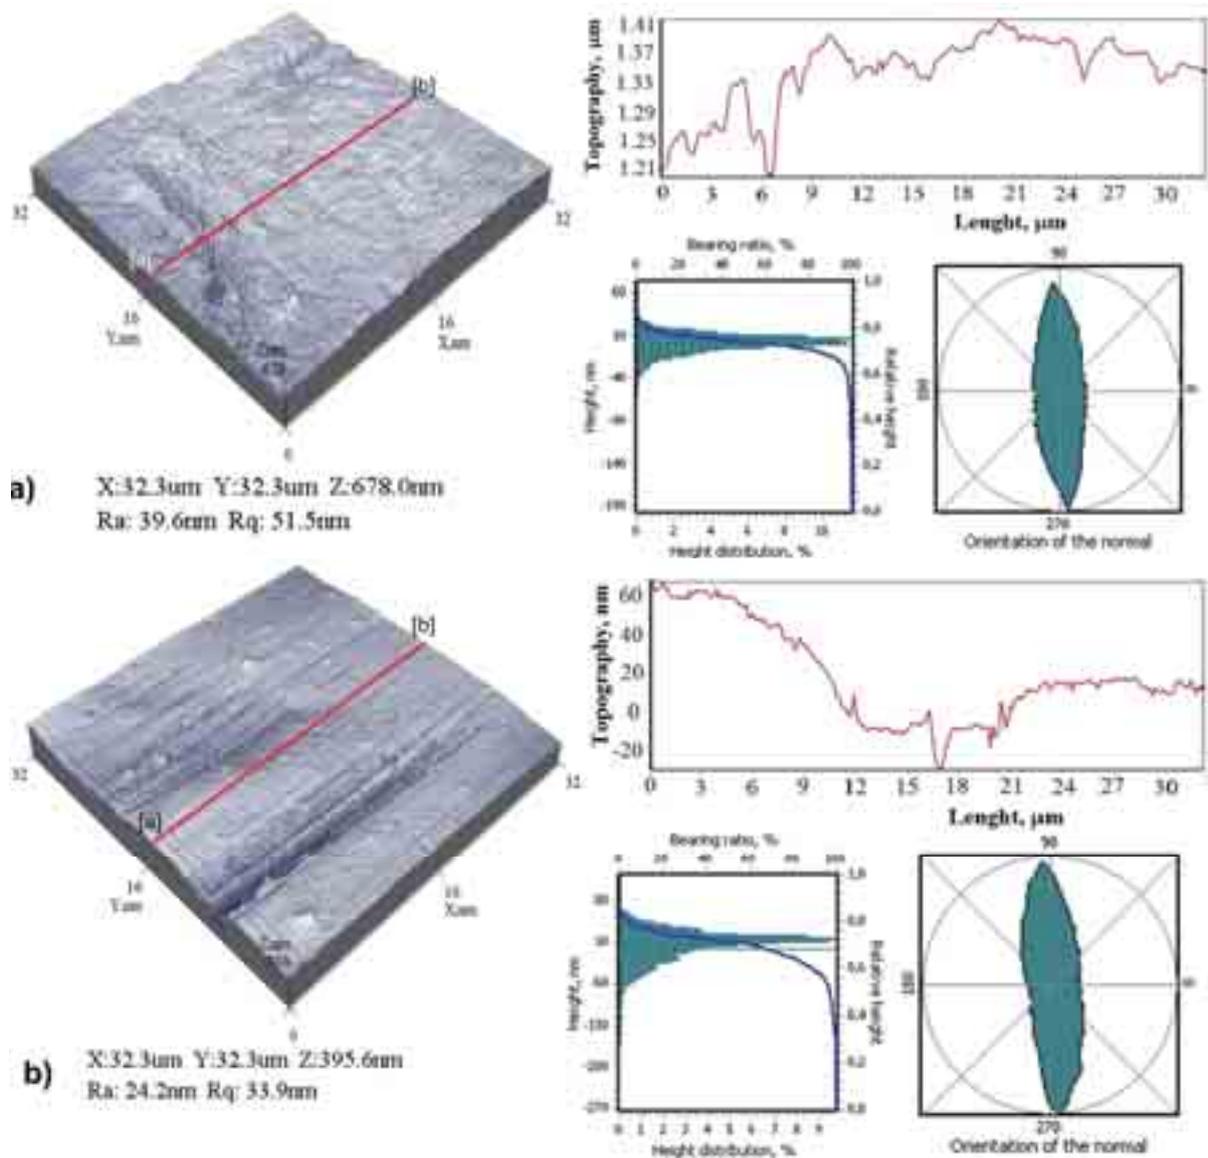
Fig. 7. Bearing journal surface topography - bearing from Xilence Case Fan – continuous mode, a) continuous mode, b) intermittent mode
