EARLY DETECTION OF FATIGUE CRACKS IN TURBINE AERO-ENGINE ROTOR BLADES DURING FLIGHT

Abstract

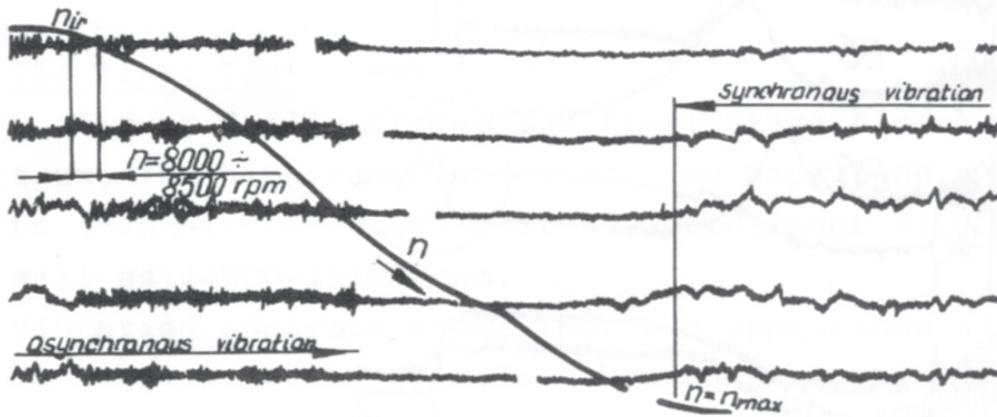
Fig. 1. Typical representation of the first stage compressor blades vibration during engine acceleration

Within the speed range from 8000 to 8500 rpm blade resonance caused by third harmonic of rotational speed is visible. At the end of acceleration phase synchronous blade vibrations (of the first flexural mode) caused by second harmonic of rotational speed can be seen; within the range from 11000 to 14500 rpm blades vibrations are minimal.

engine rotational speed (e.g. compressor blade vibrations caused by rotating stalls). Their essential advantage is that vibrations of all blades of the stage may be examined simultaneously. Typical vibration picture of compressor first stage blades taken by MDPH device during engine acceleration from idling to $n = n_{max}$ is presented on Fig. 1. At the beginning of engine acceleration vibrations asynchronous with rotational speed are visible (stall blade vibrations).

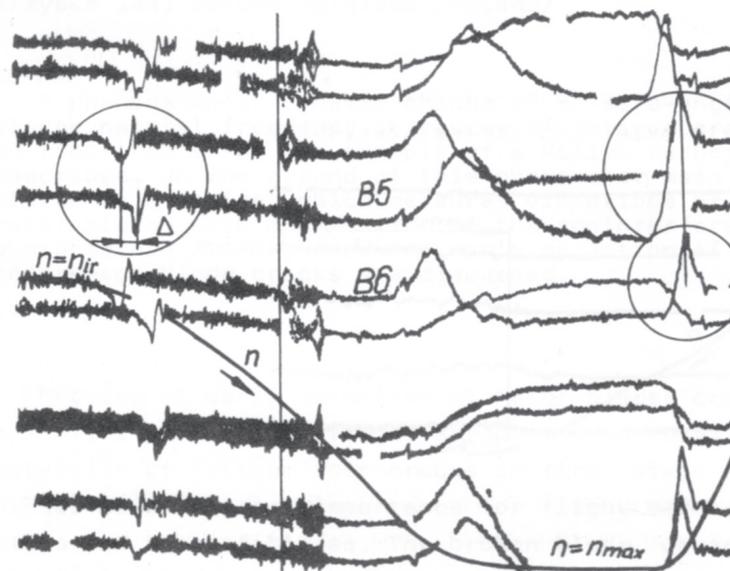
It was investigated that gentle blade vibrations (and stresses) picture observed within the whole speed range is disturbed by ingested foreign objects found on the stator blades (e.g. bird remains). In this case a part of the blades which has previously had only weak resonance is subjected to heavy fluctuation of forces (synchronous with rotational speed). The blades resonance vibrations are heavily amplified (Fig. 2). Stresses within blades are increased along with the amplitude of vibrations which during long flight may lead to initiation and propagation of fatigue cracks in the blades roots.

Fig. 2. Representation of the first stage blades vibration during engine acceleration and deceleration with steady-state stator distortions

Figure 2 illustrates the first stage blades vibration spectrum. The high resonance vibration amplitude of some blades can be seen within the rotational speed range of 8000-8500 rpm as well as 14500-15100 rpm.

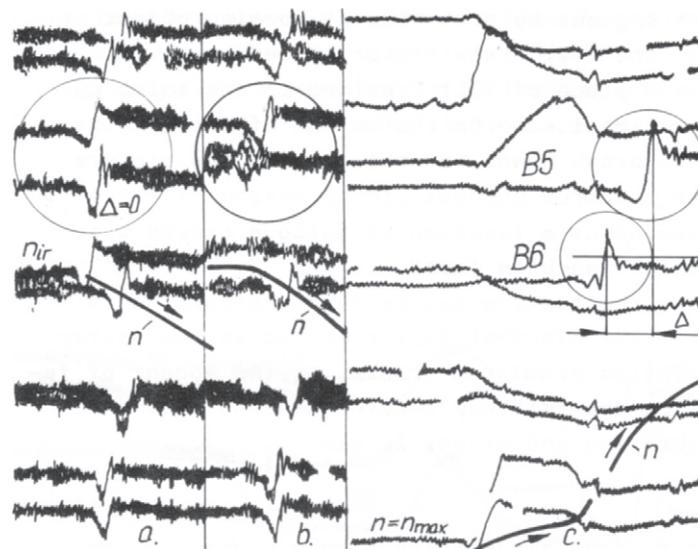
Vibration analysis shows that the appearance of cracks in blades is accompanied by specific changes in initial spectrum of their vibrations (Fig. 3). The frequency of free vibrations of the cracking blade decreases. As a result of this the two above mentioned strong resonance ranges drift towards lower values of rotational speed. In consequence, the first resonance range drops below engine idling. The second resonance range moves also into the direction of lower engine rotational speeds (as the blade crack develops). Relatively quickly this resonance is displaced into the rotational speed range of 13500-14000 rpm in which the resonance never occurs if the blades have no cracks. The overall time of crack propagation in tested engine, up to the moment of blade break-down, has totaled 29 minutes.

Fig. 3. Crack initiation and propagation symptoms in blades number B5 and 86 (compare with Fig. 2), (a) the resonance bandwidth of B5 is found to be near the B4, (b) displacement of the resonance bandwidth of the B5 blade below the engine idling is visible, (c) the resonance bandwidth shift from the scope of 14500-15100 rpm to 13000-13500 rpm is visible

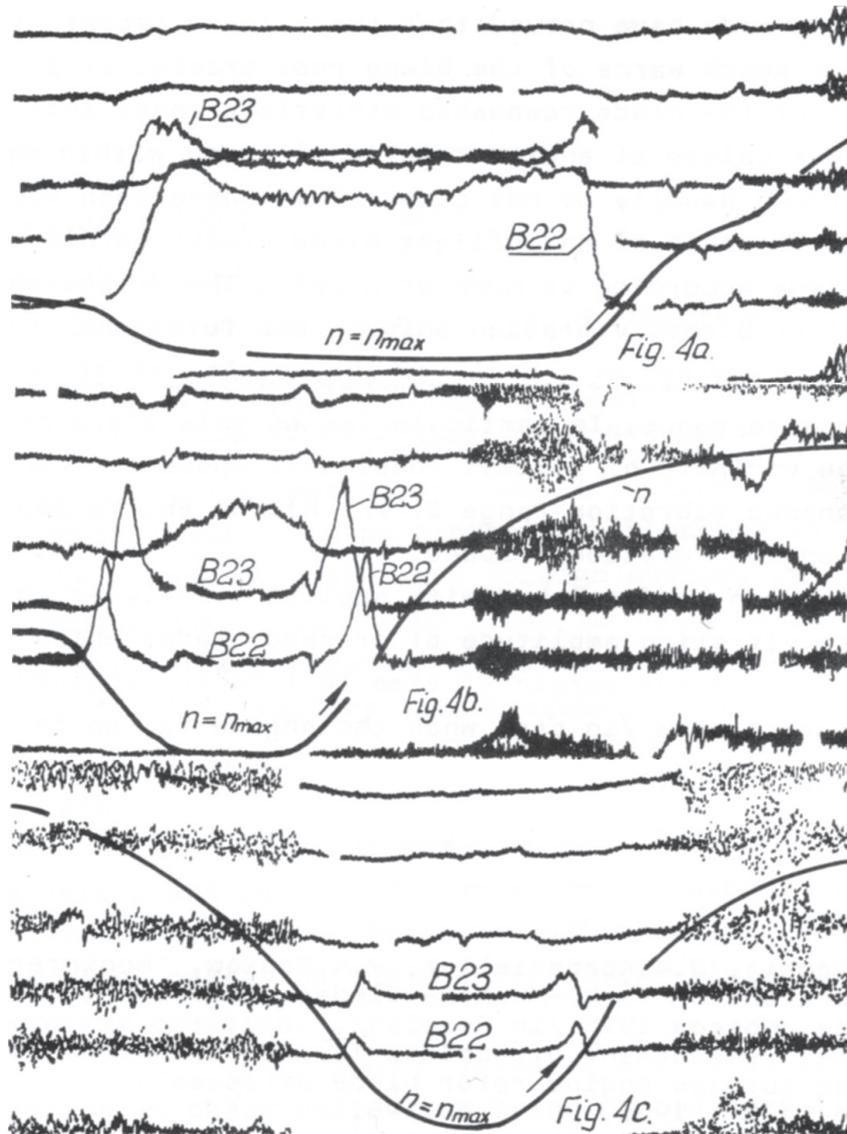
The resulting blades vibrations spectrum taken in conditions of a partial foreign object presence in the stator is demonstrated on Fig. 4a. The engine was run up to the moment of fatigue cracks initiation within the blades (Fig. 4b) and then the engine was shut down and the felt removed from the inlet. Next the engine was rerun and the blades vibration spectrum was registered (Fig. 4c).

Fig. 4. Comparison of blade vibration spectra of the same blades for different conditions, (a) with steady-state stator distortions, (b) cracked blades (steady-state stator distortions), (c) cracked blades (normal flow conditions)

Comparison of both vibration spectra taken demonstrates that the vibration spectrum of cracked blades essentially differs from that of blades without cracks (like in the first test) though the blades measurements indicated that the cracks affected only about 15% of blade cross-section. In total, engine was run, about 16 hrs. from the moment of cracks appearance on three blades up to the break-down of one of them.

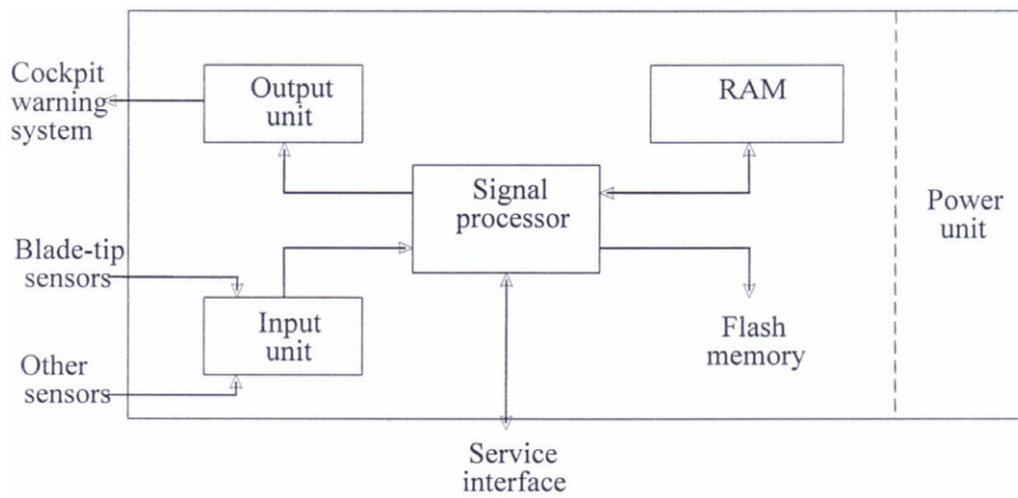
Fig. 5. Diagram of onboard computer

Development of the system requires detailed knowledge on the engine dynamics and aircraft design. The onboard software includes built-in models of the engine and its sub-assemblies and also experimentally set threshold values.

The system inform the pilot only about failures of higher priority and then advise him special procedure. Minor malfunctions and exceedances are reported only to ground personnel. Data from flights are transferred to ground database system. It gathers data generated by onboard computers from the whole fleet. The ground database handles reach engine health and usage information, which could be searched, analyzed. The software looks for suspicious trends and advice maintenance actions.
