# EARLY DETECTION OF FATIGUE CRACKS IN TURBINE AERO-ENGINE ROTOR BLADES DURING FLIGHT

**Ryszard Szczepanik**

*Air Force Institute of Technology,  
Księcia Bolesława Street 6, 01-494 Warsaw, Poland  
tel.: +48 22 6851101, fax: +48 22 8364471  
e-mail: ryszard.szczepanik@itwl.pl*

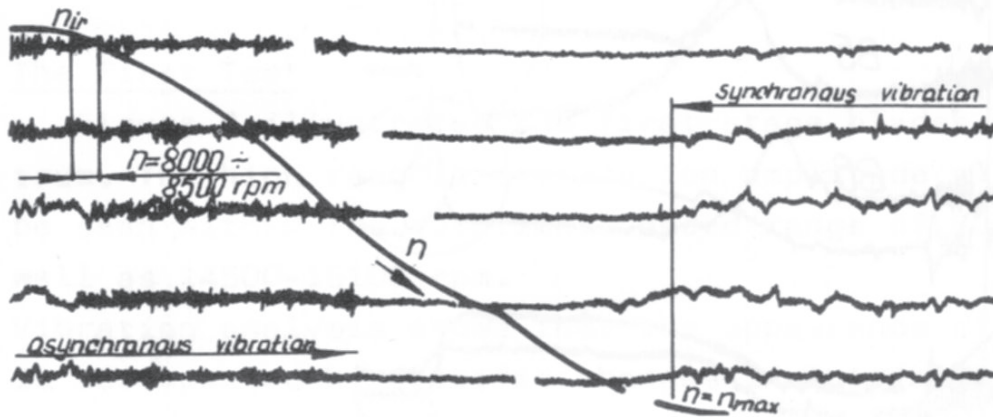
Fig. 1. Typical representation of the first stage compressor blades vibration during engine acceleration

Within the speed range from 8000 to 8500 rpm blade resonance caused by third harmonic of rotational speed is visible. At the end of acceleration phase synchronous blade vibrations (of the first flexural mode) caused by second harmonic of rotational speed can be seen; within the range from 11000 to 14500 rpm blades vibrations are minimal.

engine rotational speed (e.g. compressor blade vibrations caused by rotating stalls). Their essential advantage is that vibrations of all blades of the stage may be examined simultaneously. Typical vibration picture of compressor first stage blades taken by MDPH device during engine acceleration from idling to  $n = n_{\max}$  is presented on Fig. 1. At the beginning of engine acceleration vibrations asynchronous with rotational speed are visible (stall blade vibrations).

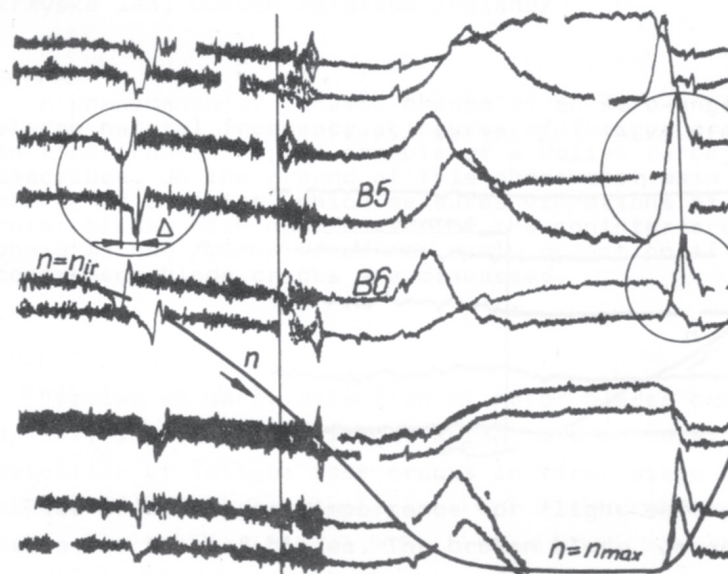
Fig. 2. Representation of the first stage blades vibration during engine acceleration and deceleration with steady-state stator distortions

Figure 2 illustrates the first stage blades vibration spectrum. The high resonance vibration amplitude of some blades can be seen within the rotational speed range of 8000-8500 rpm as well as 14500-15100 rpm.

It was investigated that gentle blade vibrations (and stresses) picture observed within the whole speed range is disturbed by ingested foreign objects found on the stator blades (e.g. bird remains). In this case a part of the blades which has previously had only weak resonance is subjected to heavy fluctuation of forces (synchronous with rotational speed). The blades resonance vibrations are heavily amplified (Fig. 2). Stresses within blades are increased along with the amplitude of vibrations which during long flight may lead to initiation and propagation of fatigue cracks in the blades roots.

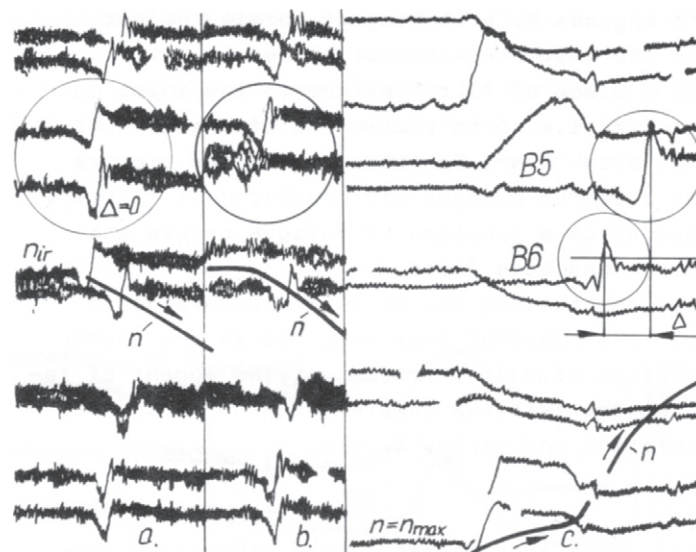
Vibration analysis shows that the appearance of cracks in blades is accompanied by specific changes in initial spectrum of their vibrations (Fig. 3). The frequency of free vibrations of the cracking blade decreases. As a result of this the two above mentioned strong resonance ranges drift towards lower values of rotational speed. In consequence, the first resonance range drops below engine idling. The second resonance range moves also into the direction of lower engine rotational speeds (as the blade crack develops). Relatively quickly this resonance is displaced into the rotational speed range of 13500-14000 rpm in which the resonance never occurs if the blades have no cracks. The overall time of crack propagation in tested engine, up to the moment of blade break-down, has totaled 29 minutes.

Fig. 3. Crack initiation and propagation symptoms in blades number B5 and 86 (compare with Fig. 2), (a) the resonance bandwidth of B5 is found to be near the B4, (b) displacement of the resonance bandwidth of the B5 blade below the engine idling is visible, (c) the resonance bandwidth shift from the scope of 14500-15100 rpm to 13000-13500 rpm is visible

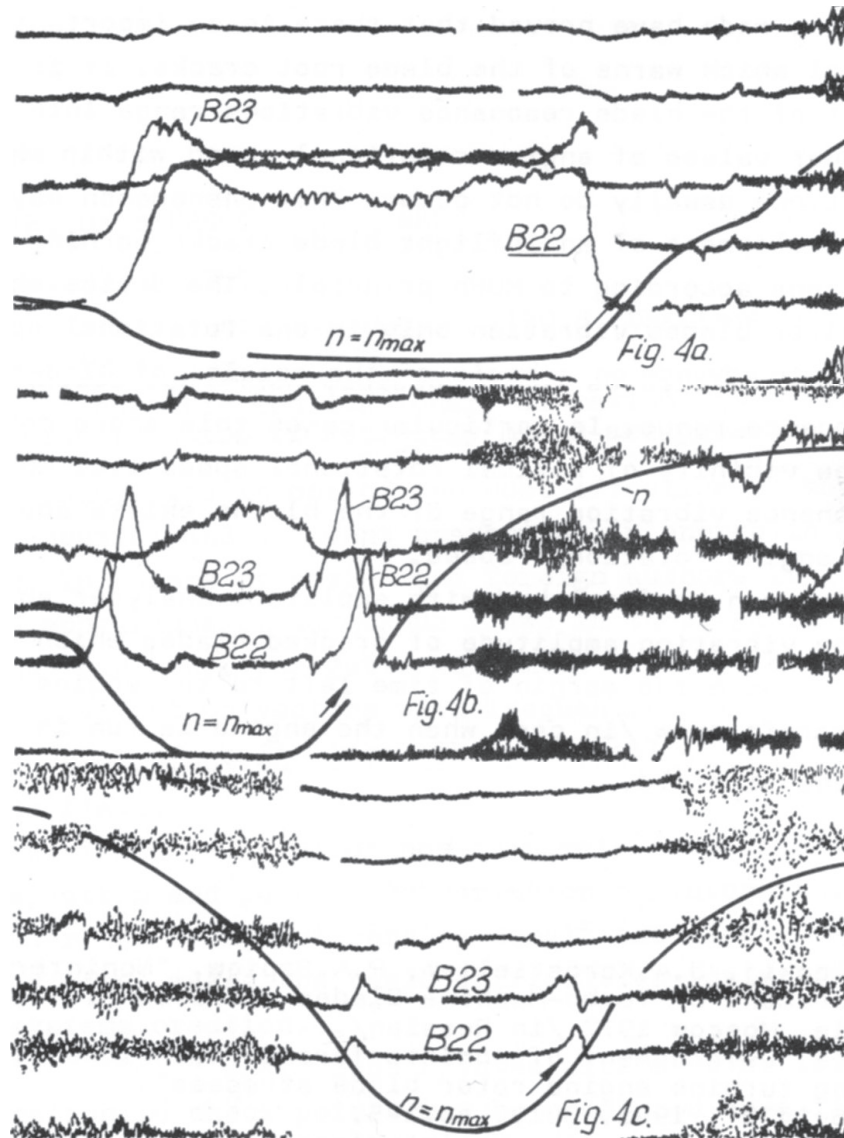
The resulting blades vibrations spectrum taken in conditions of a partial foreign object presence in the stator is demonstrated on Fig. 4a. The engine was run up to the moment of fatigue cracks initiation within the blades (Fig. 4b) and then the engine was shut down and the felt removed from the inlet. Next the engine was rerun and the blades vibration spectrum was registered (Fig. 4c).

Fig. 4. Comparison of blade vibration spectra of the same blades for different conditions, (a) with steady-state stator distortions, (b) cracked blades (steady-state stator distortions), (c) cracked blades (normal flow conditions)

Comparison of both vibration spectra taken demonstrates that the vibration spectrum of cracked blades essentially differs from that of blades without cracks (like in the first test) though the blades measurements indicated that the cracks affected only about 15% of blade cross-section. In total, engine was run, about 16 hrs. from the moment of cracks appearance on three blades up to the break-down of one of them.

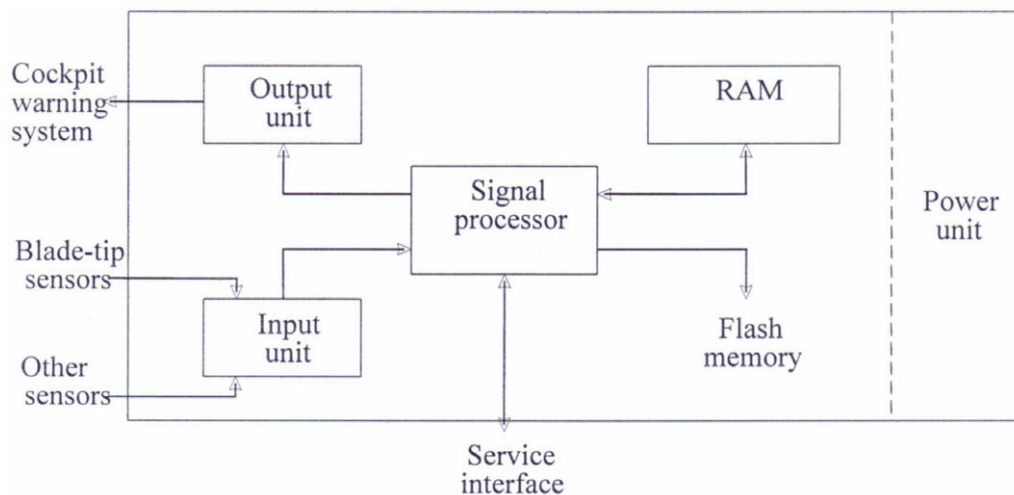
Fig. 5. Diagram of onboard computer

Development of the system requires detailed knowledge on the engine dynamics and aircraft design. The onboard software includes built-in models of the engine and its sub-assemblies and also experimentally set threshold values.

The system inform the pilot only about failures of higher priority and then advise him special procedure. Minor malfunctions and exceedances are reported only to ground personnel. Data from flights are transferred to ground database system. It gathers data generated by onboard computers from the whole fleet. The ground database handles reach engine health and usage information, which could be searched, analyzed. The software looks for suspicious trends and advice maintenance actions.
