## ATTEMPT OF INJECTORS FAILURE DETECTION BASED ON MEASUREMENT OF THE ANGULAR SPEED DISCRETE VALUE

The paper presents results of the experiment focused on detection of faulty injector of medium speed diesel engine, in way of analysis of IAS (Instantaneous Angular Speed) of the crankshaft. The experiment was carried out at laboratory stand in Gdynia Maritime University, equipped with diesel engine Sulzer 3AL 25/30 driving electro-generator. Sulzer 3AL 25/30 is three cylinder, medium speed, four stroke marine diesel engine, with maximum output 400 kW at 750 rpm. In order to evaluate of IAS utility for diagnosis of the engine, two kinds of wrong adjustment of fuel injection valve's spring were simulated. First malfunction was too weak spring (initial tension of 15.0 MPa against 25.0 MPa in normal condition), the second was too strong tension of the spring (35.0 MPa). The base of experiment was to angular speed recording, in three different conditions of the engine: healthy one and with two simulated malfunctions. Measurements were carried out at two different loads, respectively 150 kW and 250 kW. The IAS was measured and recorded by the measurement system ETNP-10, which mode of oper

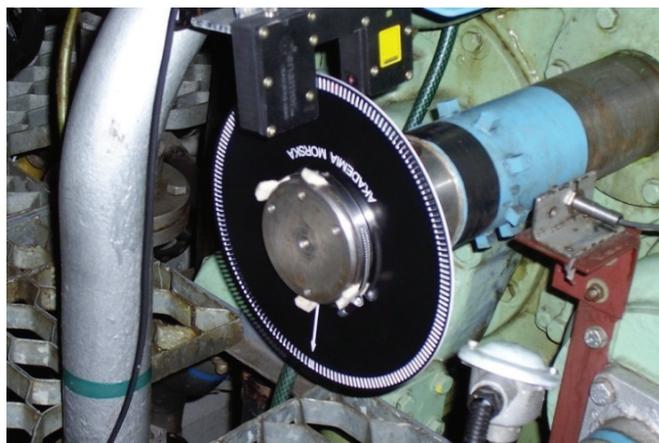
Fig. 1. Perforated disc and laser sensor mounted at crankshaft's free end

The rig for carrying out the experiment consist of instantaneous angular speed measurement set consisting of perforated disc and optical sensor, Fig. 1, and data processing and storage block ETNP – 10.

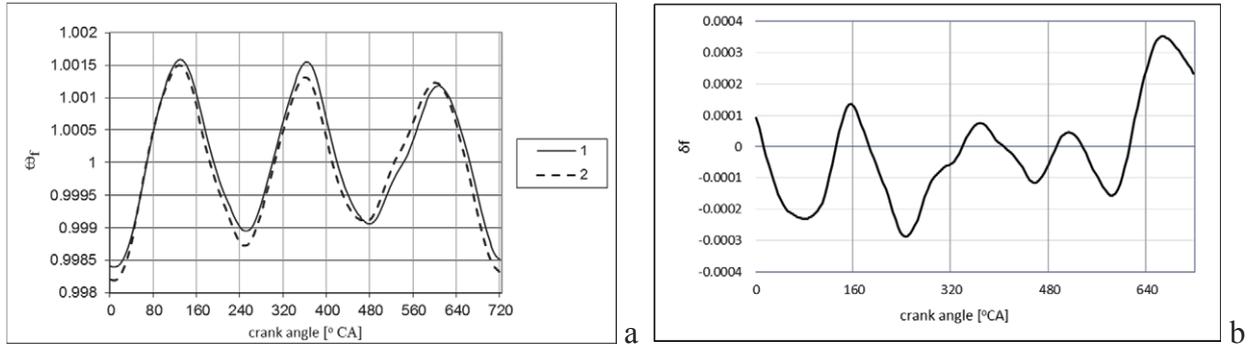
Fig. 2. Runs of relative angular speed of healthy engine (line 1) and faulty (line 2) – a, and related to that failure values of parameter  $\delta_f$  – b

possible and whether evaluation of severity (fault level) of malfunction is possible. Answers for all above questions shall come from one source – analysis of angular speed deviation. For detecting and localisation of malfunctions, three diagnostic parameters were elaborated. First one was designated as a difference between relative angular speed of runs with simulated malfunction and healthy engine. Example of runs of healthy and faulty condition comparison and the curve of coefficient  $\delta_f$  are presented in Fig. 2.

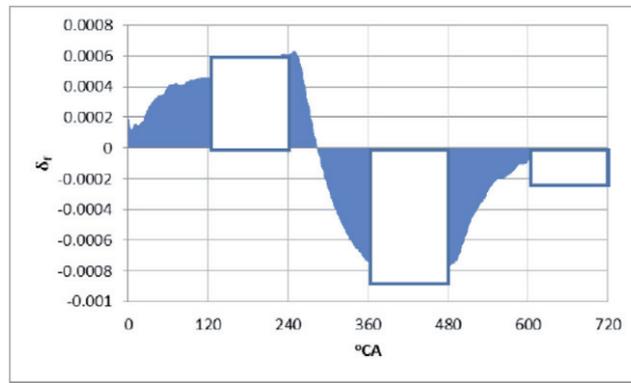
Fig. 3. Determining of the area underneath of  $\delta_f$  curve in selected angular intervals

Second parameter was designated as an area underneath the  $\delta_f(\alpha)$  curve, within angular interval starting from TDC (Top Dead Centre) when injection occurs, and with interval width depending on number of cylinders. Method of parameters’ designation is presented in Fig. 4. It represents changes of kinetic energy in reference to healthy run. The width of the interval for three-cylinder engine was established at level of  $180^\circ$  of CA, because of broad angular distance between injections ( $240^\circ$ ).

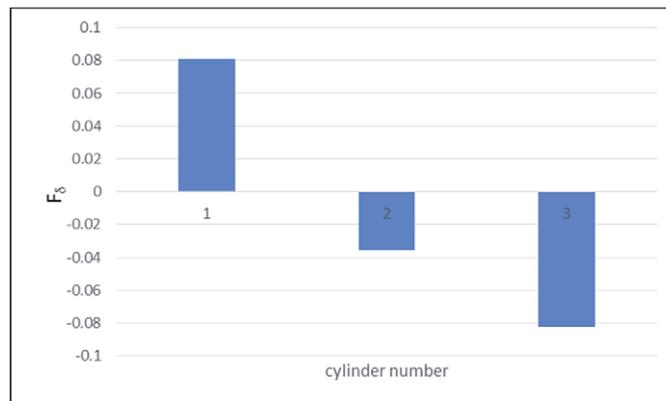
Fig. 4. Example of pattern of diagnostic parameter  $F_\delta$  for 3-cylinder engine

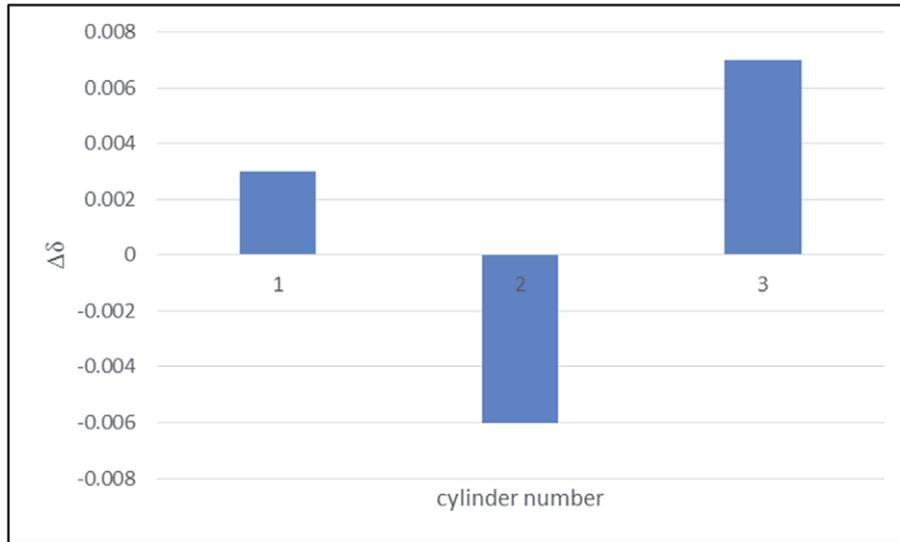
Fig. 5. Example pattern of diagnostic parameter  $\Delta\delta$  of 3-cylinder engine

Third parameter was a difference of  $\delta_f$  value in the end and the beginning of interval and was signed as  $\Delta\delta$ . Example of parameter's values for three cylinders is presented in Fig. 5. This parameter describes general tendency of relative angular speed changes in angular interval between TDC's of subsequent working strokes.

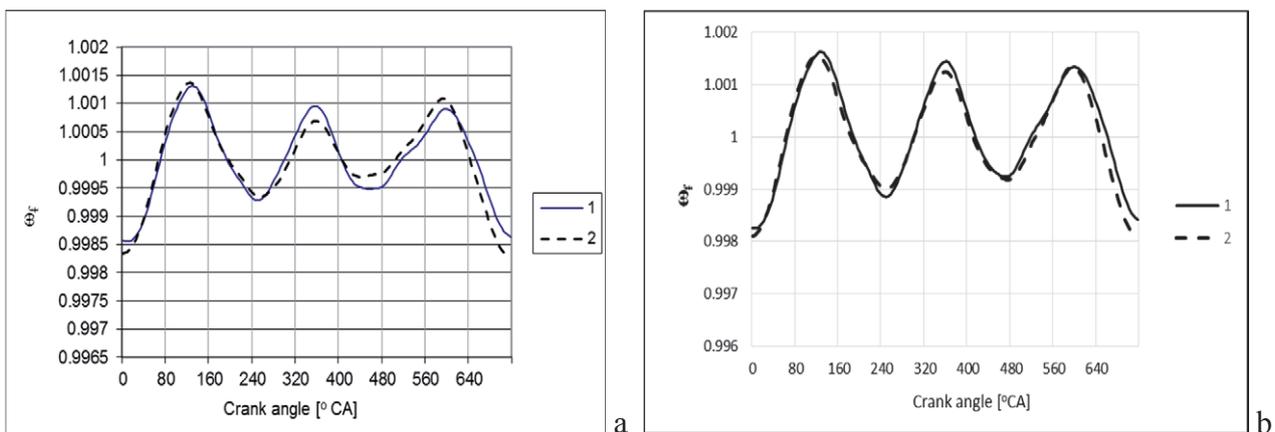
Fig. 6. Angular speed variations of healthy engine (2) and “weak spring” (1): a – load 150 kW; b – load 250 kW

First simulated malfunction was the incorrect return spring adjustment set at 15.0 MPa instead of required 25.0. Faulty injector was installed in second cylinder. Measurements were carried out at load of 150 kW and subsequently at 250 kW. Every record consisted of 10 revolutions (5 cycles) and was repeated three times for further averaging. Averaged record was smoothed using triple noise decomposition by Savitzky – Golay Filter. After smoothing, the curve was compared with healthy engine run and diagnostic coefficient were calculated. Results of attempt of detection weak spring malfunction are presented below. Comparison of runs of healthy engine and with malfunction are presented in Fig. 6.

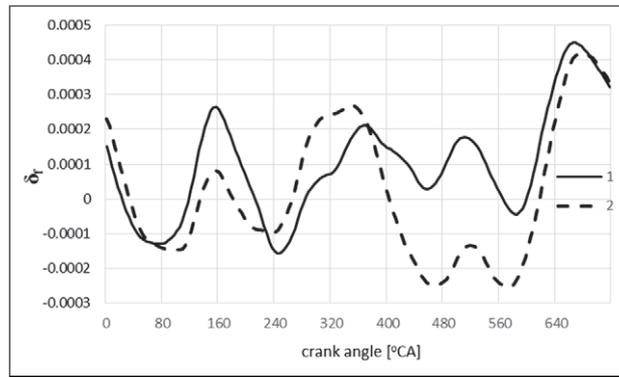
Coefficient  $\delta_f$  presented in Fig. 7 reflects deviations from healthy run. Maximum value of deviation's span is about 23% of maximum value of healthy engine fluctuation. The picture shows difference between runs, in interval of 320°-600° CA, what indicates influence of load at angular speed disturbance due to malfunction of the injection valve.

Fig. 7. Values of parameter  $\delta_f$  “weak spring”: 1 – load 250 kW, 2 – load 150 kW

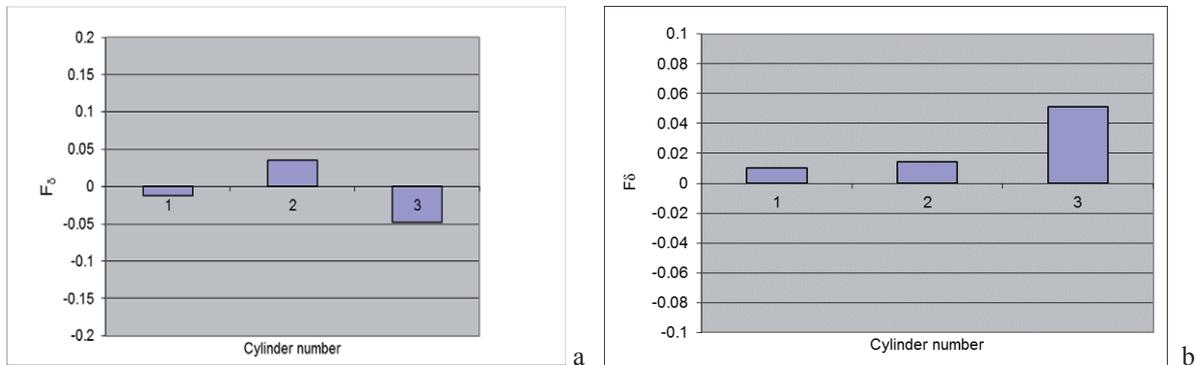
Coefficient  $F_\delta$  presented in Fig. 8 shows tendency of changes of kinematic energy of rotation. Irregularity of pattern indicates that engine is in state of malfunction. The biggest deviation from normal condition is observed in zone of the 2<sup>nd</sup> cylinder, at load of 150 kW, and the 3<sup>rd</sup> cyl. at load of 250 kW.

Fig. 8. Pattern of coefficient  $F_\delta$  “weak spring”: a – load 150 kW, b – load 250 kW

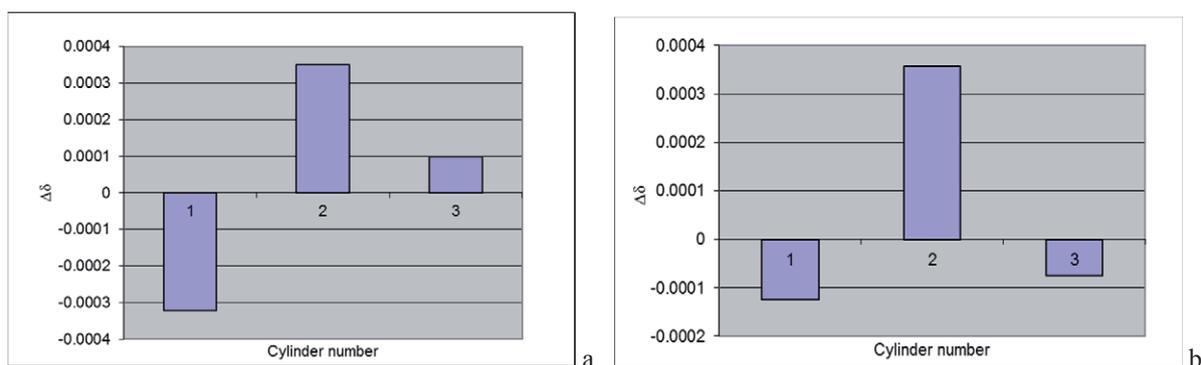
Coefficient  $\Delta\delta$  presented in Fig. 9. shows general tendency of relative angular speed deviation from normal condition run. This parameter points faulty cylinder in way of comparison of absolute values, where highest value indicates the faulty one.

Fig. 9. Pattern of coefficient  $\Delta\delta$  “weak spring”: a – load 150 kW; b – load 250 kW – b

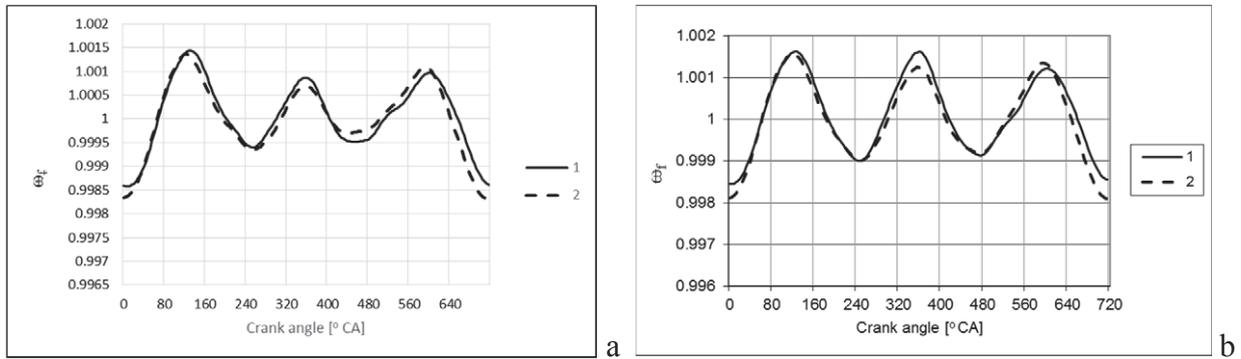
Fig. 10. Angular speed variations of healthy engine (2) and “strong spring” (1): a – load 150 kW; b – load 250 kW

calculated. Results of attempt of detection of the “strong spring” malfunction are presented below. Runs comparison is presented in Fig. 10, coefficient  $\delta_f$  in Fig. 11, coefficient  $F_\delta$  in Fig. 12 and coefficient  $\Delta\delta$  in Fig. 13.

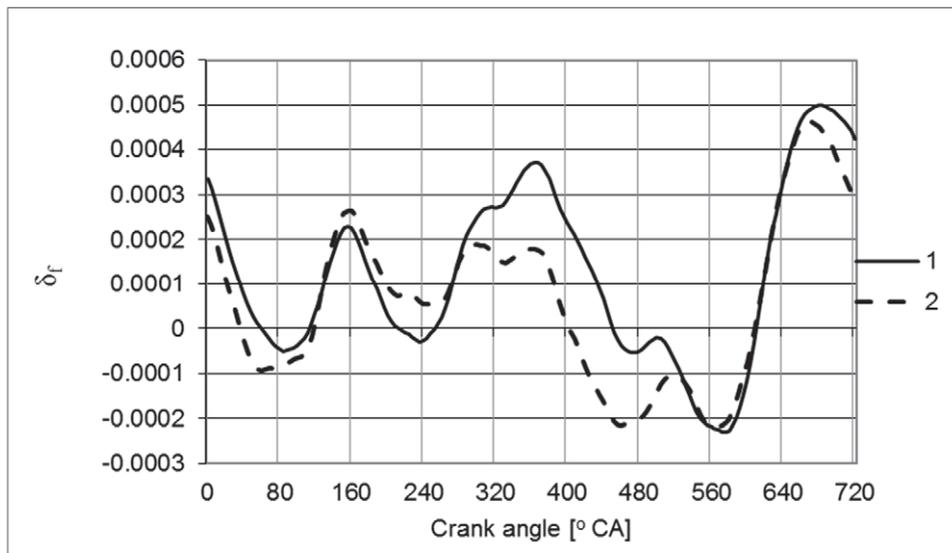
Coefficient  $\delta_f$  presented in Fig. 11 shows deviations from healthy run. Maximum value of deviation’s span is about 33% of maximum value of the healthy engine fluctuation, what is 10% higher than recorded for “weak spring”. Picture shows difference between runs in interval of 320°–540° CA, what indicates influence of the engine load at value of deviation caused by the injection valve malfunction.

Fig. 11. Values of parameter  $\delta_\omega$  for “strong spring”: 1 – load 250 kW, 2 – load 150 kW

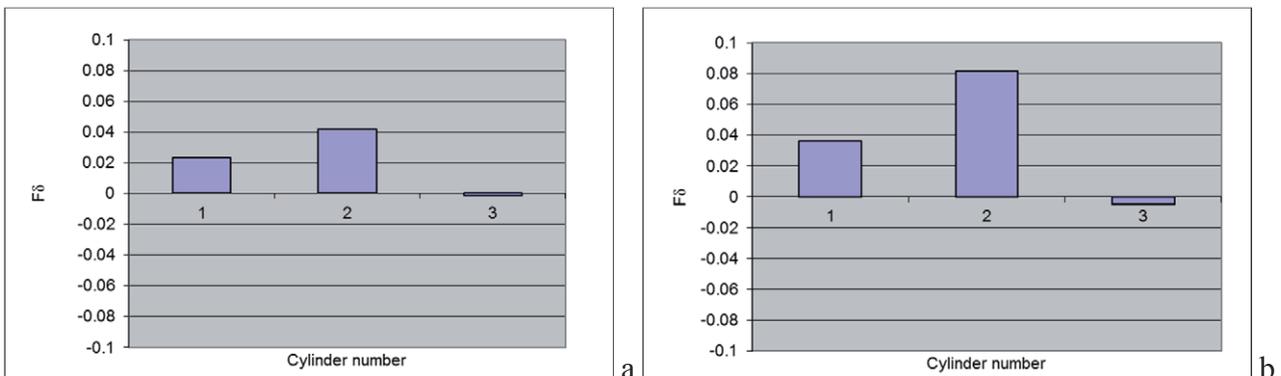
Fig. 12. Pattern of coefficient  $F_\delta$  for “strong spring”: a – load 150 kW, b – load 250 kW

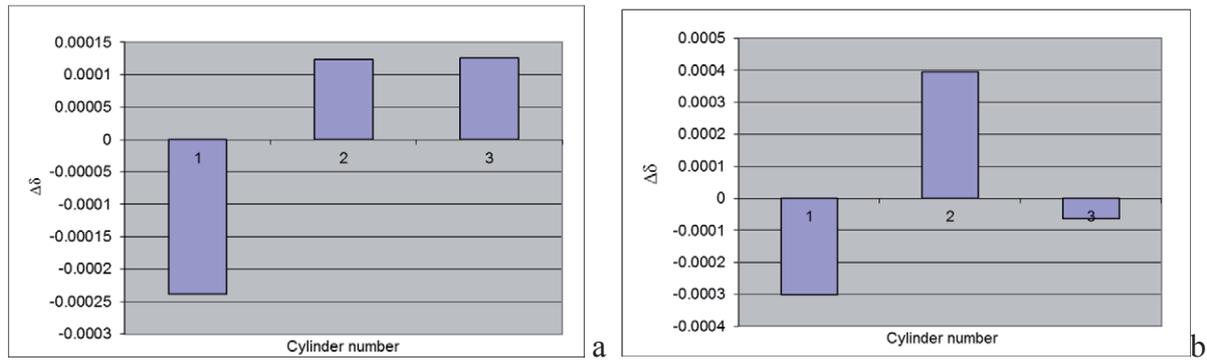
Fig. 13. Pattern of coefficient  $\Delta\delta$  for "strong spring", a – load 150 kW; b – load 250 kW
