## EXPERIMENTAL RESEARCHES OF DYNAMIC LOADS OF ARMoured PERSONNEL CARRIER AND ITS CREW DURING COLLISION WITH RIGID OBSTACLE AND ALL-TERRAIN VEHICLE

### Abstract

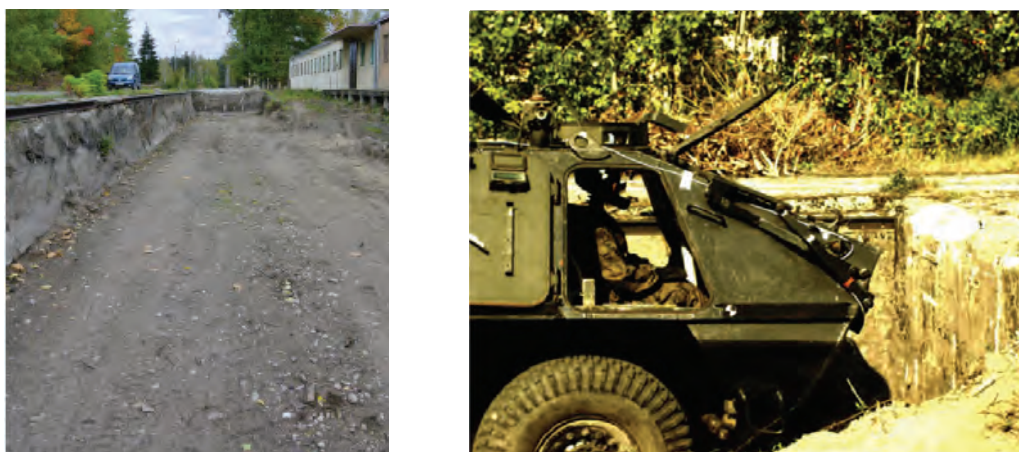
Figure 1 presents a view of a track finished with a rigid retaining wall and a personnel carrier prepared for a crash test.

*Fig. 1. The view of a test track with a rigid retaining wall and a personnel carrier prepared for a crash test*

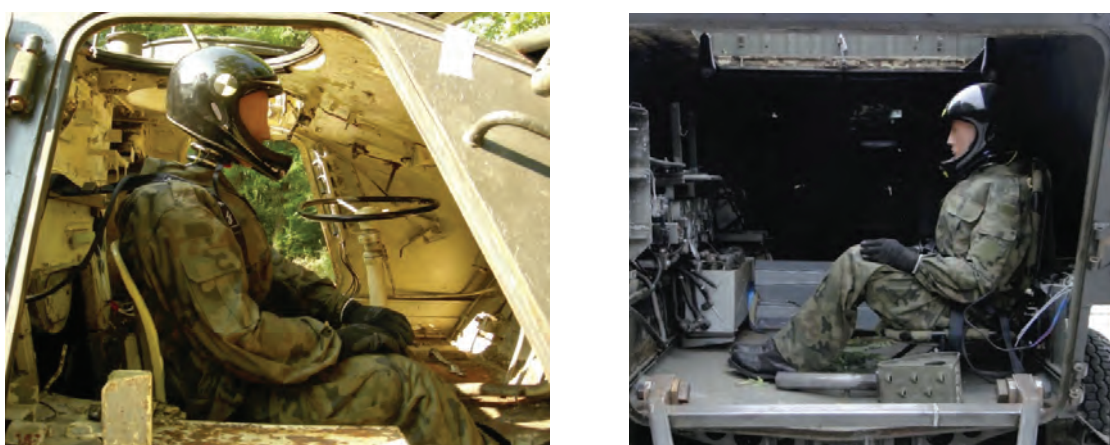
During crash tests, anthropomorphic measurement equipment – Hybrid III 50th Male Dummy [5] type – was used for recording the values of loads affecting the soldiers. 50-centile male test dummy Hybrid III is the most common dummy used in the automotive industry. It is used to evaluate the safety and structure. It allows acquisition of physical values truly reflecting a possible influence on a human body. That kind of equipment is basically designed for frontal car crash tests. A dummy located in the driver compartment was placed on a standard seat of the SKOT vehicle, without a headrest, and fastened with four-point seat belts. A dummy located in the landing troop compartment was placed on a seat making standard equipment for an APC Rosomak and it was fastened with a lap belt (Fig. 2).

*Fig. 2. A dummy located in the driver compartment (left) and in the landing troop compartment (right)*

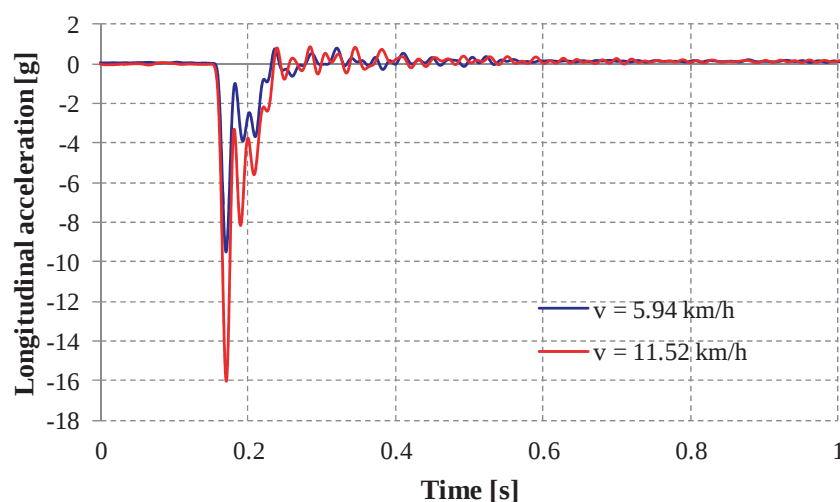
Courses of analysed values, recorded during experimental tests, were subject to filtration and scaling. In relation to the body acceleration, a digital filter in accordance with CFC60 was used. Its limit frequency amounts to 100 Hz. Fig. 3 presents examples of longitudinal acceleration courses for two impact velocities: 5.94 and 11.52 km/h. In all cases, courses of the body decelerations are very similar. Differences only refer to obtained extreme values. Deceleration duration amounted to about 80 ms. At this time the carrier was stopped and then was rebounded from the retaining wall.

Fig. 3. Comparison of the longitudinal acceleration for the trial 3 and 4

Figure 5 specifies chosen phases of collision with a concrete obstacle for a trial no. 4. The impact took place at 150 ms of the measurement time (according to the courses in Fig 3 and 8).

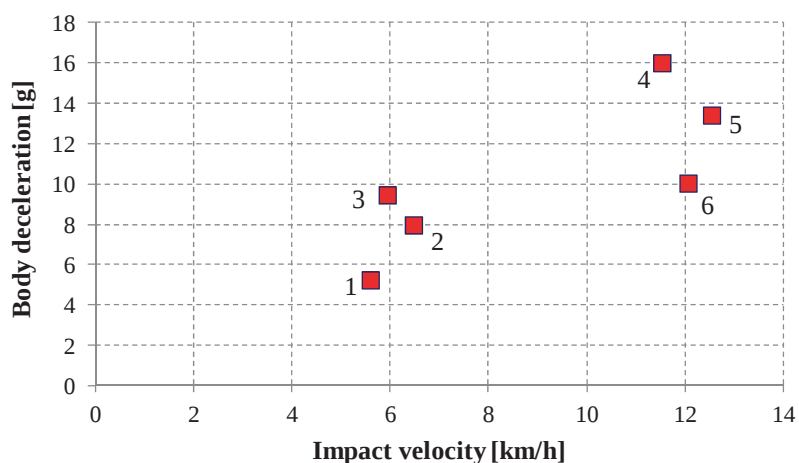
Table 1 specifies, defined on the basis of analysis of the records from the fast video cameras, real impact velocities and recorded maximum body deceleration values in the landing troop compartment for individual trials. Obtained results are illustrated in Fig. 4.

Higher homogeneity of obtained results can be observed for lower impact velocities (trials 1-3), however a close relation between velocity and deceleration has not been obtained. It was mostly caused by the fact that the carrier did not always move perpendicularly towards the frontal surface of the barrier at the final stage of motion.

Much higher dispersion in obtained results was observed for trials 4-6. Increased velocity negatively affects a possibility of directing the carrier on the obstacle. Moreover, in case of higher impact velocities, there was a minor damage to the upper edge of the retaining wall and the front section of the carrier was increasingly tossing up. And also, the front armour plate was broken.

Fig. 4. The distribution of maximum body deceleration

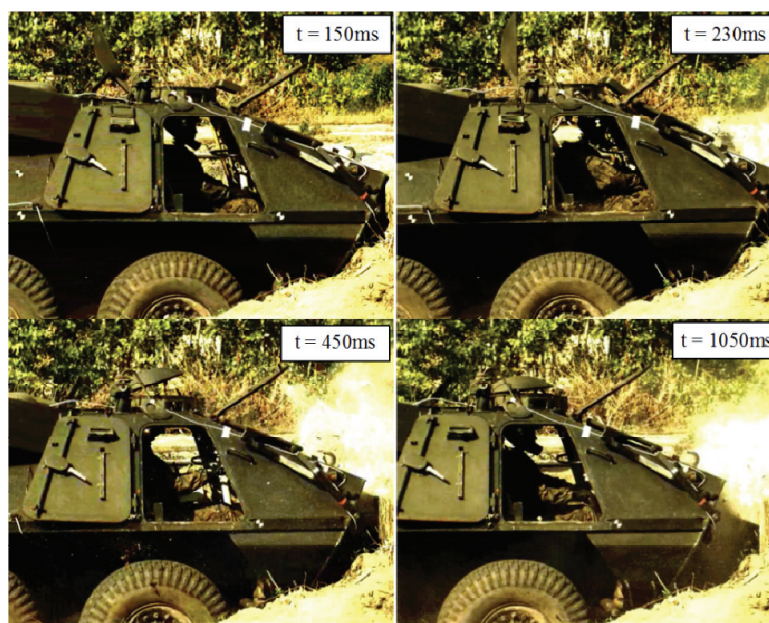
Fig. 5. Phases of APC collision with a concrete obstacle (trial no. 4)

Due to a rigid structure of the body, no significant body deformations were recorded. Only the carrier motion stopping is visible on it and then its recoil from the wall as well as the dummy motion in the driver's compartment. The carrier stopped after about 900 ms from the moment of impact.

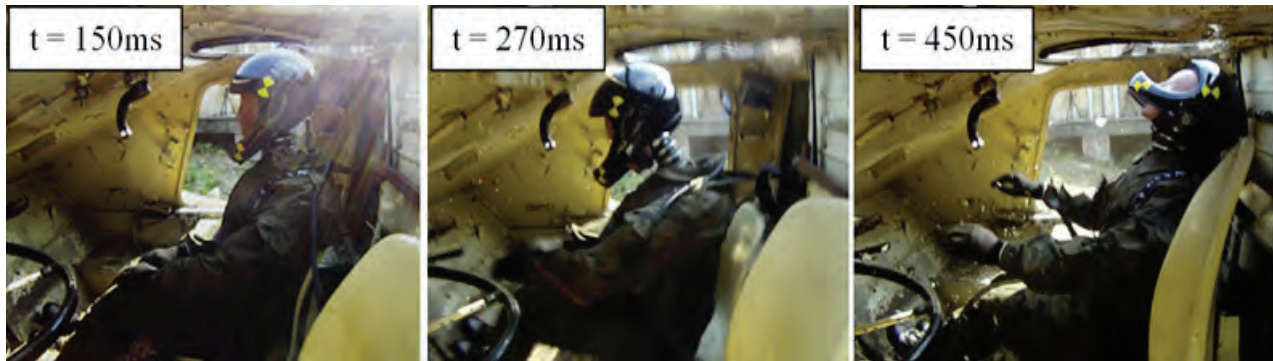
Figure 6 presents three phases of motion of the dummy located in the driver's compartment. After 120 ms from the impact, the maximum bending of the dummy's neck occurs. In case of higher velocities, the dummy's head also hits the edge of a hatch in the ceiling plate. It generates high values of forces squeezing the neck. Due to the use of a four-point seat belt, motion of the whole body is significantly limited. Only motion of the head and shoulders is visible. After 300 ms, the body bends backwards, which is characteristic for frontal collisions. The body is stopped on the backrest of the seat, while the head, in case of no head restrain, strongly tilts backwards.

*Fig. 6. Phases of motion of the dummy located in the driver's compartment (trial no. 4)*

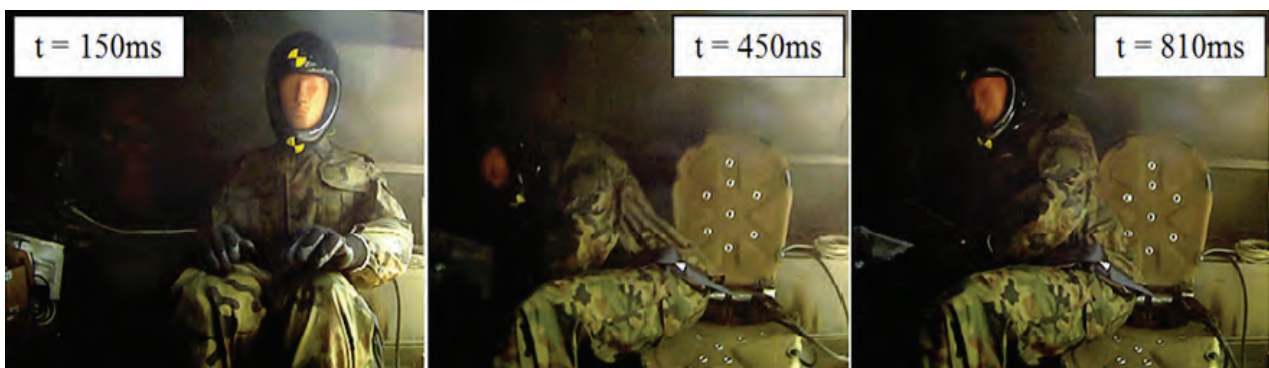
Different behaviour can be observed for a dummy located in the landing troop compartment (Fig. 7). The dummy is placed on a seat located crosswise towards direction of motion and it is protected with just a lap belt. In about 300 ms from the moment of impact, the maximum dummy displacement can be observed. Due to the fact that the pelvis is held by the belt, the body and the heads bend to the right side with simultaneous bending forward and a slight turn against the vertical axis. After the impact, the dummy does not fully return to its initial position and stops after about 660 ms.

*Fig. 7. Phases of motion of the dummy located in the landing troop compartment (trial no. 4)*

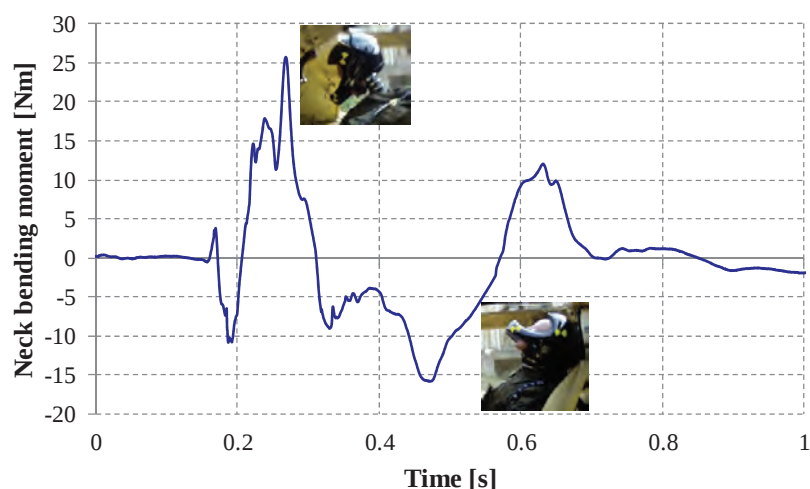
Figure 9 presents an example of the course of the neck bending moment for a dummy located in the driver's compartment for a trial no. 4. It shows indicated points where extreme values were obtained during head bending.

At the beginning, there is a short moment of bending the head backwards when the dummy's torso is pushed upwards. After that stage, the dummy's head is bent forwards and the maximum value of the moment is reached. It makes a basis for further evaluation.

Fig. 8. The course of the neck bending moment for a dummy located in the driver's compartment (trial no. 4)

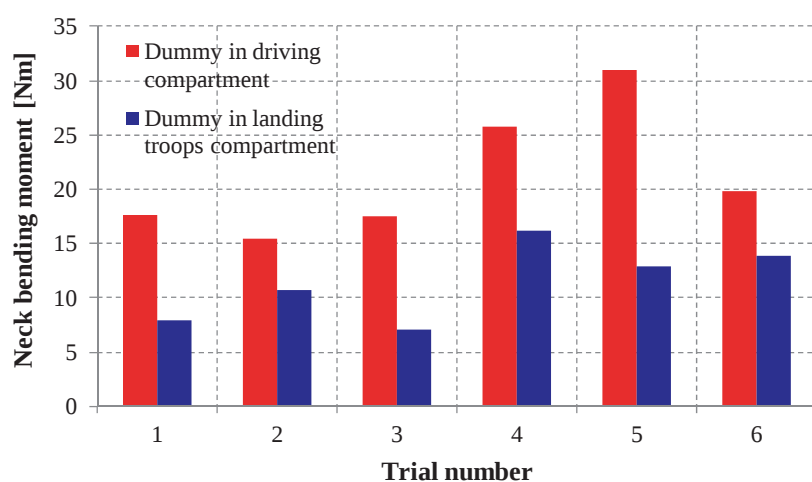
The maximum moments for individual trials are specified on fig. 9. It should be mentioned that in case of the dummy placed in the landing troop compartment, presented values refer to the moment of bending the head to the side (acting against the longitudinal axis of the dummy). The maximum values were obtained for a trial 5 and amounted to about 31 Nm. Once again, higher harmony in obtained results was stated for lower velocities.

Fig. 9. The maximum values of neck bending moment

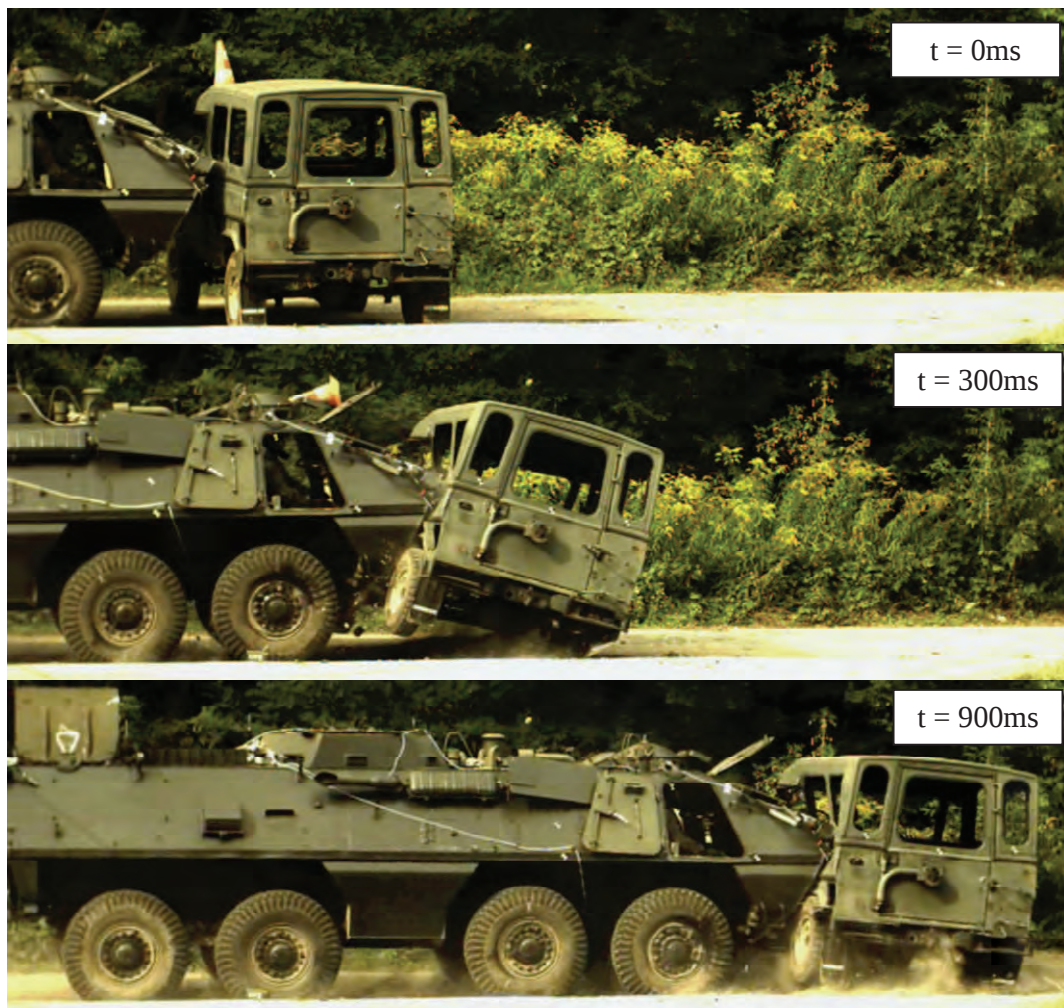
At the second stage of the research, three crash tests with a motionless vehicle, Tarpan Honker, placed longitudinally and crosswise against direction of the carrier motion, were carried out. Fig. 10 presents selected phases of the crash for a vehicle placed crosswise to the right side.

*Fig. 10. Phases of APC collision with a Tarpan Honker*

After collision, the vehicle was pushed sideways until complete stopping. While in case of the crash test when hitting a vehicle in the back, it was pushed forward. Due to big differences in weights of the vehicles taking part in the collision (11 960 kg for the SKOT personnel carrier and 1360 kg for the Tarpan Honker), recorded values for the carrier body decelerations are many times lower than the values obtained in the crash tests with a rigid wall. The maximum decelerations values amounted to about 1 g.
