## ATTEMPT OF INJECTORS FAILURE DETECTION BASED ON MEASUREMENT OF THE ANGULAR SPEED DISCRETE VALUE

Mirosław Dereszewski, Adam Charchalis

Gdynia Maritime University  
Mechanical Faculty  
Morska Street 83, 81-225 Gdynia, Poland  
tel.: +48 58 6901398  
e-mail: deresz1@o2.pl, achar@am.gdynia.pl

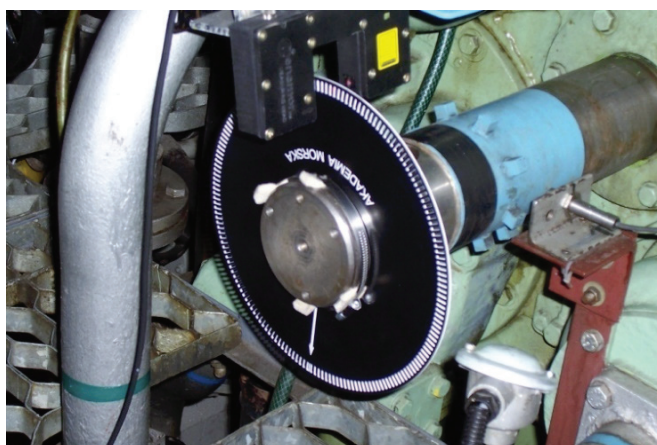
Fig. 1. Perforated disc and laser sensor mounted at crankshaft's free end

The rig for carrying out the experiment consist of instantaneous angular speed measurement set consisting of perforated disc and optical sensor, Fig. 1, and data processing and storage block ETNP – 10.

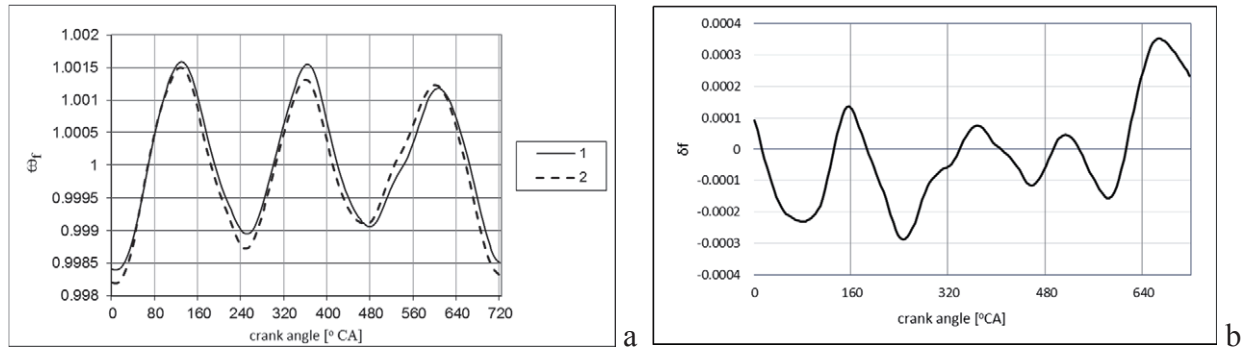
Fig. 2. Runs of relative angular speed of healthy engine (line 1) and faulty (line 2) – a, and related to that failure values of parameter  $\delta_f$  – b

possible and whether evaluation of severity (fault level) of malfunction is possible. Answers for all above questions shall come from one source – analysis of angular speed deviation. For detecting and localisation of malfunctions, three diagnostic parameters were elaborated. First one was designated as a difference between relative angular speed of runs with simulated malfunction and healthy engine. Example of runs of healthy and faulty condition comparison and the curve of coefficient  $\delta_f$  are presented in Fig. 2.

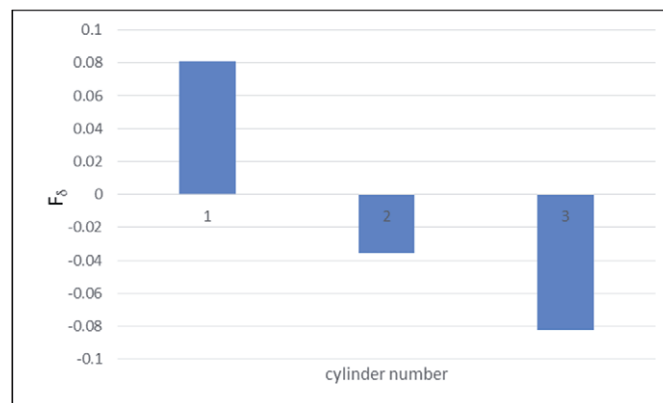
Fig. 4. Example of pattern of diagnostic parameter  $F_\delta$  for 3-cylinder engine

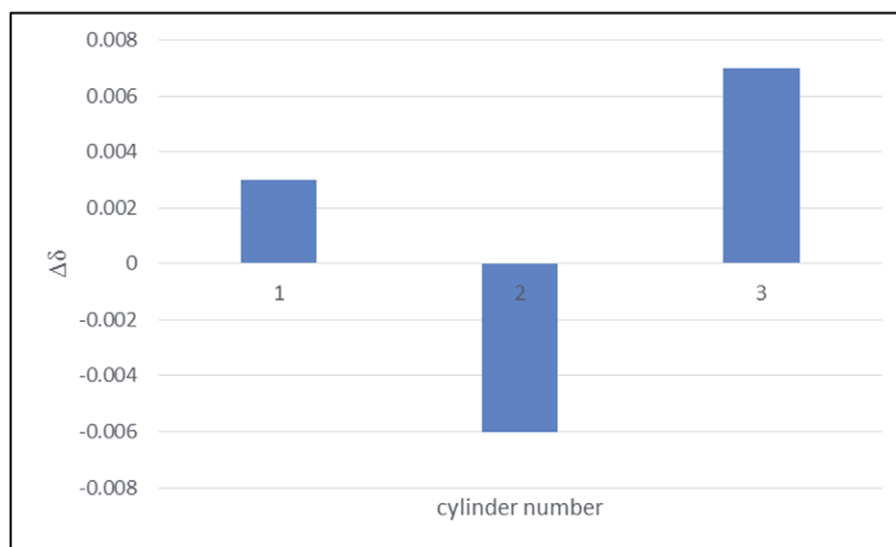
Fig. 5. Example pattern of diagnostic parameter  $\Delta\delta$  of 3-cylinder engine

Third parameter was a difference of  $\delta_f$  value in the end and the beginning of interval and was signed as  $\Delta\delta$ . Example of parameter's values for three cylinders is presented in Fig. 5. This parameter describes general tendency of relative angular speed changes in angular interval between TDC's of subsequent working strokes.

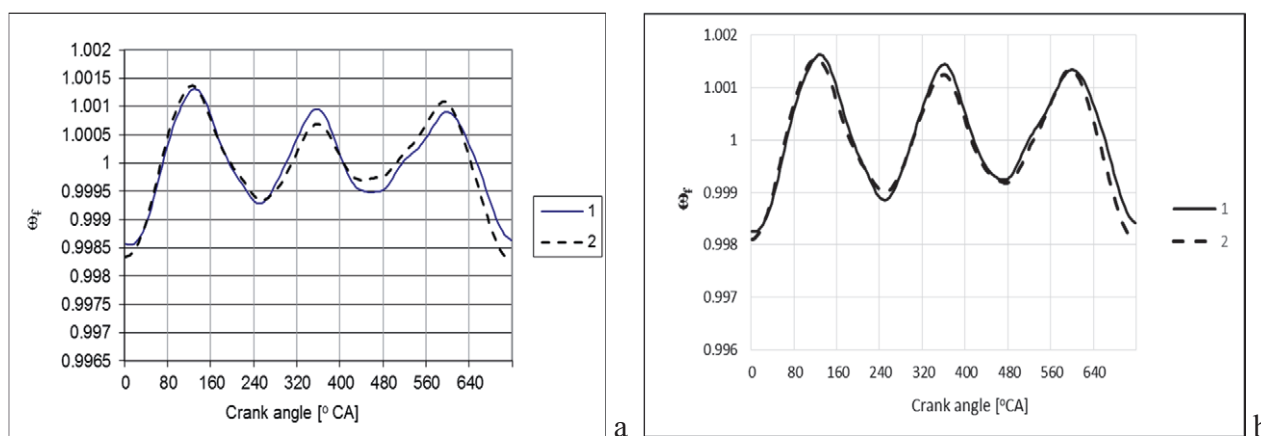
Fig. 6. Angular speed variations of healthy engine (2) and “weak spring” (1): a – load 150 kW; b – load 250 kW

First simulated malfunction was the incorrect return spring adjustment set at 15.0 MPa instead of required 25.0. Faulty injector was installed in second cylinder. Measurements were carried out at load of 150 kW and subsequently at 250 kW. Every record consisted of 10 revolutions (5 cycles) and was repeated three times for further averaging. Averaged record was smoothed using triple noise decomposition by Savitzky – Golay Filter. After smoothing, the curve was compared with healthy engine run and diagnostic coefficient were calculated. Results of attempt of detection weak spring malfunction are presented below. Comparison of runs of healthy engine and with malfunction are presented in Fig. 6.

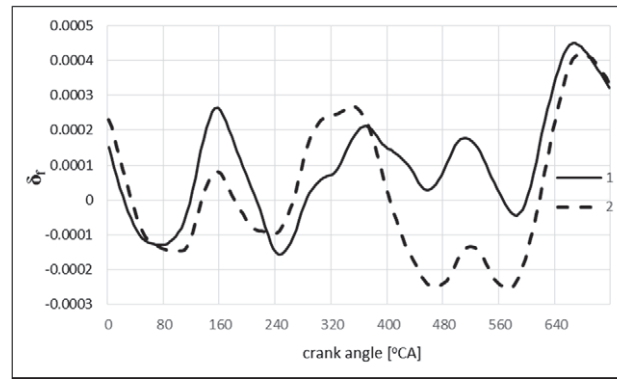
Coefficient  $\delta_f$  presented in Fig. 7 reflects deviations from healthy run. Maximum value of deviation's span is about 23% of maximum value of healthy engine fluctuation. The picture shows difference between runs, in interval of 320°-600° CA, what indicates influence of load at angular speed disturbance due to malfunction of the injection valve.

Fig. 7. Values of parameter  $\delta_f$  "weak spring": 1 – load 250 kW, 2 – load 150 kW

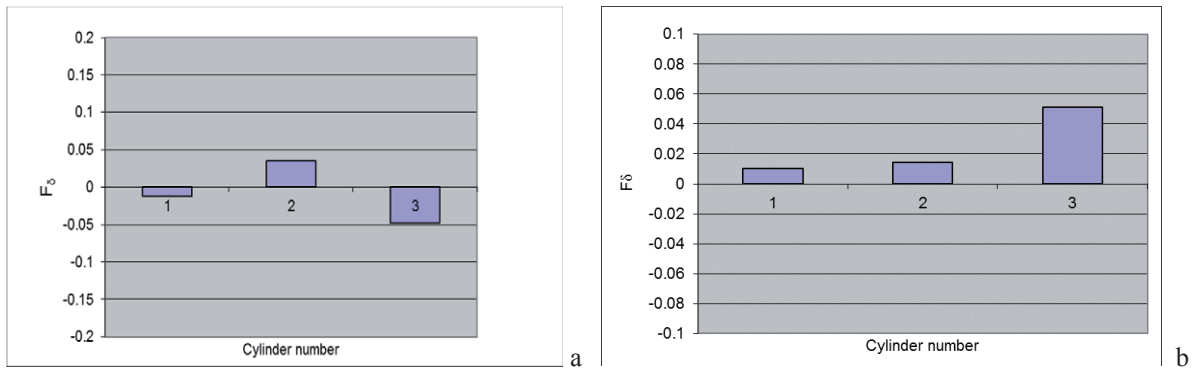
Coefficient  $F_\delta$  presented in Fig. 8 shows tendency of changes of kinematic energy of rotation. Irregularity of pattern indicates that engine is in state of malfunction. The biggest deviation from normal condition is observed in zone of the 2<sup>nd</sup> cylinder, at load of 150 kW, and the 3<sup>rd</sup> cyl. at load of 250 kW.

Fig. 8. Pattern of coefficient  $F_\delta$  "weak spring": a – load 150 kW, b – load 250 kW

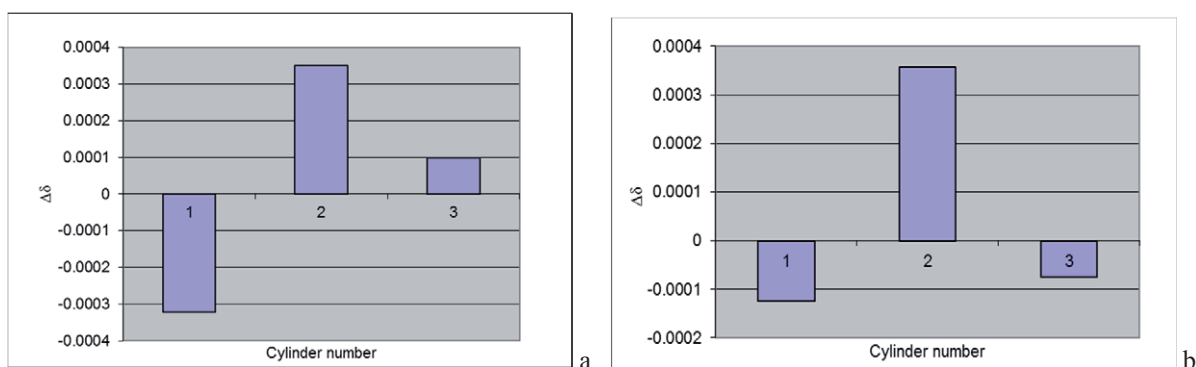
Coefficient  $\Delta\delta$  presented in Fig. 9. shows general tendency of relative angular speed deviation from normal condition run. This parameter points faulty cylinder in way of comparison of absolute values, where highest value indicates the faulty one.

Fig. 9. Pattern of coefficient  $\Delta\delta$  "weak spring": a – load 150 kW; b – load 250 kW – b

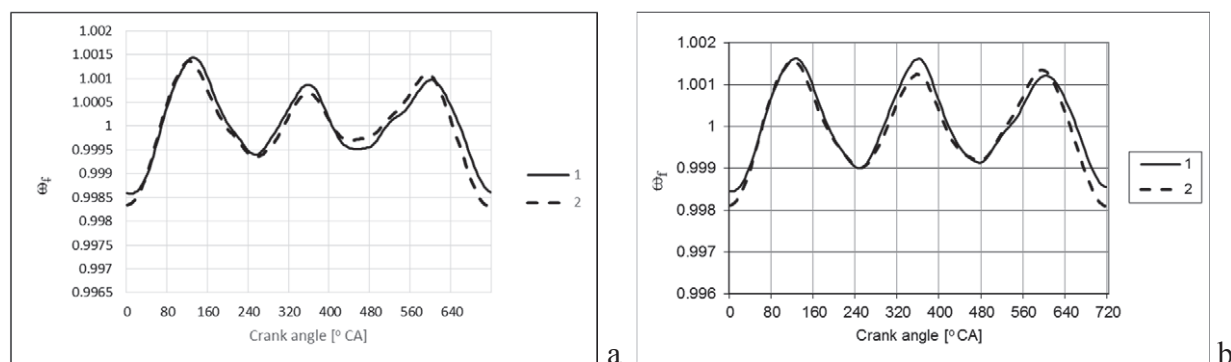
Fig. 10. Angular speed variations of healthy engine (2) and “strong spring” (1): a – load 150 kW; b – load 250 kW

calculated. Results of attempt of detection of the “strong spring” malfunction are presented below. Runs comparison is presented in Fig. 10, coefficient  $\delta_f$  in Fig. 11, coefficient  $F_\delta$  in Fig. 12 and coefficient  $\Delta\delta$  in Fig. 13.

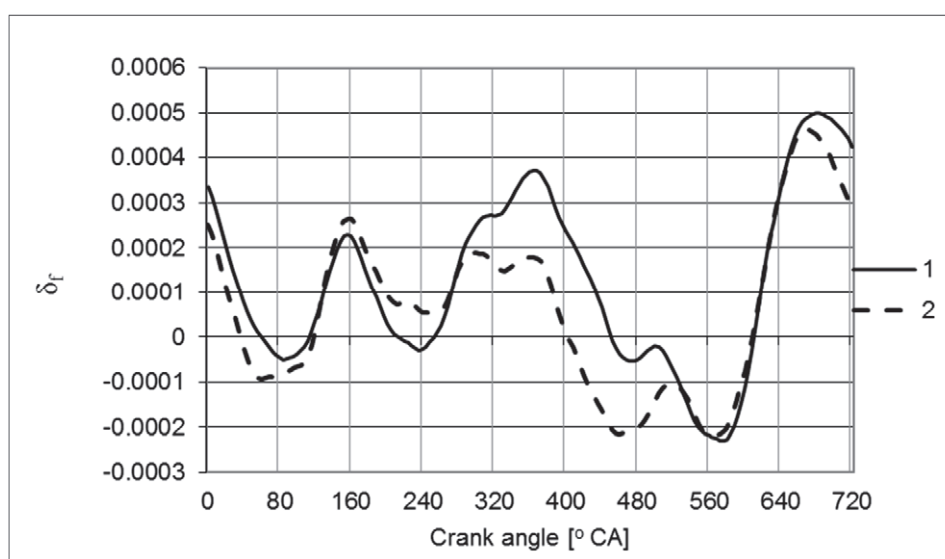
Coefficient  $\delta_f$  presented in Fig. 11 shows deviations from healthy run. Maximum value of deviation’s span is about 33% of maximum value of the healthy engine fluctuation, what is 10% higher than recorded for “weak spring”. Picture shows difference between runs in interval of 320°–540° CA, what indicates influence of the engine load at value of deviation caused by the injection valve malfunction.

Fig. 11. Values of parameter  $\delta_f$  for “strong spring”: 1 – load 250 kW, 2 – load 150 kW

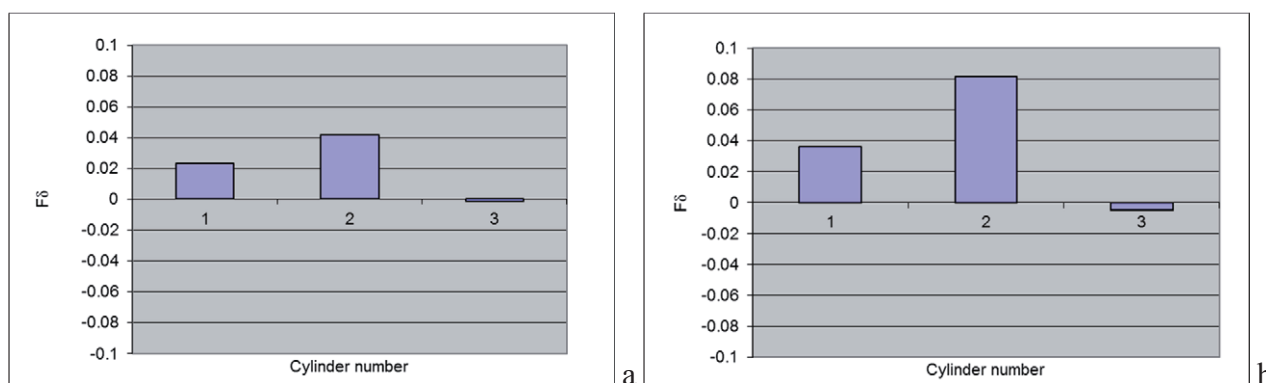
Fig. 12. Pattern of coefficient  $F_\delta$  for “strong spring”: a – load 150 kW, b – load 250 kW

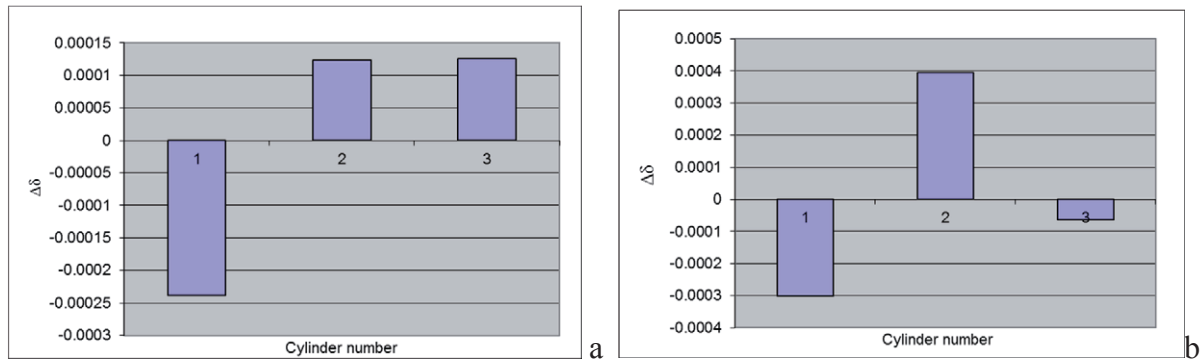
Fig. 13. Pattern of coefficient  $\Delta\delta$  for "strong spring", a – load 150 kW; b – load 250 kW
