## THE COMPUTER-AIDED ANALYSIS OF IMAGES TO ASSESS CONDITION OF GAS TURBINE BLADES

### **Abstract**

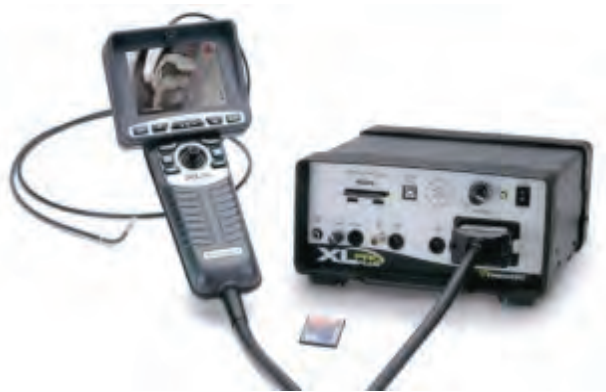
Images that present surfaces of gas turbine blades are usually acquired with use of optoelectronic devices, i.e. videoscopes or video analysers [3]. Such devices make it possible to take snapshots of hard accessible machine parts. Such devices (Fig. 1) are made up of a central unit that performs as a portable workstation capable of managing the acquired data as well as of an inspection probe provided with a powerful illumination source that provides a focused light beam, although such a light source makes it difficult to illuminate the investigated surface in a uniform manner.

*Fig. 1. An optoelectronic device – a videoscope [3]*
